MCTPC - SEACAP 21/003 - DFID

**MAINSTREAMING SLOPE STABILITY MANAGEMENT INTO
THE NATIONAL UNIVERSITY OF LAO COURSES AND THE MPWT**

TERMINAL REPORT

January 2009

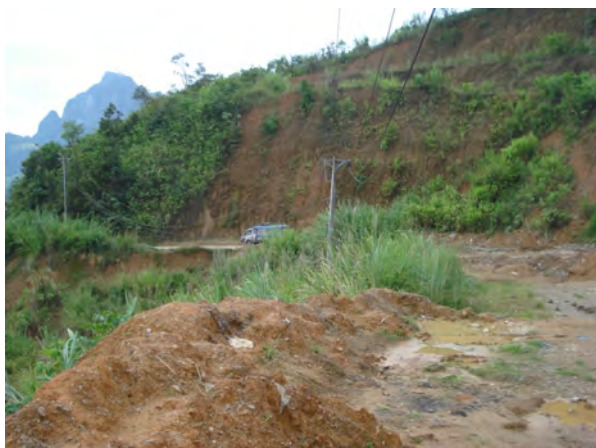
Landslide site at km 239.3

This is a pre-existing landslide with a toe in the stream channel below and a current head at original road level. It is likely that the failure was originally precipitated or aggravated by the placement of fill on the slope as a result of original road construction and, more lately, spoil disposal.

The present failure occurred during the 2008 wet season and appears to have regressed from the lower slope headwards, ultimately removing all support to the road over a distance of 60m or more.

Field observations indicate that failure at the top of the slope above the stream channel is active, probably even in the dry season. From the limited ground investigations undertaken it appears that most of the slope comprises a thickness of gravelly clay (fill material) and possible previous landslide debris overlying a silt/clay material, which is interpreted to be derived from in situ weathering of the underlying rock.

The earlier engineering response to this landslide has been to realign the road progressively into the hillside. The recommended measures are to construct a mortared masonry retaining wall on the outside edge of the road, founded on intact material beneath the failure surface. The horizontal alignment for the road should be as 'tight' to the existing cut slope as possible. It is anticipated that the depth of this wall should be up to 6m below original (pre-current earthworks) ground level, to as little as 2m – 3m in the vicinity of the trial pit locations. Removal of soil and fill from the landslide head should lead to an overall improvement in the stability of the slope below. It is recommended that visual monitoring of the alignment is carried out immediately up (239+430) and down chainage (239+250) as the movements below the road extend into these areas as well. It will be important to ensure close geotechnical supervision during construction in order to derive final designs and founding depths.

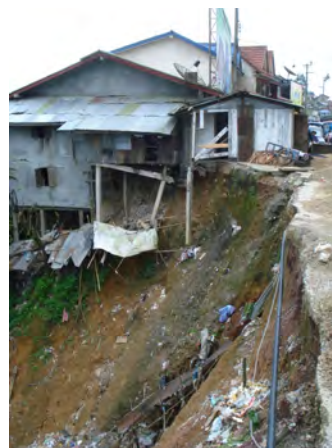
Landslide site at km 257.1

This failure occurred during the 2008 wet season in the centre of Phou Khoun. The road edge was previously retained by a masonry wall, which has collapsed into the gully below. There is a culvert outlet at this location and it is anticipated that scour beneath this outlet originally led to loss of support to the wall and its eventual failure. There is also a water supply pipe that runs across the slope, and it is understood that leakage from this also contributed to the problem. Failure of the wall has led to exposure of the road edge over a distance of approximately 15m.

Early considerations here were for a reinforced concrete cantilevered road retaining wall. Depending upon materials ultimately exposed this wall would require an exposed height of up to 7m, plus foundation, though it is likely that the required height could be significantly less than this. If this option is taken up then it will be necessary to carry out in situ testing of the ground for bearing capacity confirmation.

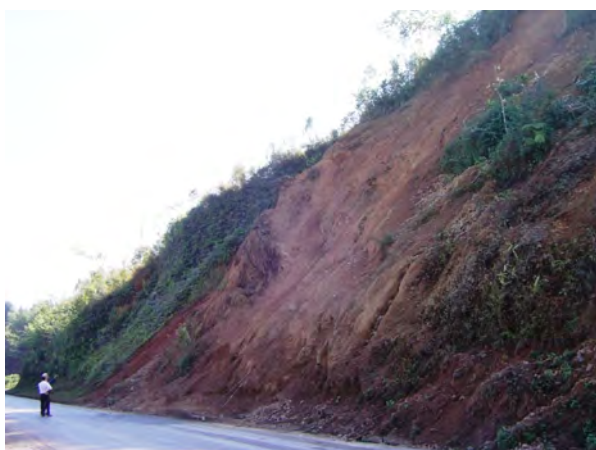
Landslide site at km 257.9

This is a cut slope failure in weathered and closely jointed phyllite. The failure depth is shallow and the slope is steep (up to 1:1 in places). The lower part of the slope is covered in slide material from above, and appeared damp during the 21/003 site inspection. There is therefore likely to be a significant source of water which will aggravate instability. Above the cut slope there is a break in slope. Inspection of this slope revealed evidence for additional instability, possibly ultimately related to the cut slope failure below. Given the uncertainty, however, it is recommended that efforts are focussed on the cut slope only. It is recommended that this comprises a 3m high, 40m long composite masonry revetment. Debris clearing and trimming from the slope in general should take place prior to constructing this wall and bio-engineering applied to the final slope.

km 257.9	108031/DWG/301 108031/DWG/302	Clear existing debris within the failed area and trim back any back or side scarps to a smooth profile. Construct 3m high, 40m long composite

masonry revetment at the toe of the slope. Plant three lines of brush layering immediately above the revetment. Elsewhere within the trimmed area plant grass slips at the spacing shown on the drawings. Reconstruct the roadside drain at the base of the revetment.
km 317.9	108031/DWG/401 108031/DWG/402	Construct 60m long gabion retaining wall as close to the base of the existing cut slopes making due allowance for the road width. Wall likely to be founded up to 6m depth but could be less than this towards each end. It is very likely that good ground conditions may not exist within the central section of the wall, but a greater depth of wall is not recommended unless it is certain that better stable conditions are no more than 1 - 2m lower. The wall dimensions should be as those given in the Slope Maintenance Manual, drawing SMM/DWG/002. On the valley side of the new wall the fill should be removed from site and disposed of at a safe stable location. It must be emphasised that the wall only provides a temporary solution, and that in the long term, wall movements can be expected to occur.

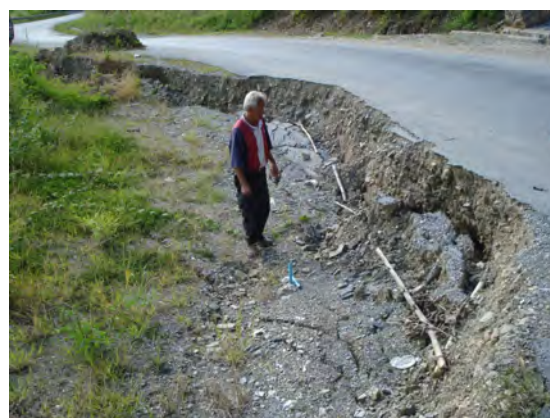
Landslide site at km 317.9

This is a large landslide that extends from the stream channel below the road to the hillside above. There is every indication that this landslide has been in existence for many years. The road had been realigned further into the hillside prior to the commencement of 21/001, but in recent years it is apparent that movements have continued and the road continues to fail. In 21/001 the extent of this movement was recognised and some surface improvement works and monitoring was carried out. The ground movements have continued and some of these works have been damaged as a result.

During 21/001 three boreholes were put down. These found landslide and fill material but were inconclusive in terms of identifying the failure plane. A makeshift inclinometer was installed in one of these holes and readings implied shallow movement at a depth of approximately 2.4m below ground level. This is interpreted to be movement on a shallow surface, above the main landslide movement.

During 21/003 further field observation have been made and it is confirmed that the slopes below and above the road are continuing to fail. Movements on the slopes above the stream channel below the road are particularly active.

The driving force for this movement is anticipated to be toe erosion (at least in terms of precipitating the original failure), slope steepness on the lower slope, weak material on the sliding surface (as yet unconfirmed) and groundwater, given the large catchment area above. The placement of fill and spoil on the slope may have aggravated the instability.

The recommendation at this site is to construct a gabion retaining wall to a depth of up to 5m. This should retain the road against shallow failure but cannot be founded beneath the ultimate failure surface that might be of the order of 10m based on field observations (ref drawing 108031/DWG/401). Consequently, the wall will provide some temporary support to the road but may ultimately fail. It will be important to ensure close geotechnical supervision during construction in order to derive final designs and founding depths.

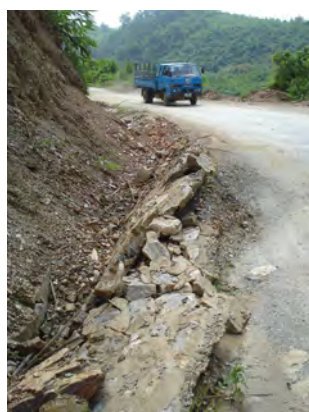
Landslide site at km 336.4

The section of road between 336+295 and 336+330 has been undergoing deep seated movement since before SEACAP 21/001 began in October 2006. Boreholes were put down on the outside edge of the road but these were inconclusive in terms of failure depth and materials. The interpretation at the time of 21/001 was that the failure had been precipitated as a result of the steepness of slope, the extremely disturbed nature of the underlying rock (as exposed in the cut slope) and possibly, originally, toe erosion in the river below. The rock appears to be particularly weak and tectonically disturbed. The conclusion of 21/001 was that a solution at this location would be expensive and would probably comprise the extension of the existing culvert at 336+220 downstream to a point where it would have enabled a fill slope to be constructed above it, thus providing support to the slope above. Such a solution would need careful investigation and design were the funds to be available. The 21/001 works were only therefore aimed at carrying out monitoring and superficial slope improvement and drainage works.

During 21/003 fieldwork it has become apparent that the extent of slope instability has increased significantly. This increased instability comprises a slow failure of the entire cut slope between 336+230 and 336+330. It is apparent that this failure has daylighted in the toe of the cut slope because the side drain is pushed forward in many places. The road between 336+230 and 336+295

is not yet showing any signs of disturbance, which supports this interpretation. The hillsides above the road are also failing in association with the cut slope instability described above. The majority of this movement appears to be fresh, i.e. indicative of first-time movement, though there is evidence of weathered scarp slopes indicative of previous movement.

Given that the only permanent solution would be to realign the road away from the cut slope into the valley on the top of a substantial culverted fill slope, and in view of the significant cost of carrying out such works, the recommendation here is to accept that movements of the road will continue to occur and to make adequate provision for maintenance that might include regular reinstatement of the road surface and the roadside drain, as well as minor cut slope trimming.

km 336.4	108031/DWG/501 108031/DWG/502	Remove all loose debris. Reinststate road surface and roadside drain.
Km 341.2 341.8	108031/DWG/601 108031/DWG/602	Construct mortared masonry retaining walls 8m and 5m long at the locations shown on the drawings. These must be located immediately adjacent to the existing road such that the crest of the wall is at the road edge. The walls must be founded in original ground (weathered rock) and are expected to be up to 3m depth. The existing failed areas in the slopes below should be cleared of loose debris and any back or side scarps trimmed back to a smooth profile. The surface should then be protected using both bio-engineering methods and hand-applied concrete in the areas shown on the drawings.

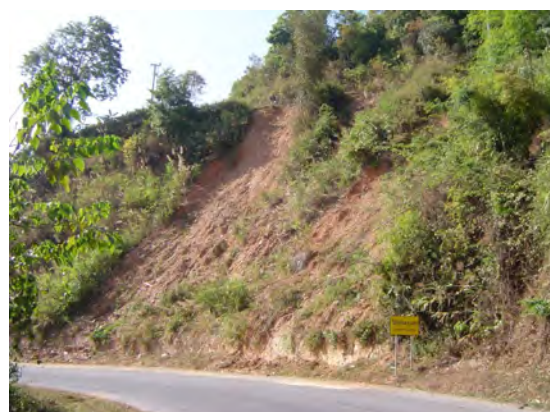
Landslide site at km 341.2

This is a slope located between two sections of road joined by a hairpin bend. Shallow instability (probably 1-2m deep) has occurred over large parts of the slope over a road distance of approximately 50m. The instability has taken place predominantly in the upper slope and this has extended back to the edge of the side drain to the upper road in two main locations. The scars associated with these features are approximately 8m and 5m width respectively. If this process is allowed to continue then the edge of the road itself will itself fail. The debris from these failures has overtopped the revetment wall to the road below and material is in the side drain.

The side drain to the upper road section on the outside edge is surplus to drainage requirements and it is recommended that it is filled in. This would allow walls to be constructed in masonry to the edge of the road on the upper section. These walls should be constructed in masonry and founded on in situ rock beneath the fill that currently comprises the upper slope. Once this is done and the material has been trimmed, the resultant slope below the walls should be protected with hand-applied shotcrete down to the level of the steep break in slope below. This should be sufficient to protect the upper section of road. For the section below, it is recommended that all loose material be cleared and the slope protected with bio-engineering. If, in this process loose intact rock is exposed in places, then this can be protected with either hand-applied shotcrete or masonry revetment.

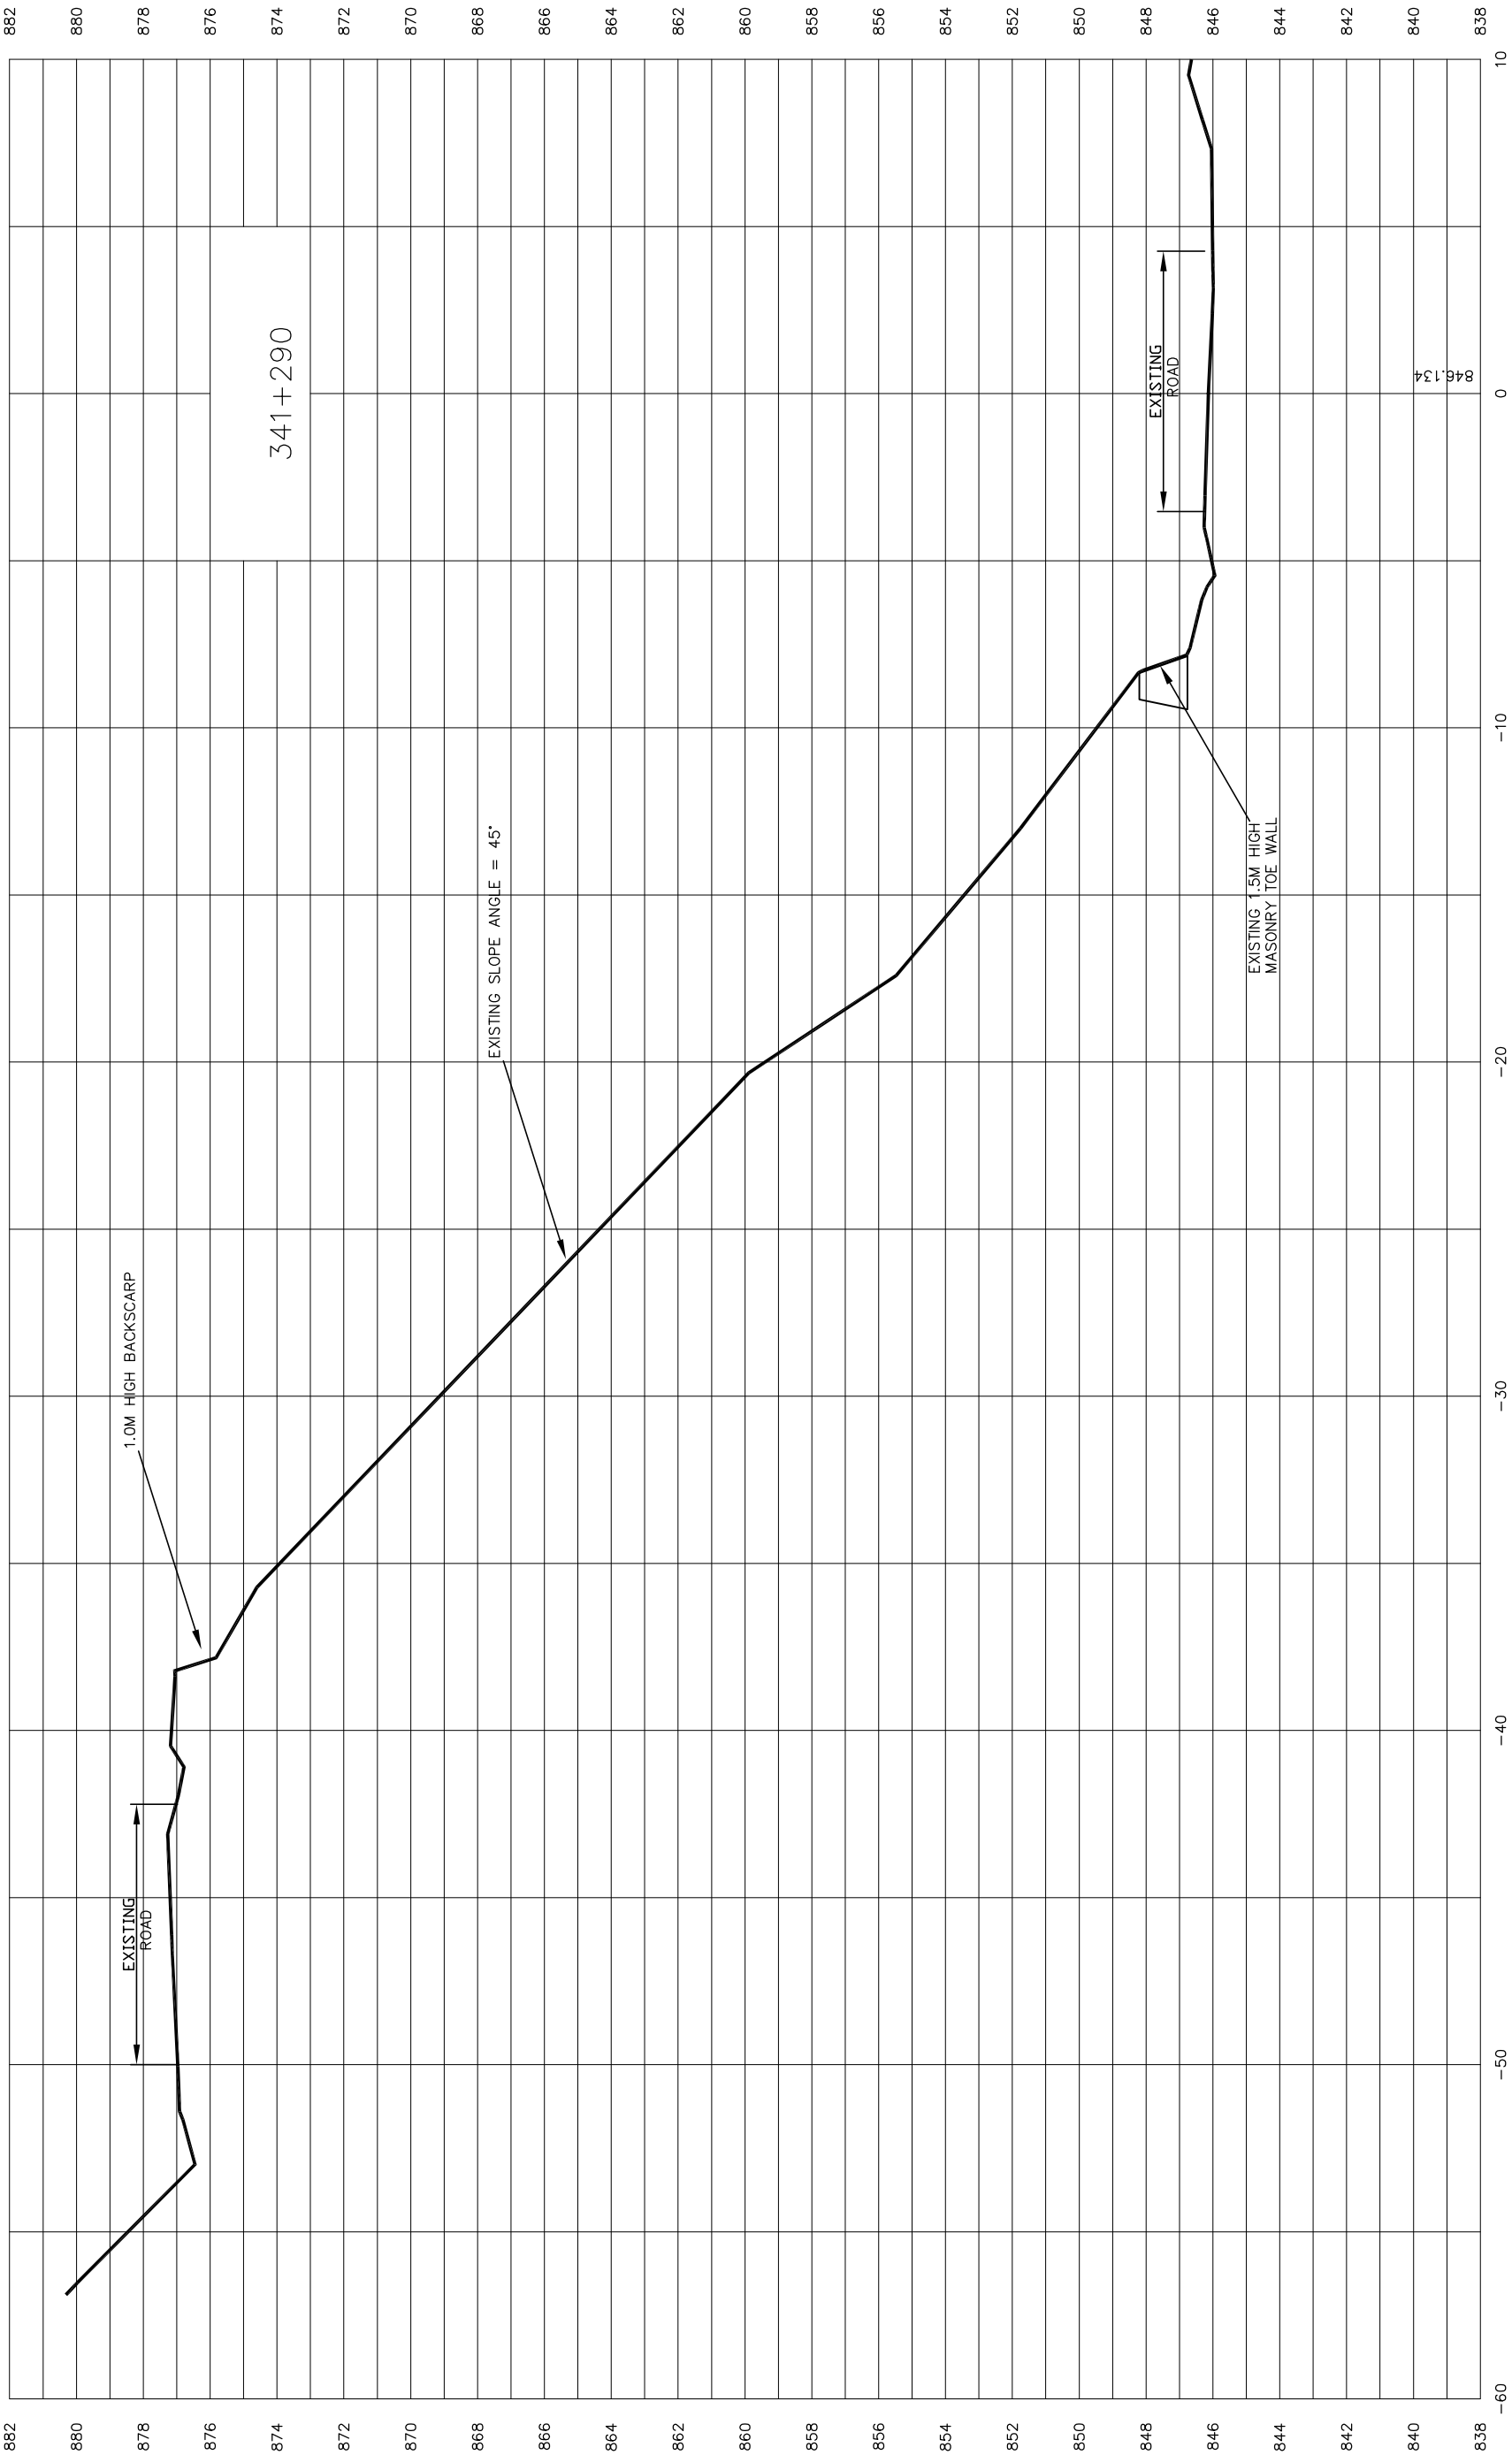
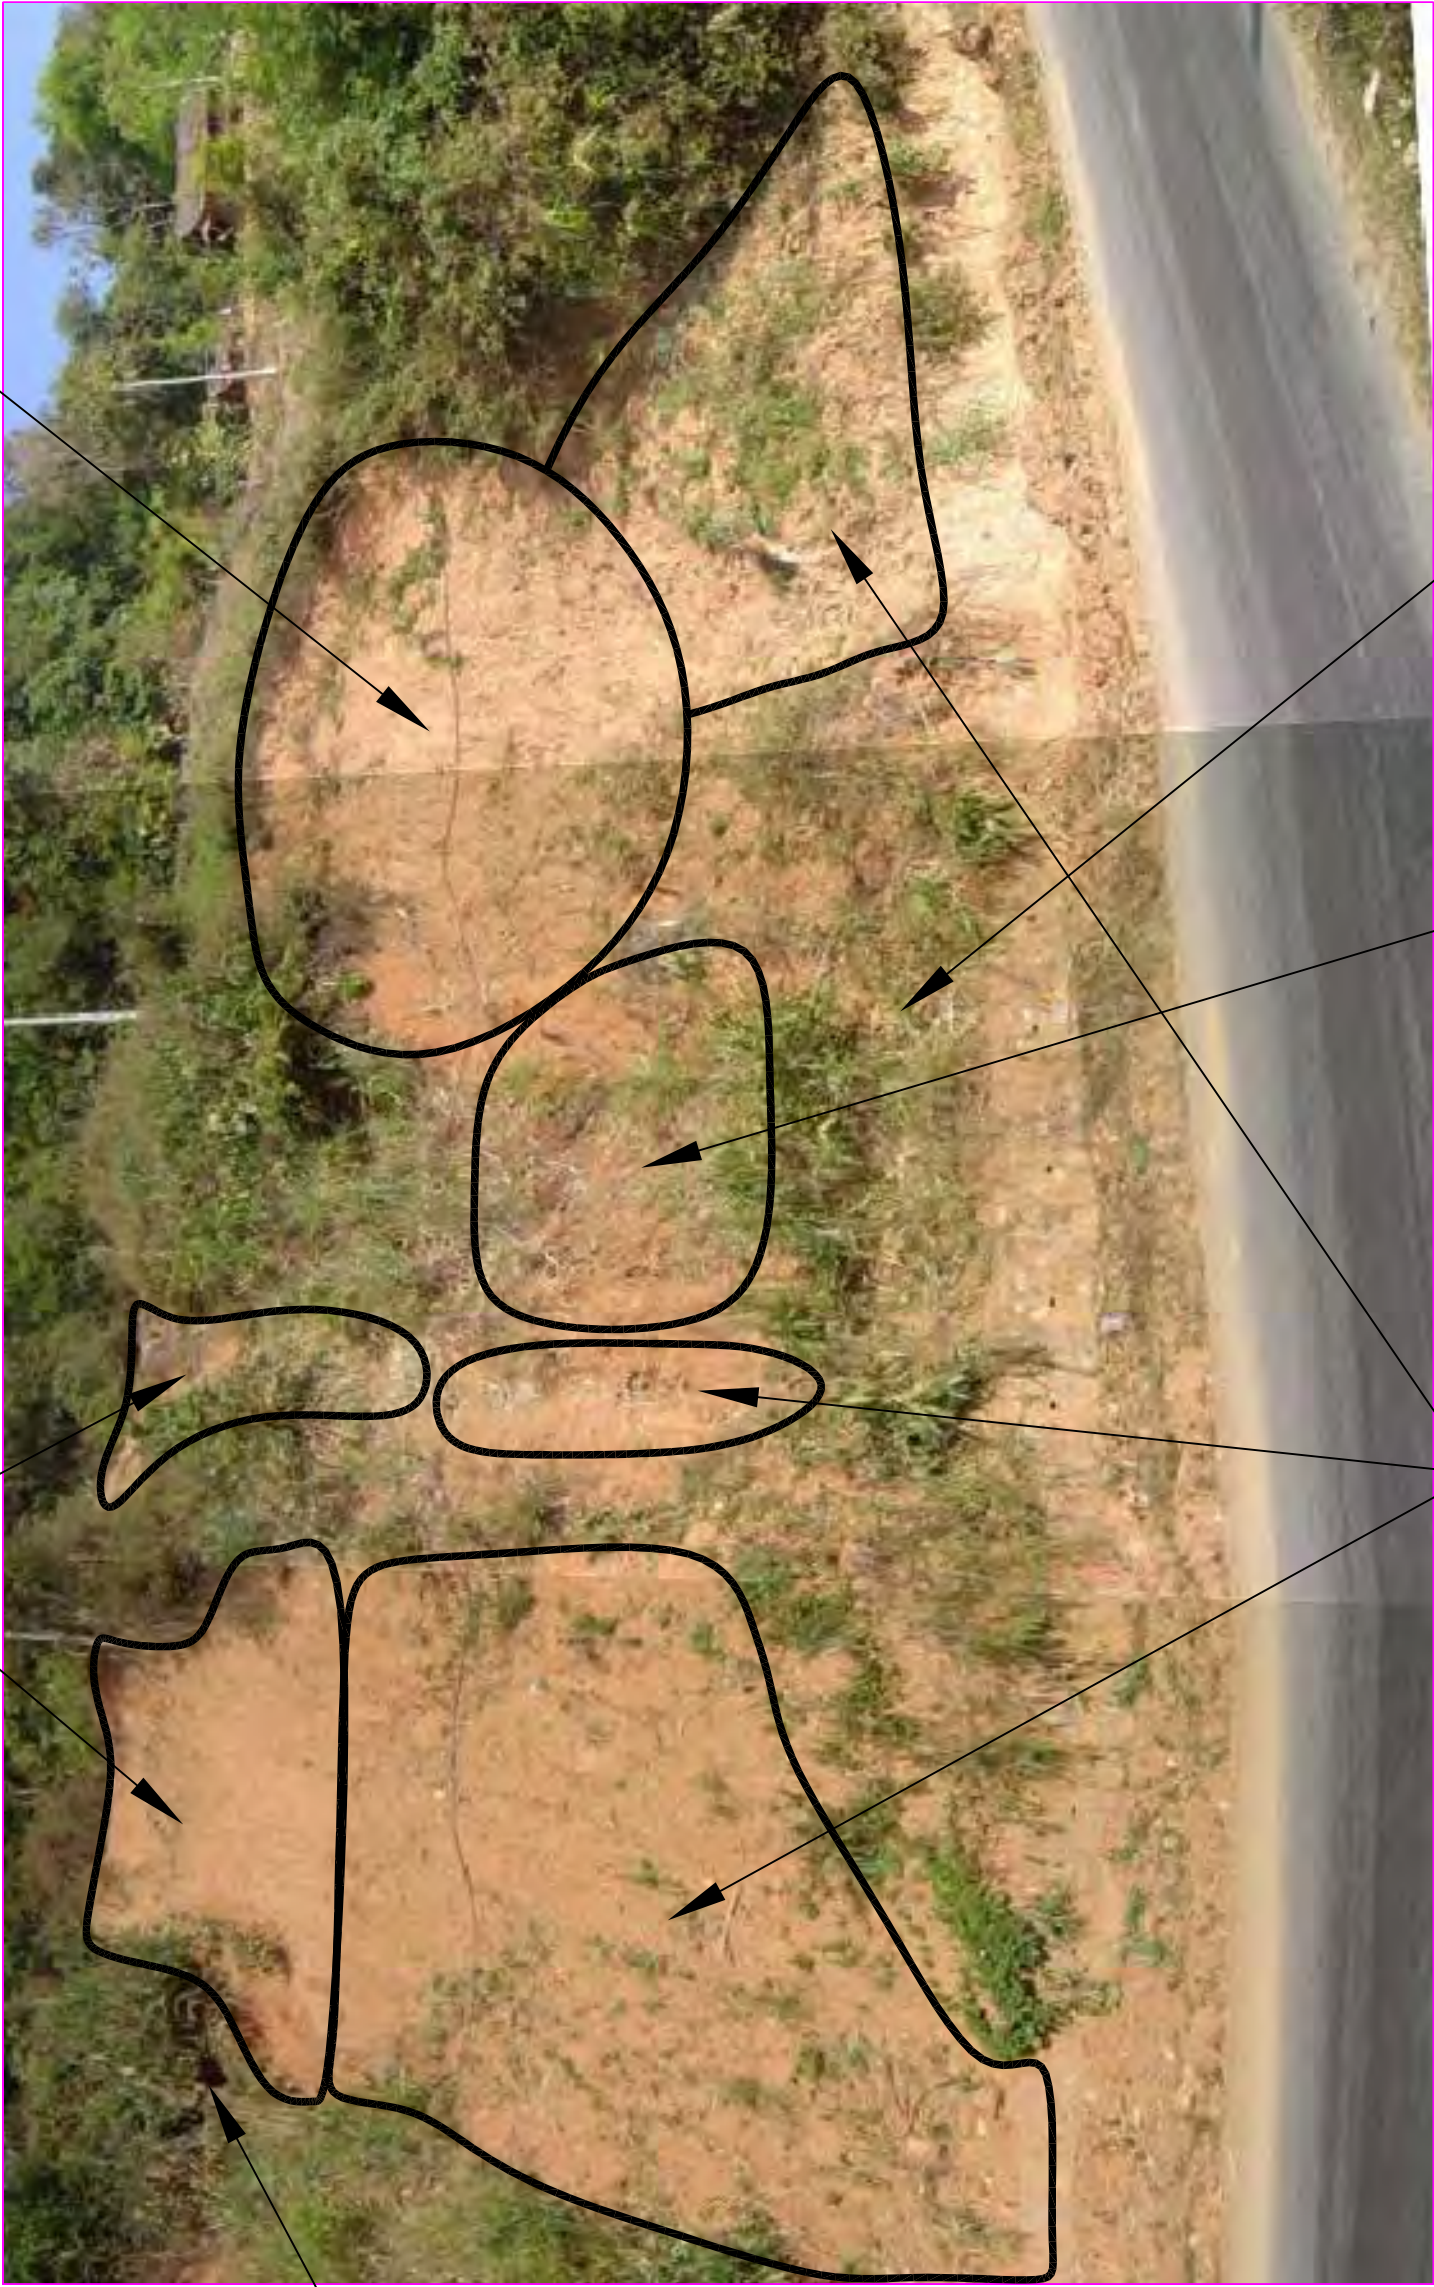
ROAD 13 N - KM 341.2
RECOMMENDED REMEDIAL WORKS

POSSIBLE RE-ACTIVATION
OF REVEGETATED FAILURE:
OBSERVE IN 2009 WET SEASON

CONCRETE 50MM HAND-APPLIED
REINFORCED SURFACING BELOW
NEW RETAINING WALLS

REPAIR DAMAGED VEGETATION
WITH GRASS PLANTING AS NECESSARY
WHEN TRIMMING OF DEBRIS IS COMPLETE
