**MCTPC - SEACAP 21/003 - DFID**

**MAINSTREAMING SLOPE STABILITY MANAGEMENT INTO  
THE NATIONAL UNIVERSITY OF LAO COURSES AND THE MPWT**

**TERMINAL REPORT**

**January 2009**

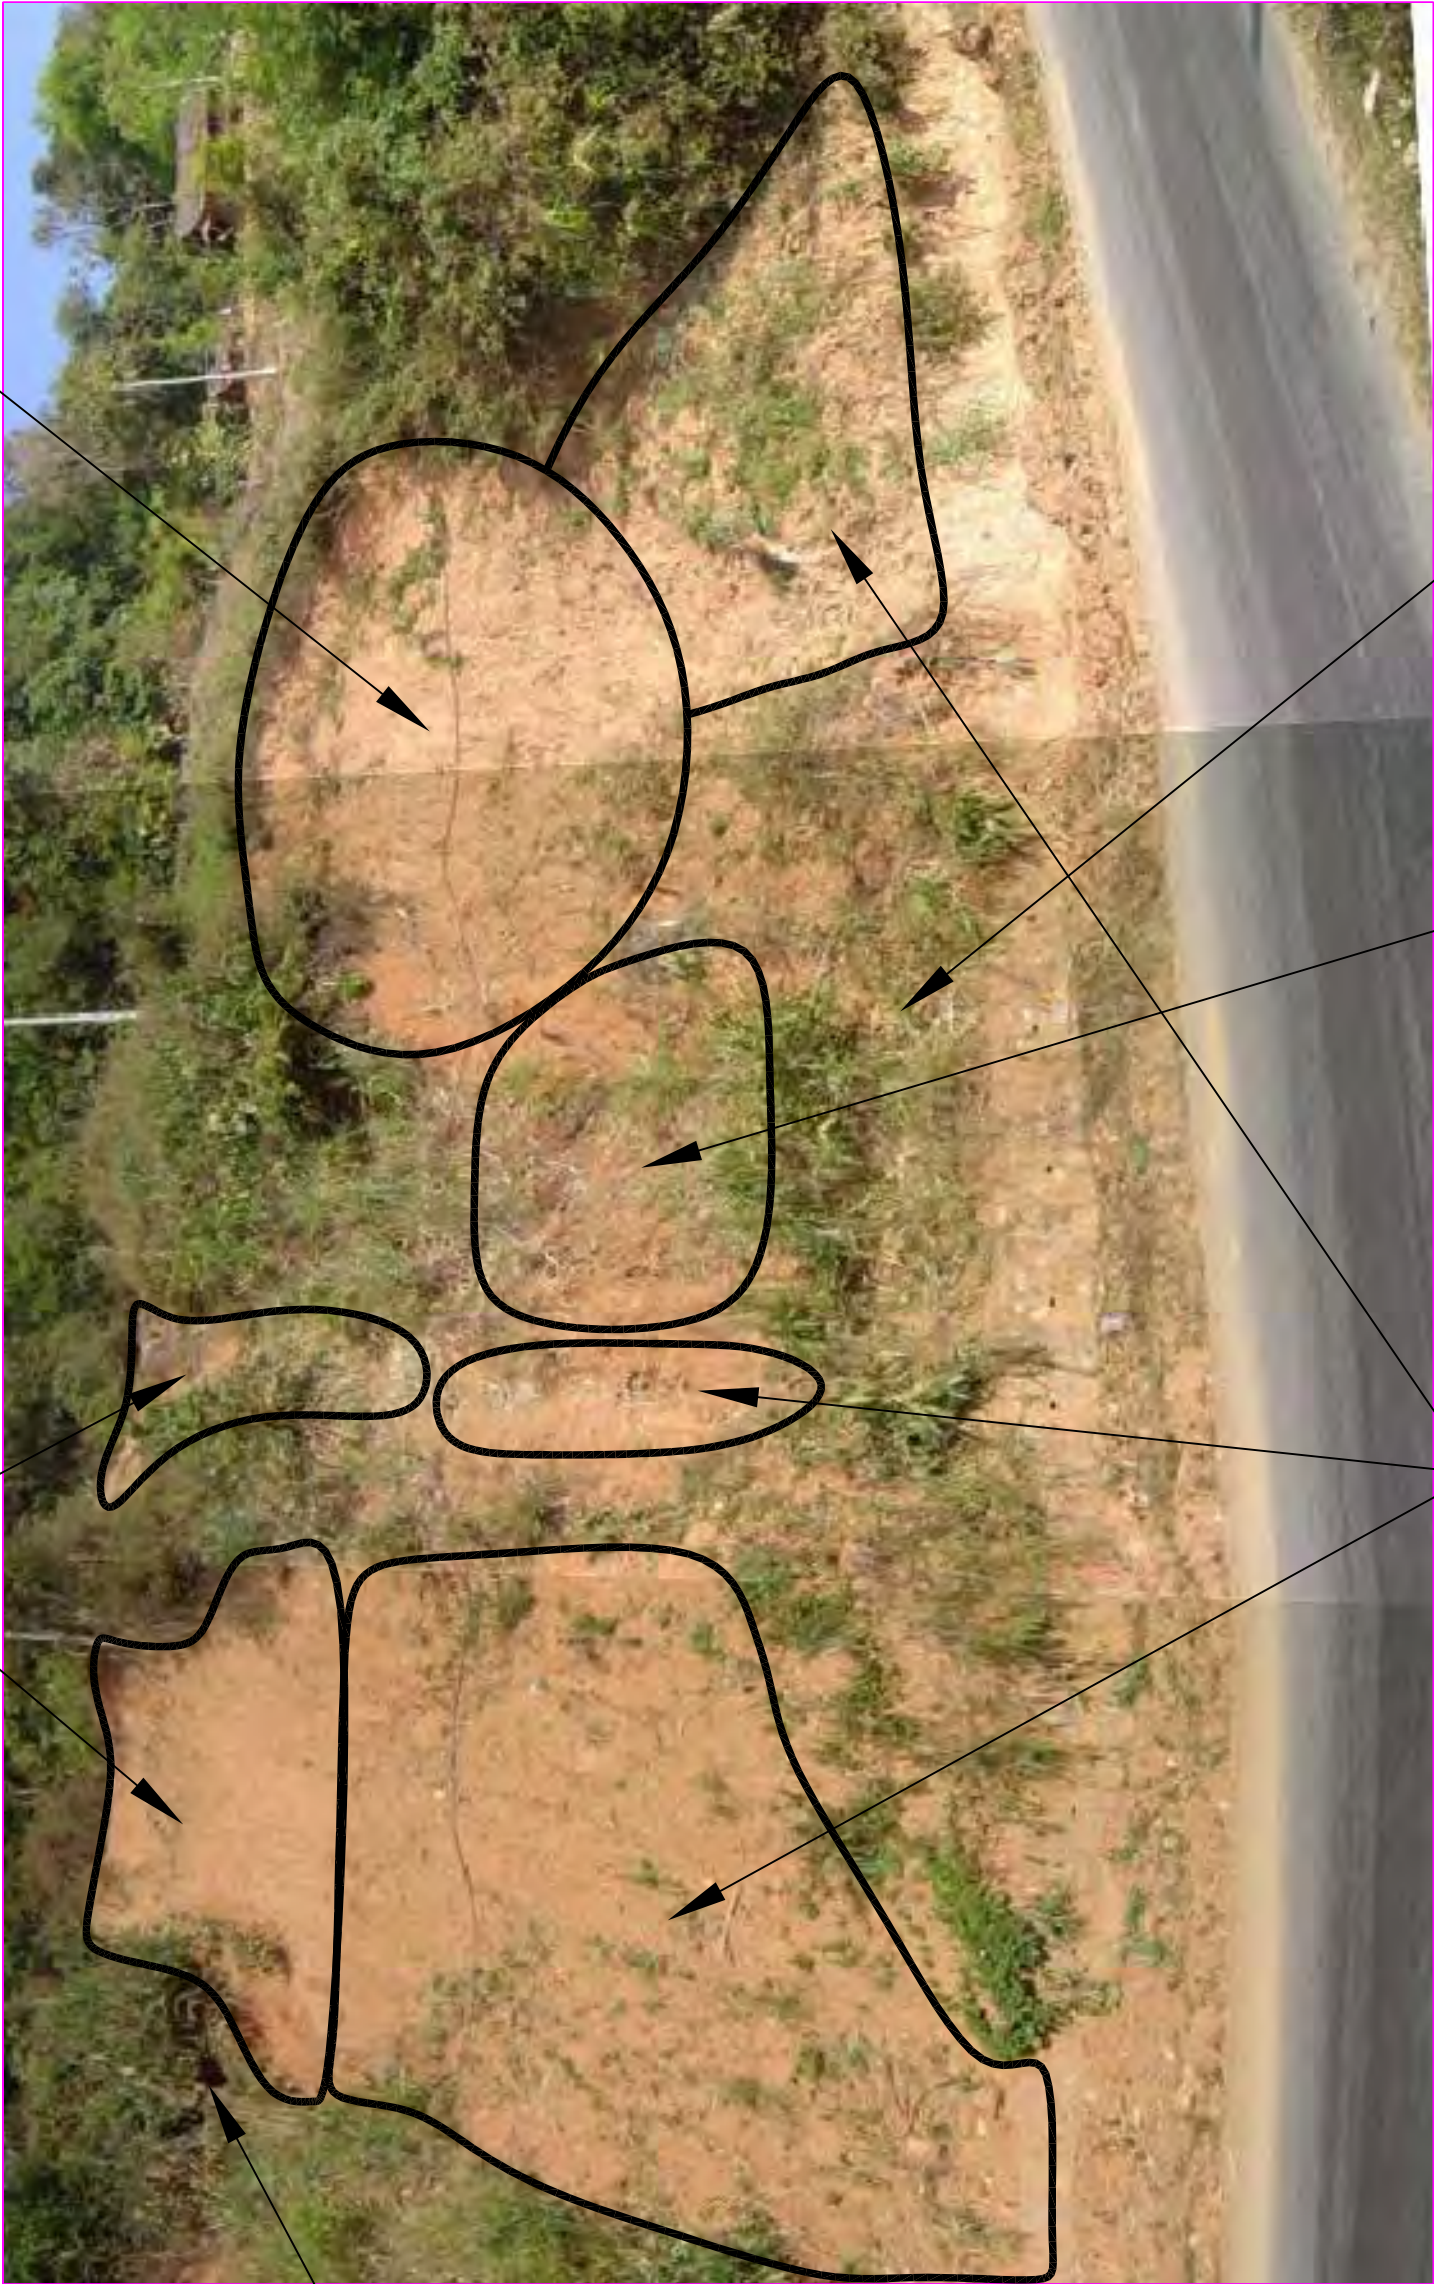
ROAD 13 N - KM 341.2  
RECOMMENDED REMEDIAL WORKS

POSSIBLE RE-ACTIVATION  
OF REVEGETATED FAILURE:  
OBSERVE IN 2009 WET SEASON

CONCRETE 50MM HAND-APPLIED  
REINFORCED SURFACING BELOW  
NEW RETAINING WALLS

REPAIR DAMAGED VEGETATION  
WITH GRASS PLANTING AS NECESSARY  
WHEN TRIMMING OF DEBRIS IS COMPLETE
