SEACAP 24

CASE STUDY OF DAK LAK RRST PAVEMENT AND SURFACE DETERIORATION

Dr J R Cook
Project Team Leader

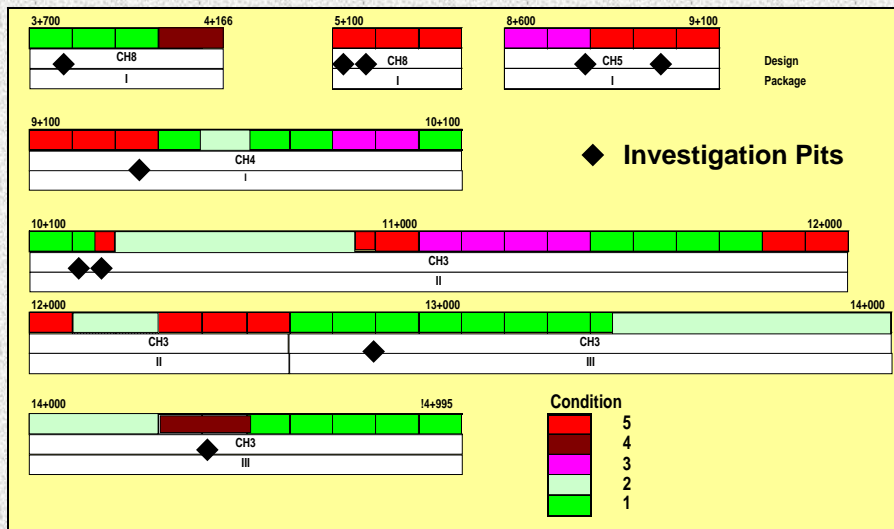
1. **Good** condition, occasional minor cracking & rutting
2. **Fair** condition, slight stripping of seals leading to occasional shallow potholes, occasional rutting (<20mm) & occasional interconnected or crocodile cracking
3. **Moderately poor** condition, with significant crocodile cracking and scattered potholes, rutting up to 70-80mm
4. **Bad** condition, extensive crocodile cracking and potholes with rutting up to 200mm
5. **Very bad** condition – essentially pavement has lost integrity with severe ruts and loosening of base material

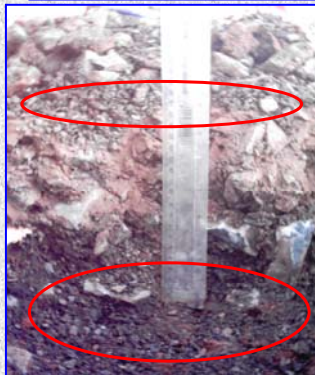
Poor grading and segregation in macadam

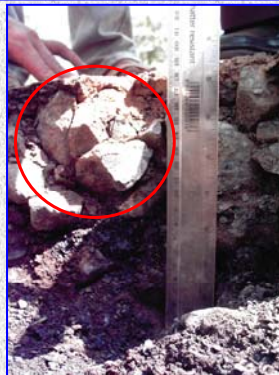
Large oversize in macadam

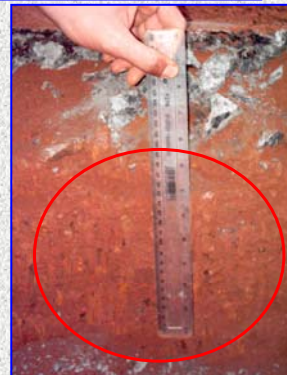
Poor gravel in placed in 1 layer? (specified 2)
