**Rural Transport Project 2**

**RURAL ROAD  
GRAVEL ASSESSMENT  
PROGRAMME**

**MODULE 4  
FINAL REPORT**

**DATA ANALYSIS**

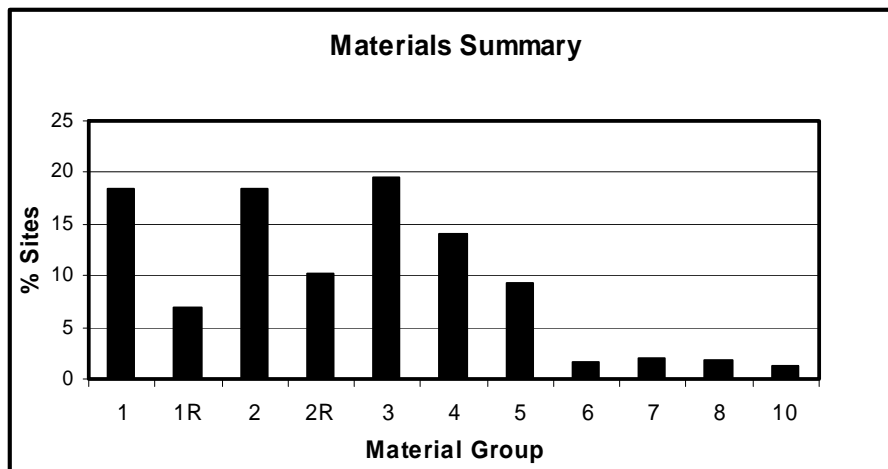
**Figure 3.5 Relative Occurrence of Surfacing Materials**

The relative overall occurrence of these materials is shown on Figure 3.5, which indicates the seven principal material groups on which the analysis was concentrated.

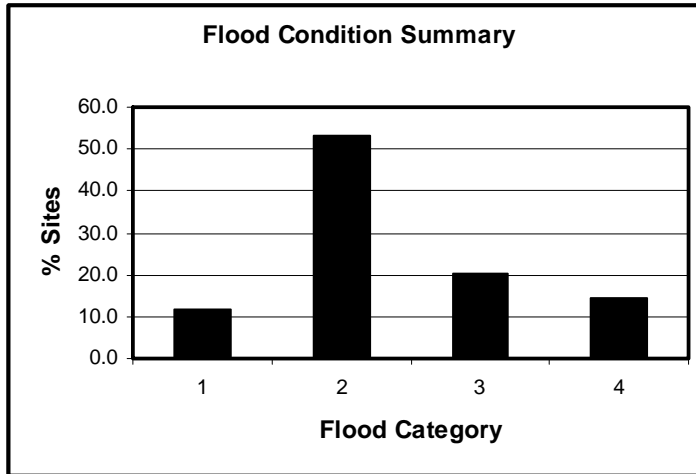
Figure 3.6 RRGAP Survey Site Flood Conditions

**Surface and Sub-Surface Hydrology:** Flooding of unsealed road surfaces was identified as a potential deterioration factor and Figure 3.6 summarises the range of data recovered. Associated with this is the ability of a road to shed surface water, summarised in Figure 3.7. Tabulated information on ground-water levels, flood conditions and road surface water run-off is included as part of the Module 3 Factual Report.

- 1: No flood
- 2: Occasional flood
- 3: Yearly minor flooding
- 4: Yearly major flooding

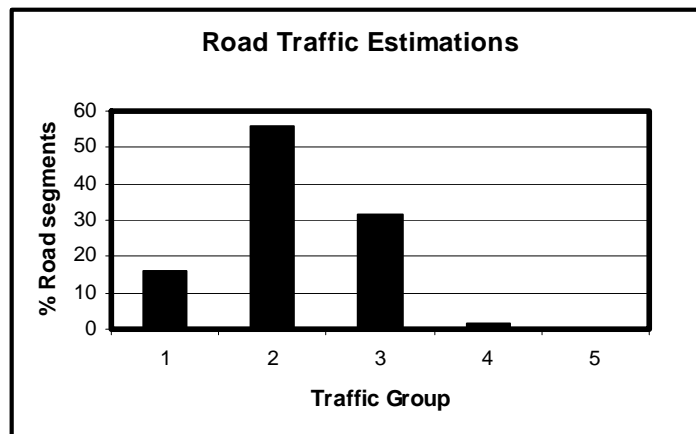
**Figure 3.8 Estimated Traffic Summary**

- 1: 2-wheel traffic only
- 2: 2-wheel traffic + local light truck
- 3: Local + minor commercial traffic
- 4: "3" with heavy trucks
- 5: Steady commercial traffic

Axle Loads	The deterioration of paved roads caused by traffic results from both the magnitude of the individual wheel loads and the number of times these loads are applied. For pavement design purposes it is necessary to consider not only the total number of vehicles that will use the road but also the wheel loads (or, for convenience, the axle loads) of these vehicles. For gravel roads the relationship between axle loading and deterioration rates is not well researched. RRGAP data indicate that vehicular traffic on most District and Commune roads is anyway principally light axle loading (Figure 3.8)

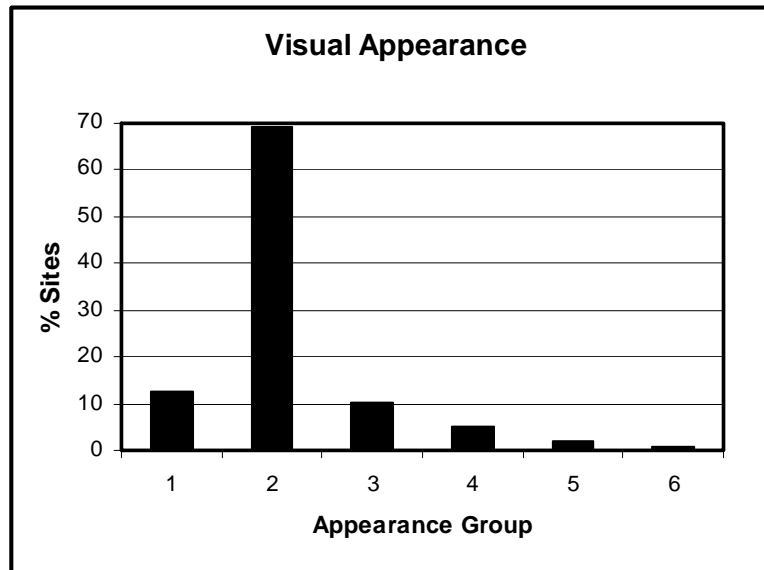
Figure 3.12 Profile Visual Appearance Summary

1	Good surface shape - no stone protrusion
2	Some deterioration/stone protrusion
3	Up to 25% of sub-grade exposure
4	25 to 50% of sub-grade exposure
5	Extensive sub-grade exposure up to 75%
6	>70% sub-grade exposure

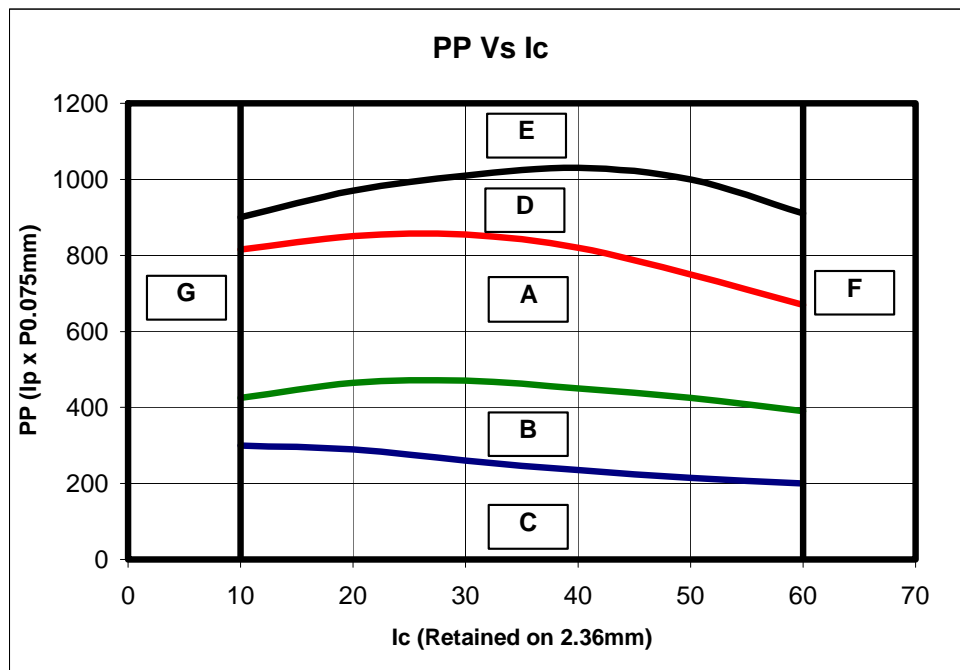
**Figure 4.3 Plasticity Product and Particle Size Assessment**

Experience has indicated the value of these indices as material assessment criteria and Figure 4.3, which utilises the Plasticity Product value has proved useful in other regions. RRGAP data has therefore also been plotted in this format in Appendix B.

- A: Good performance under wet and dry conditions
- B: Good performance under wet conditions; corrugates in dry conditions
- C: Lacks cohesion: rapid deterioration with traffic
- D: Good in dry conditions; slippery in wet; potholes/erosion
- E: Poor in both wet and dry conditions
- F: Too coarse: erodes badly; difficult to maintain
- G: Too fine; traffickability problems in wet and very dusty when dry

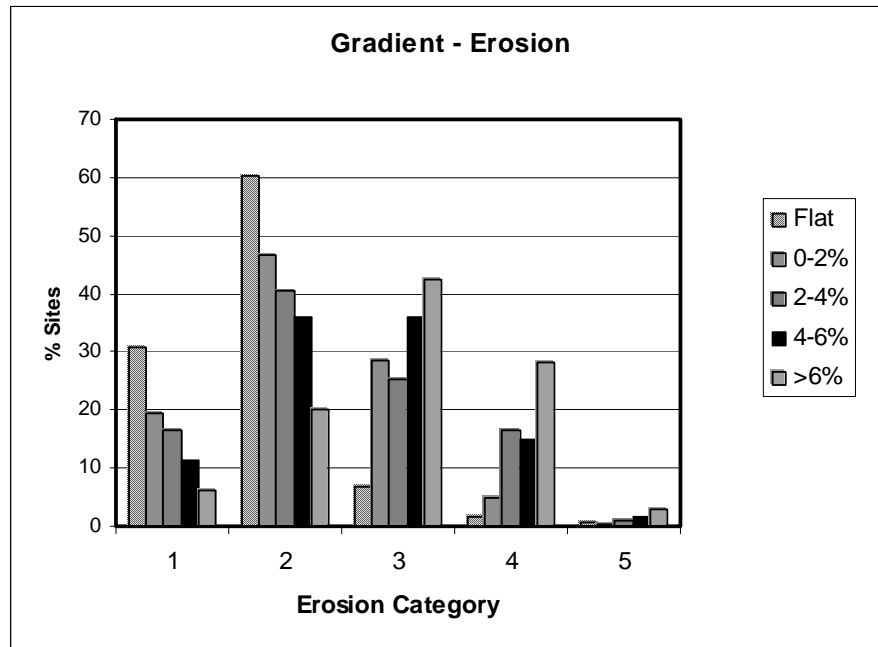
**Figure 4.12 Gradient-Surface Erosion Relationships**

Road Gradient at Survey Point				
	Flat	>0-2%	>2-4%	>4-6%	>6%
% Slight or no erosion	91	67	47	47	26
% Significant erosion	9	23	53	53	74

**Table 4.5 Summary of Gradient-Surface Erosion Relationships**

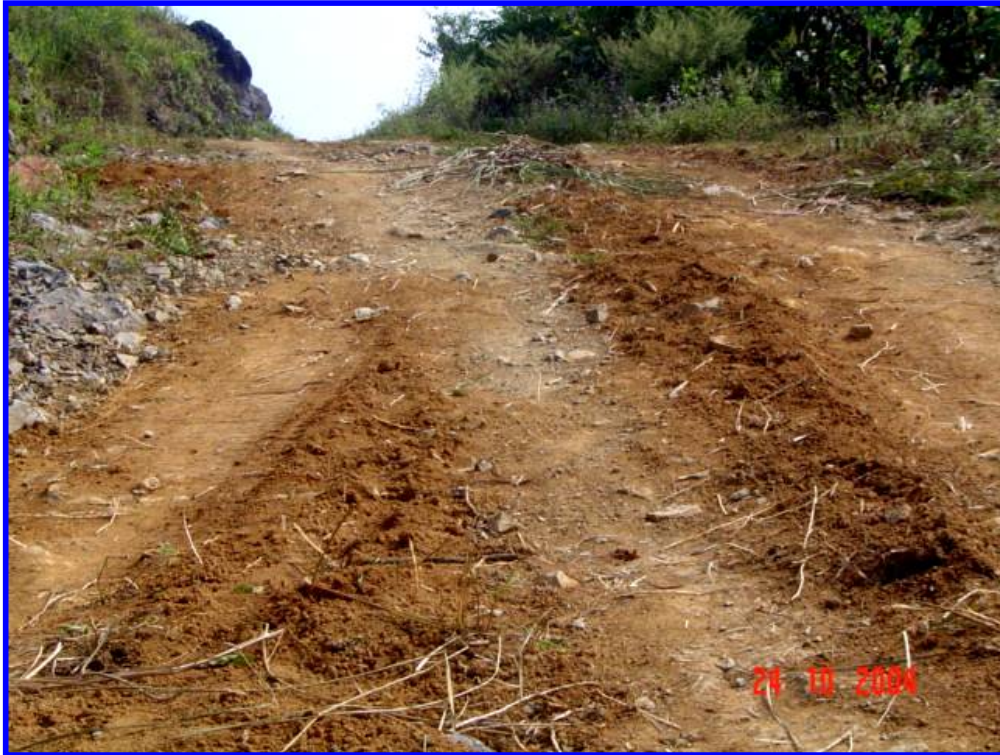
**Photograph IV : Inappropriate Material Use for Maintenance**

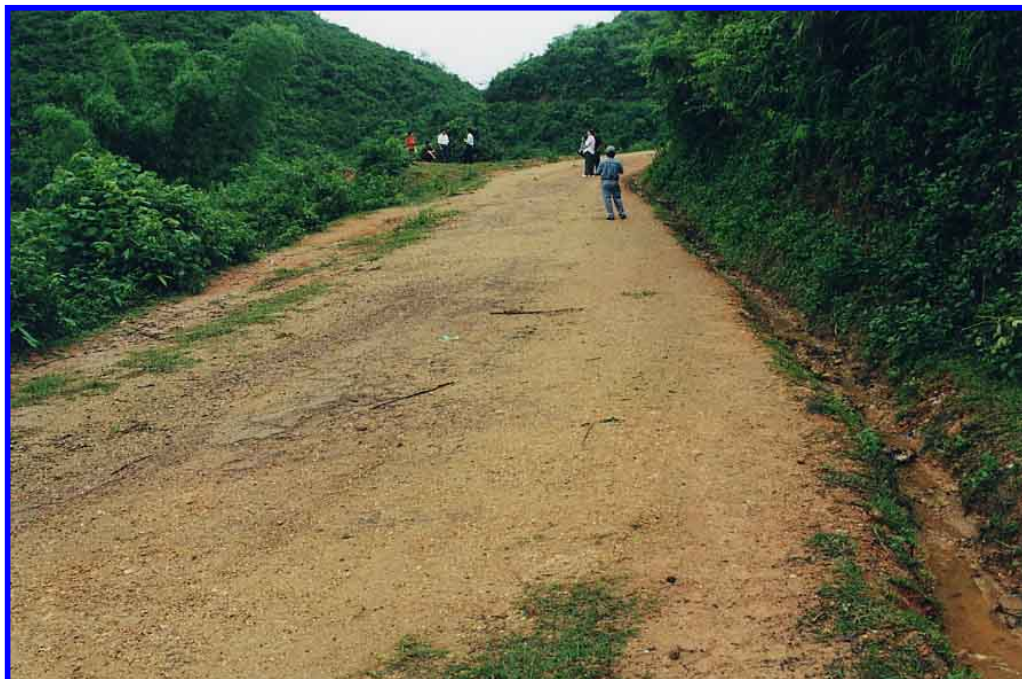
**Photographs V : Gravel eroded within 1 year on steep gradient. However underlying material is stronger, suggesting that an Engineered Natural Surface or other use of the insitu material would have been more appropriate**

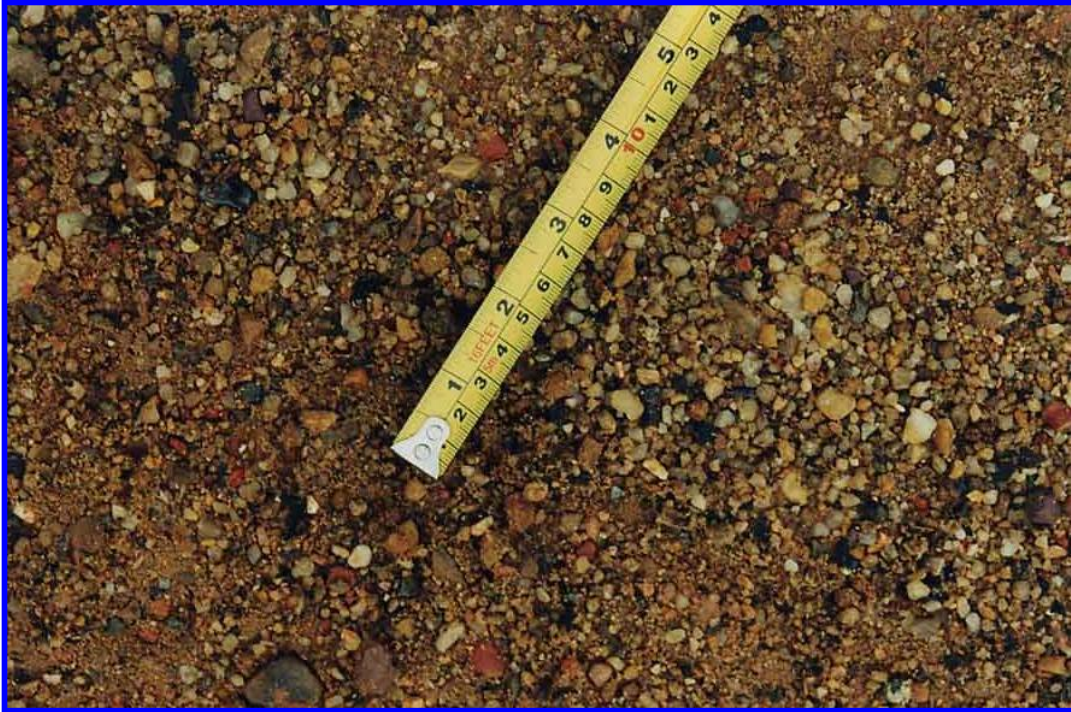
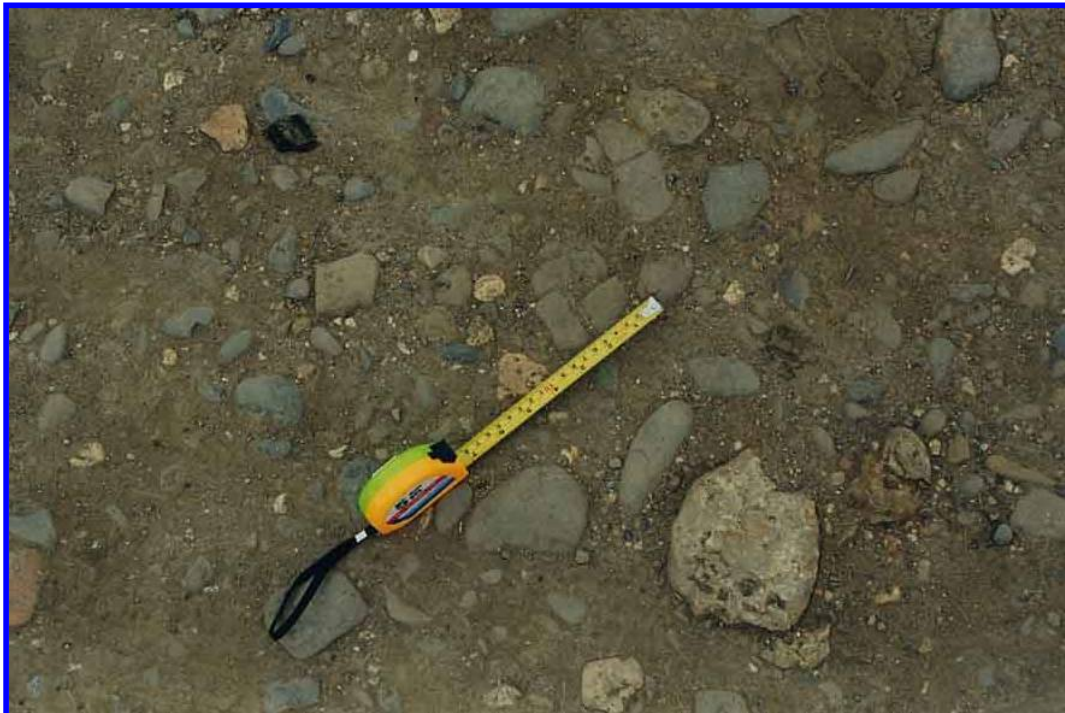
**Photographs VI : Examples of Poorly Graded Gravel**

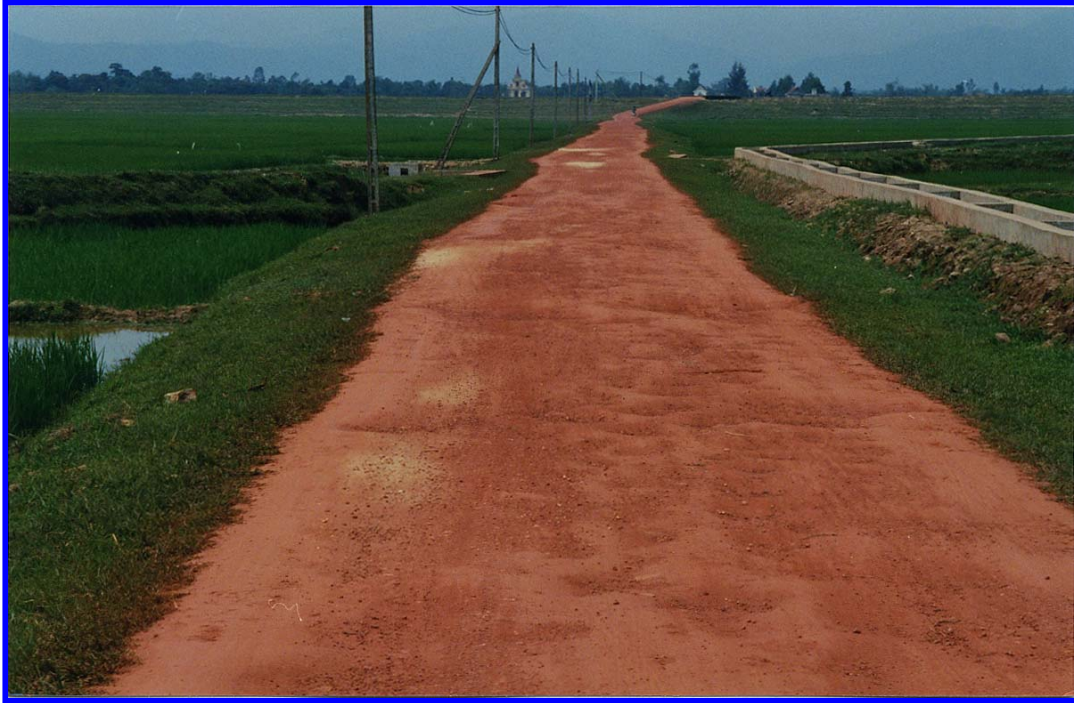
**Photographs VII : Lack of Routine Maintenance leads to accelerated deterioration**

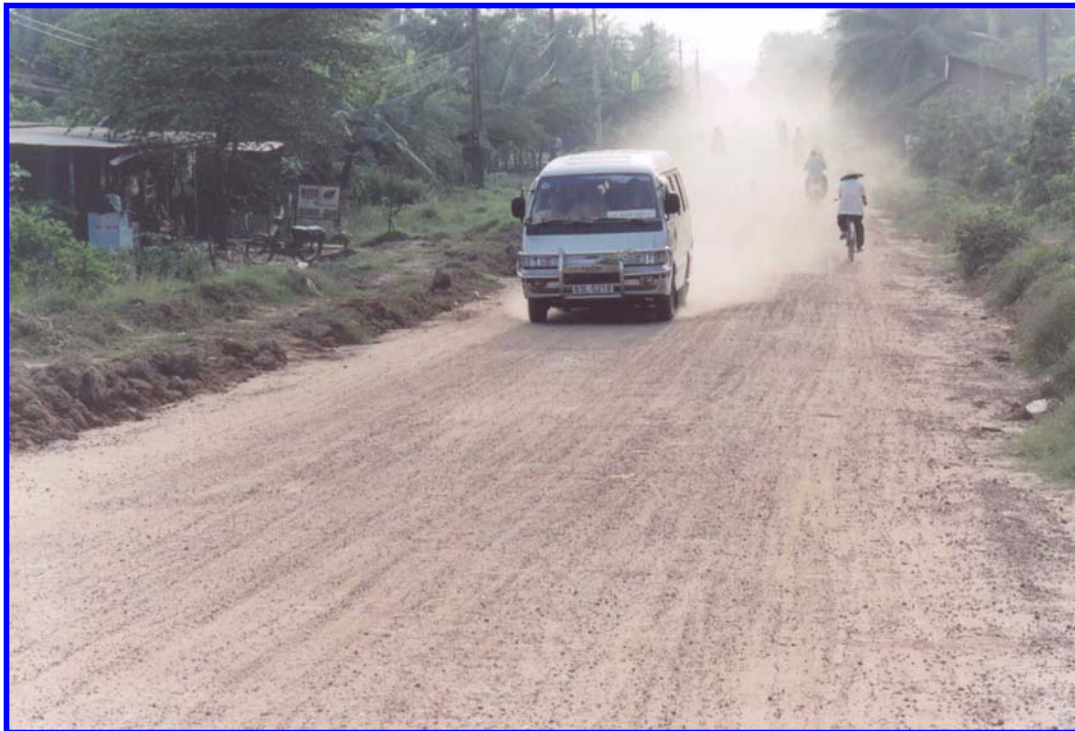
**Photographs VIII : Dust emissions & material loss in dry weather**
