REHABILITATION OF NATIONAL HIGHWAY DAMAGED BY RAIN USING GEOSYNTHETICS IN HILLY TERRAIN – A CASE STUDY

S D Vedpathak, G N Dalmia and S P Bagli

Strata Geosystems (India) Pvt. Ltd.

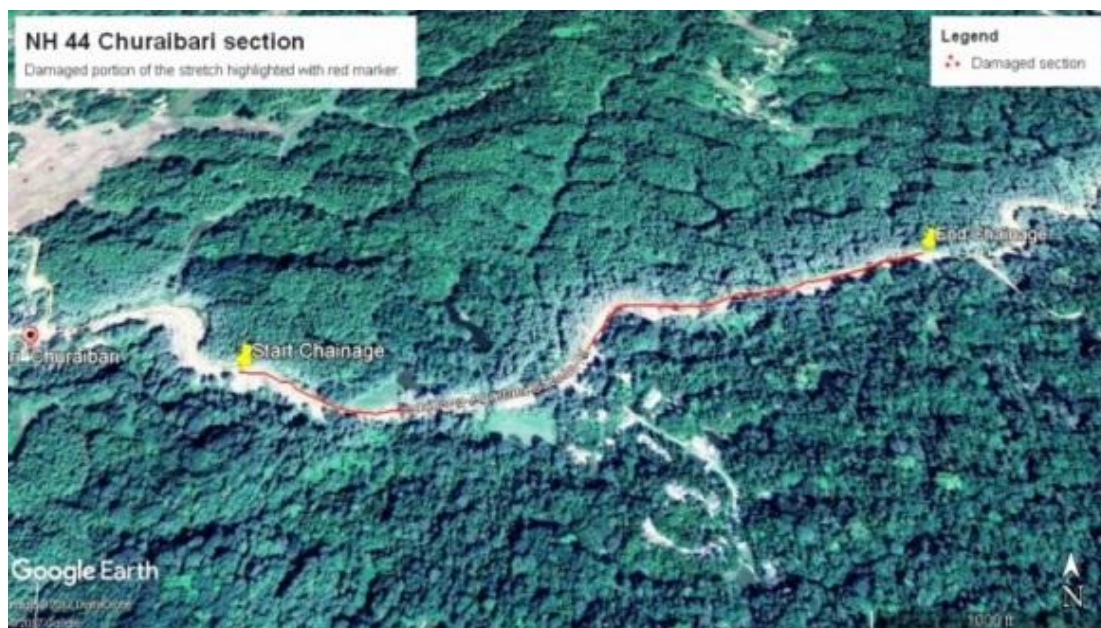
The highway was damaged near Churaibari on the Assam side of the border. The subgrade of the highway is highly plastic but weak clayey soil. The area traverses forested and undulating terrain and drainage was an issue which was compounded by subgrade of low permeability. There were heavy downpours in the month of March 2016, which completely damaged the stretch of about 1500m and made it difficult for vehicles to ply. Figure 2 shows the extent of the damaged highway. Conventional repairs proved unsuccessful. With the bottleneck of stranded vehicles the situation turned chaotic and untenable with blockage of all goods to Tripura and virtual isolation from the rest of the country.

FIGURE 2(a) Damaged stretch through the dense forest

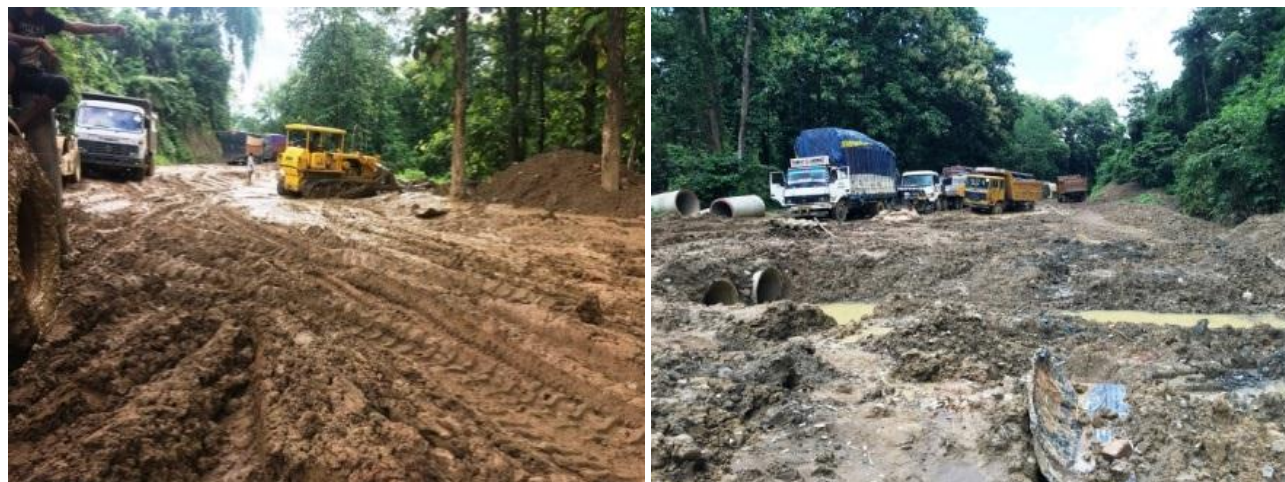
FIGURE 2(b) Actual site condition

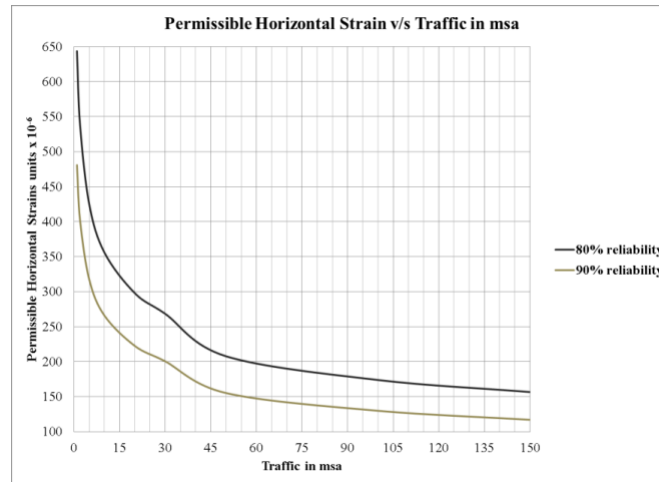
FIGURE 4(a) Permissible horizontal tensile strain values v/s traffic in msa

Horizontal tensile strain values are dependent on the modulus of bituminous layer. The viscosity gradient and the temperature variation affect the strain value. In Fig. 4(a) a small bend at 30msa is a result of the variation of viscosity gradient and temperature of the bituminous mix.

Based on the equations 1-4 charts were prepared for corresponding limiting strains values v/s different design traffic in msa (traffic ranging from 1msa to 150msa). These charts are shown in Fig. 4.

Based on Fig. 4(a) and 4(b) typical values for permissible strain limit are shown in Table 2.

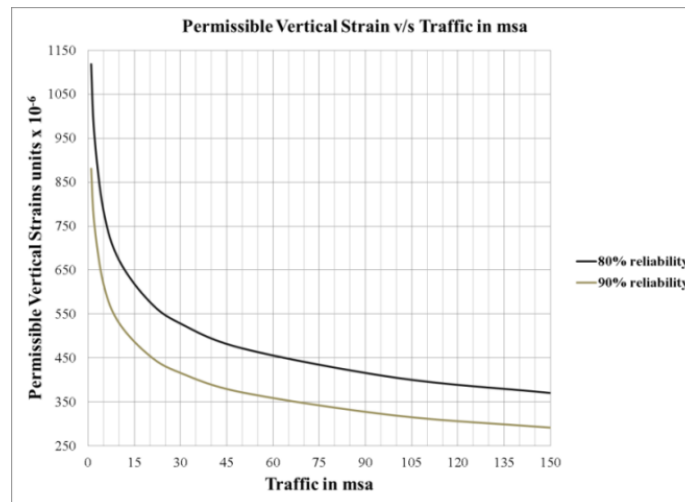
FIGURE 4(b) Permissible vertical subgrade strain values v/s traffic in msa

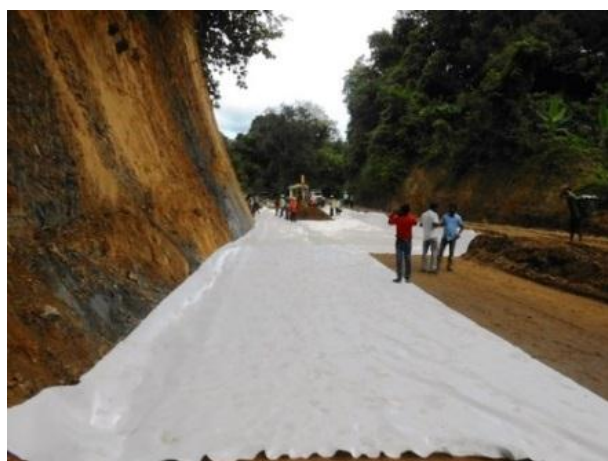
FIGURE 6(a) Laying of Nonwoven geotextile on dressed subgrade

Owing to logistics problems owing to rains, the geosynthetic materials including the StrataWeb® geocells could reach the affected site only by the end of July 2016. However thereafter, rehabilitation work commenced immediately. Remnants of the existing road were scrapped off. The subgrade was dressed, levelled and compacted. A nonwoven was placed above the compacted surface to prevent intermingling of the engineered section with the weak plastic subgrade. Work was executed over half the width of the carriageway while allowing whatever traffic that can painfully move, to pass along the other side. Construction up to the GSB above the geocell took about two weeks for the completion. The construction sequence is shown in the Fig. 6.

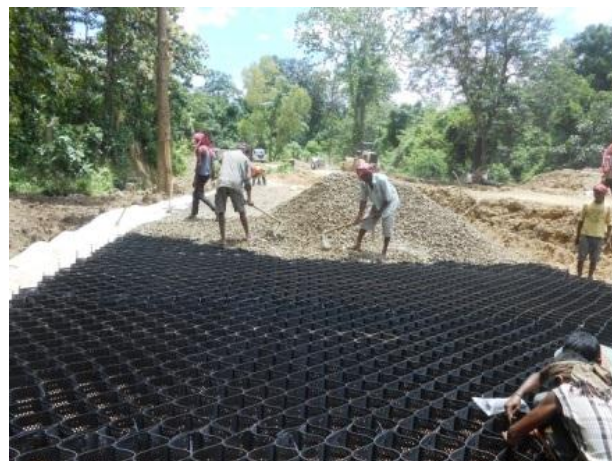
FIGURE 6(b) StrataWeb® geocells being infilled with graded aggregate

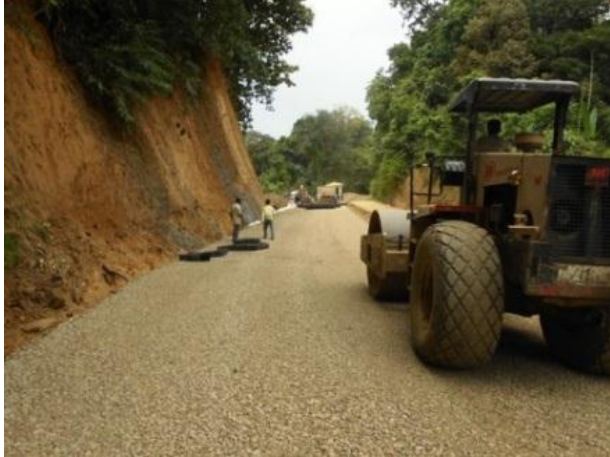
FIGURE 6(c) Granular base being compacted

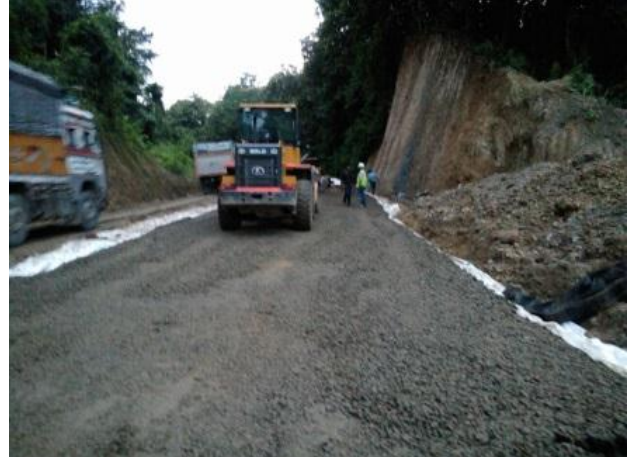
FIGURE 6(d) Pavement without bituminous topping

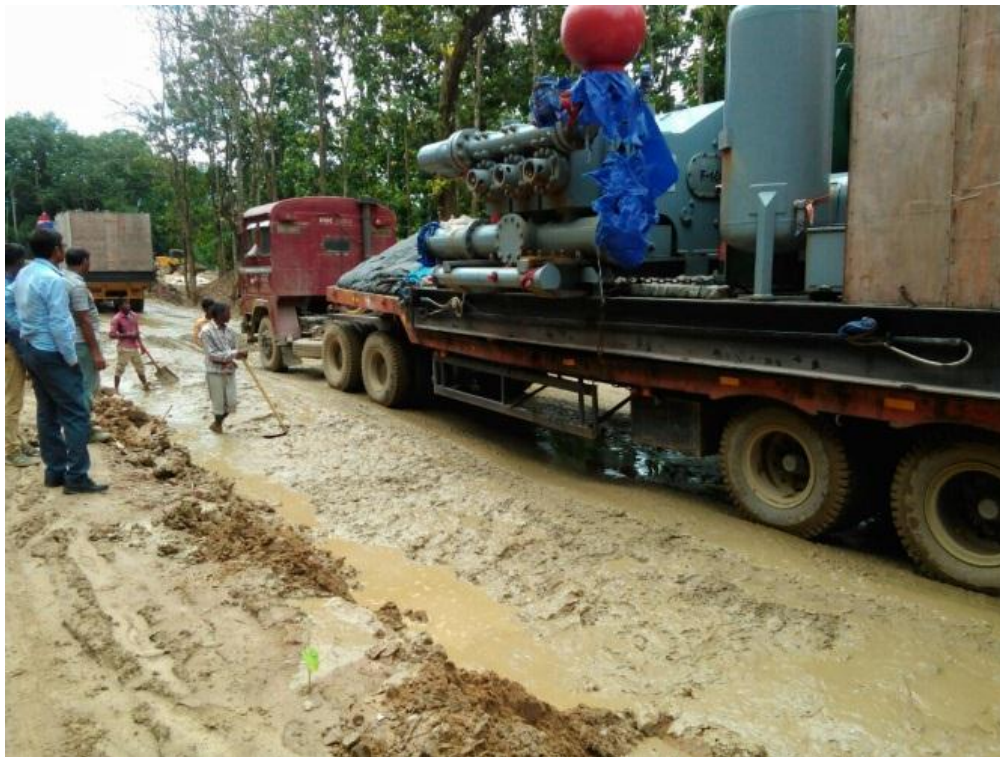
The geocell solution by Strata allowed immediate movement of vehicular traffic. Amidst the heavy downpour in mid-August, the Authorities decided to assess the performance of the system under regular traffic and put-off asphaltting the surface. The highway was opened to traffic for all class of vehicles directly over the granular base was laid. Figure 7 shows uninterrupted heavy traffic movement during heavy downpour. Subsequent to the mid-August downpour and opening up to regular traffic, no undulation or settlements were observed on the unpaved section.

FIGURE 7 Continuous traffic movements over geocells during monsoons

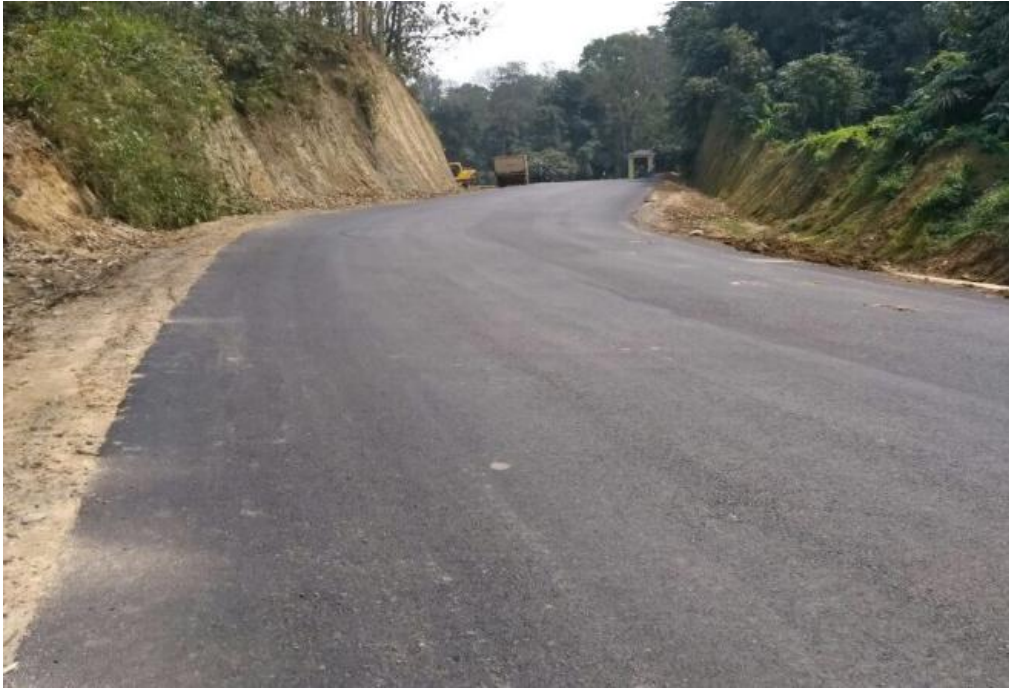
Thereafter, the surface was asphalted and work was deemed completed. The finished asphalted surface is shown in Fig. 8. Post construction visual observations were carried out. After one year,

FIGURE 8 Finished asphalted surface

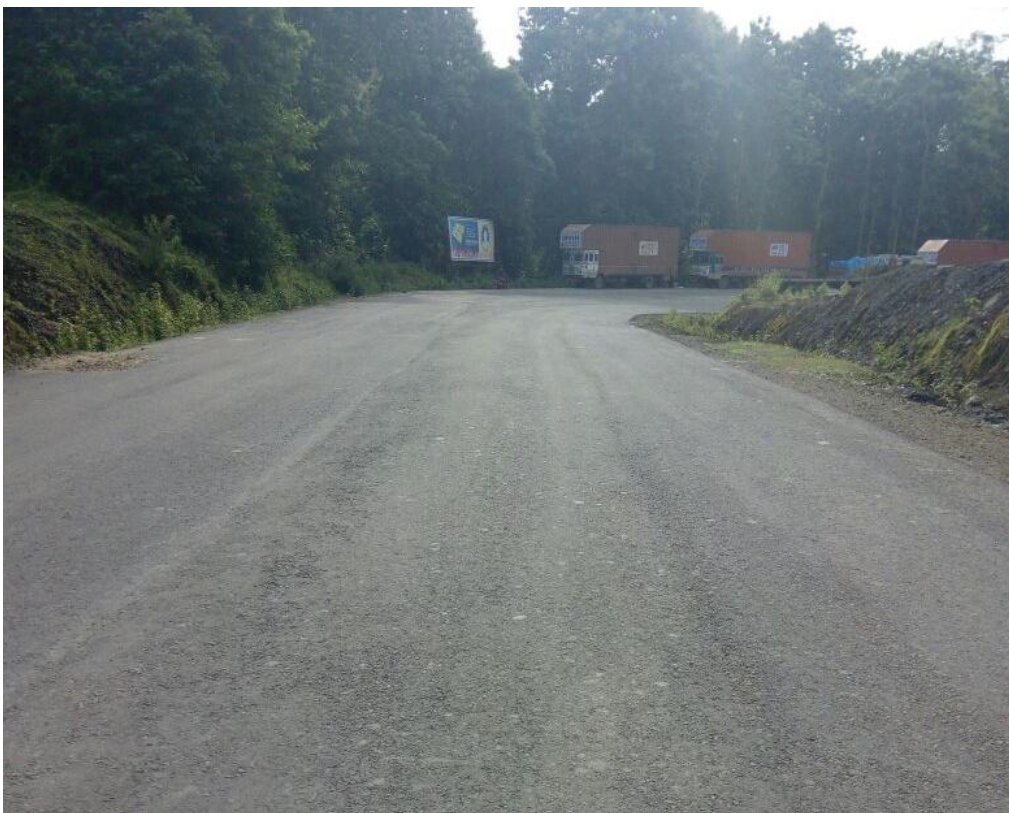
with conditions including the 2017 heavy monsoons, the condition of the same stretch (Figure 9) has proven the effectiveness of the geocell reinforced system.

FIGURE 9 Finished surface after one year

No distress in the pavement was observed indicating overall good performance of the road.
