# **EXPERIENCE ON APPLICATION OF OTTA SEAL ON LOW VOLUME ROADS IN TANZANIA**

**By Eng. Joseph M. Nyamhanga**  
Regional Manager  
**TANROADS – RUKWA REGION**  
**TANZANIA**

IRF/TARA/gTKP 2009 Convention on Rural Roads  
25-27 November 2009: Arusha, Tanzania

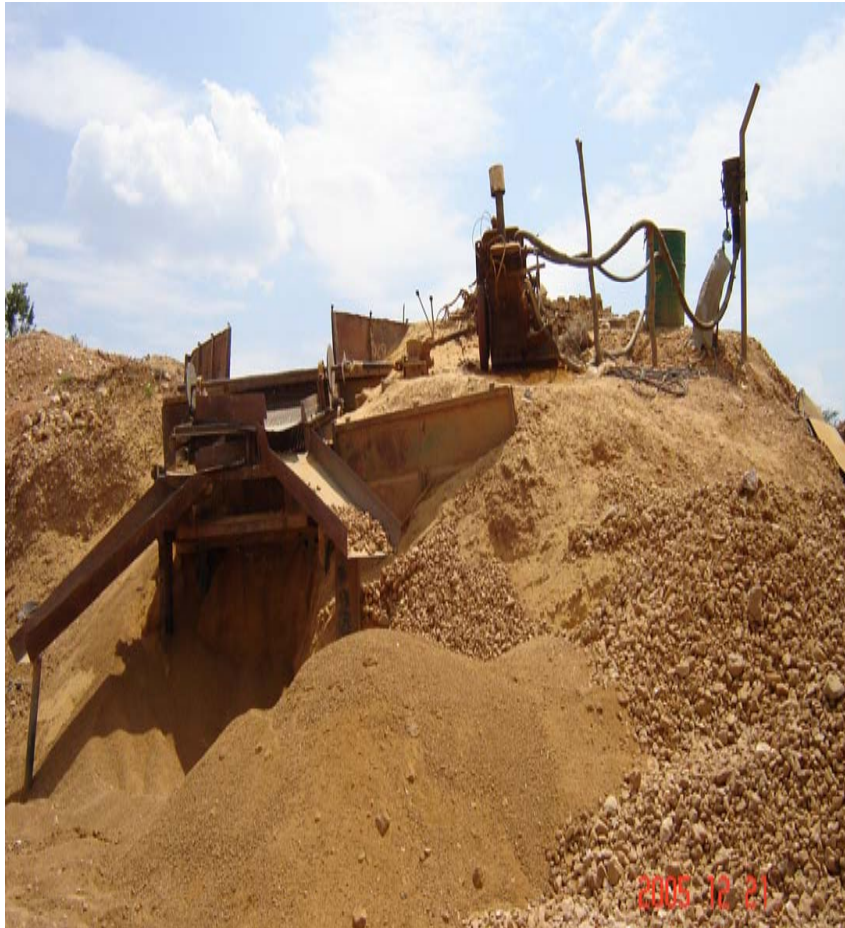
**Photo 1 and 2:** Small Locally Fabricated Aggregate Screening Plant for Otta Seal Project in Kagera Region (Left) and Chipping Production Plant for Conventional Bituminous Surface Dressing Project in Rukwa Region (Right)

- Difficulty in screening large quantity of aggregates from natural gravel
- Prolonged heavy rains in some regions such as Kagera
- Difficulty in cutting back Pen 150/200 to MC 3000 cutback
- Contractors waiting for a long period before application of the second Otta Seal
- Aesthetics/appearance of Otta sealed roads raised concern and criticism at the beginning due to absence of “black top” and presence of dust

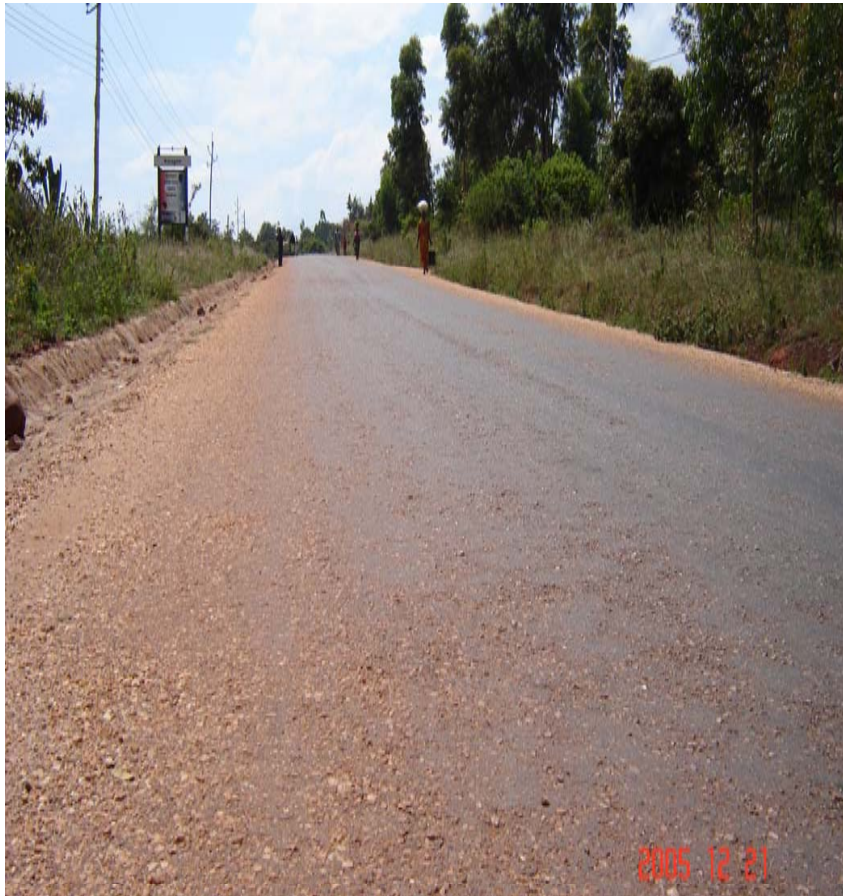
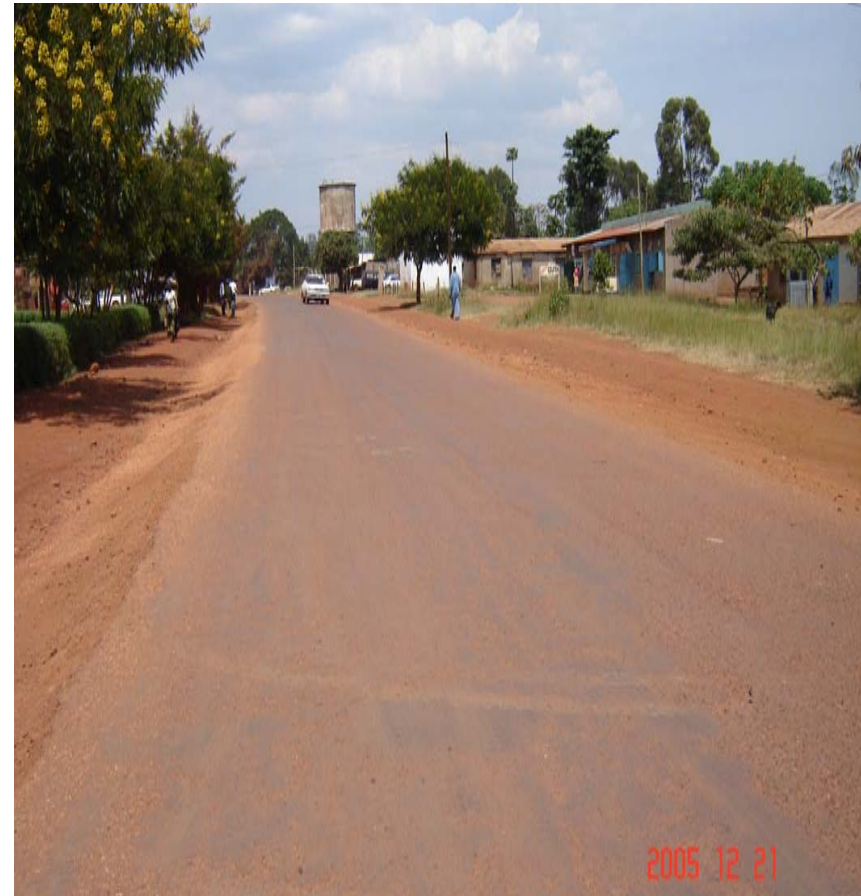
**Photo 3 and 4: First Otta Seal on Omugakorongo-Nyakahanga  
Regional Road in Kagera Region After About 3 Months of Trafficking**

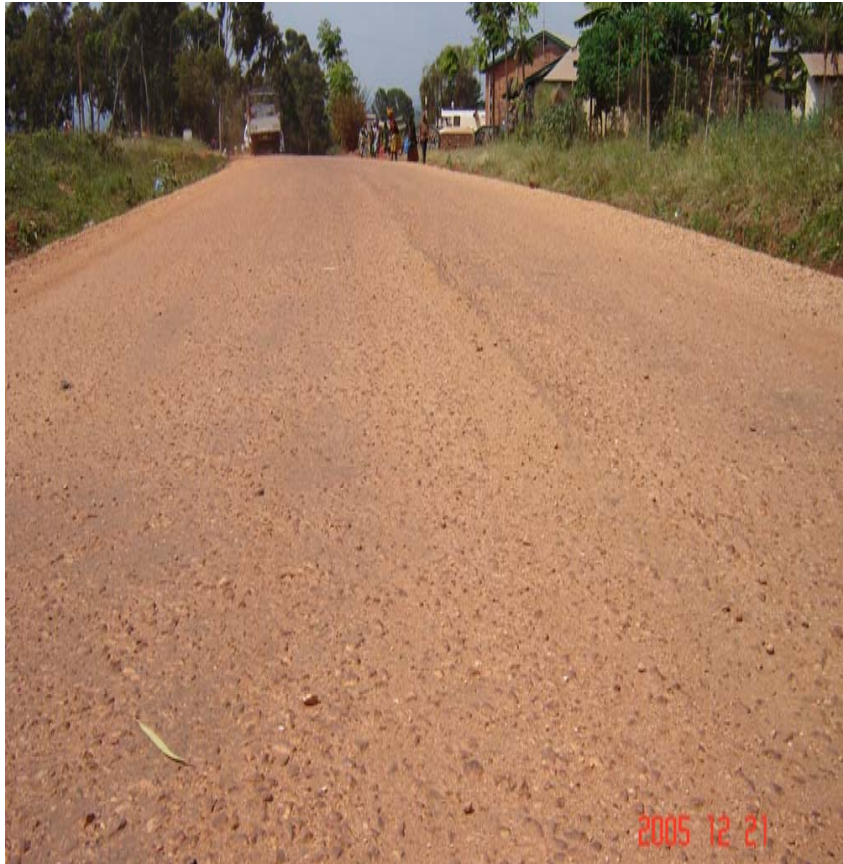
**Photo 5 and 6:** Second Otta Seal on Omugakorongo-Nyakahanga Regional Road (Left) Few Days After Application and Second Otta Seal on Kyetema-Kanazi-Kanyinya Regional Road (Right) in Kagera Region After More Than 3 Years of Application and Trafficking

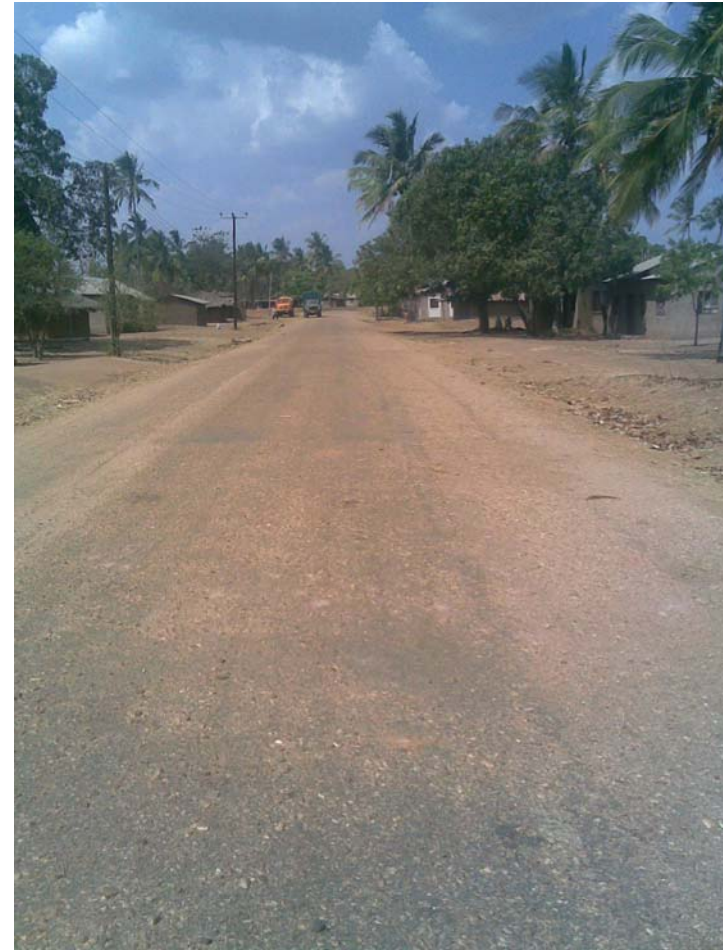
**Photo 11, 12 and 13:** Otta Seal on Nansio-Bulamba Regional Road in Mwanza Region (Left) and Mpeta-Lupaso Regional Road in Mtwara Region (Right)

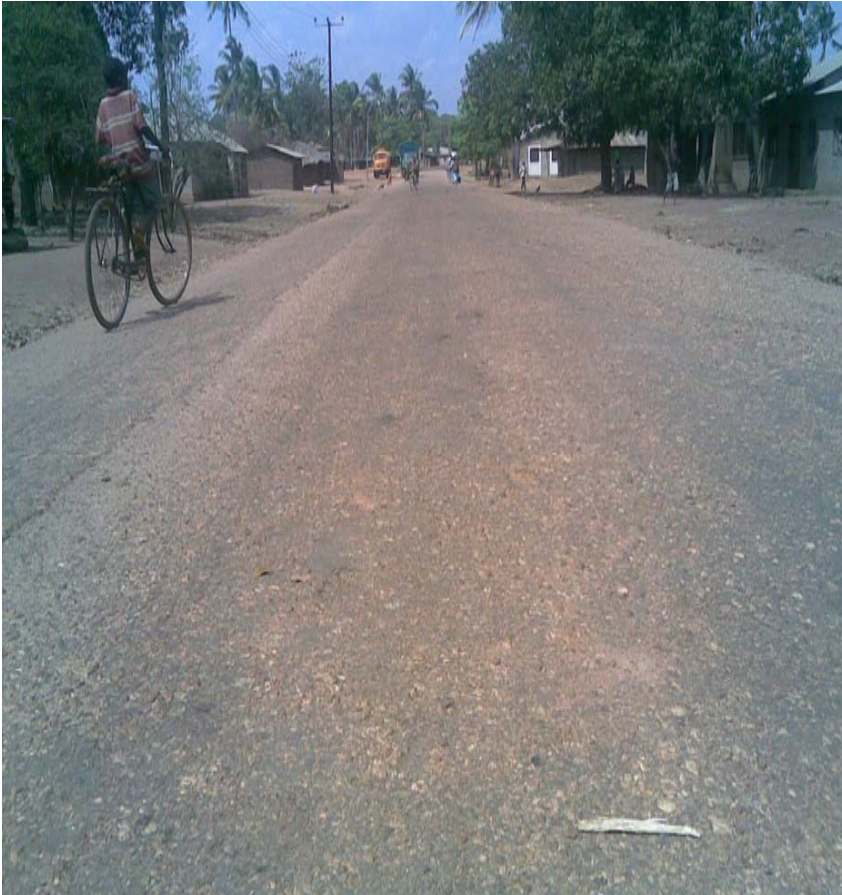
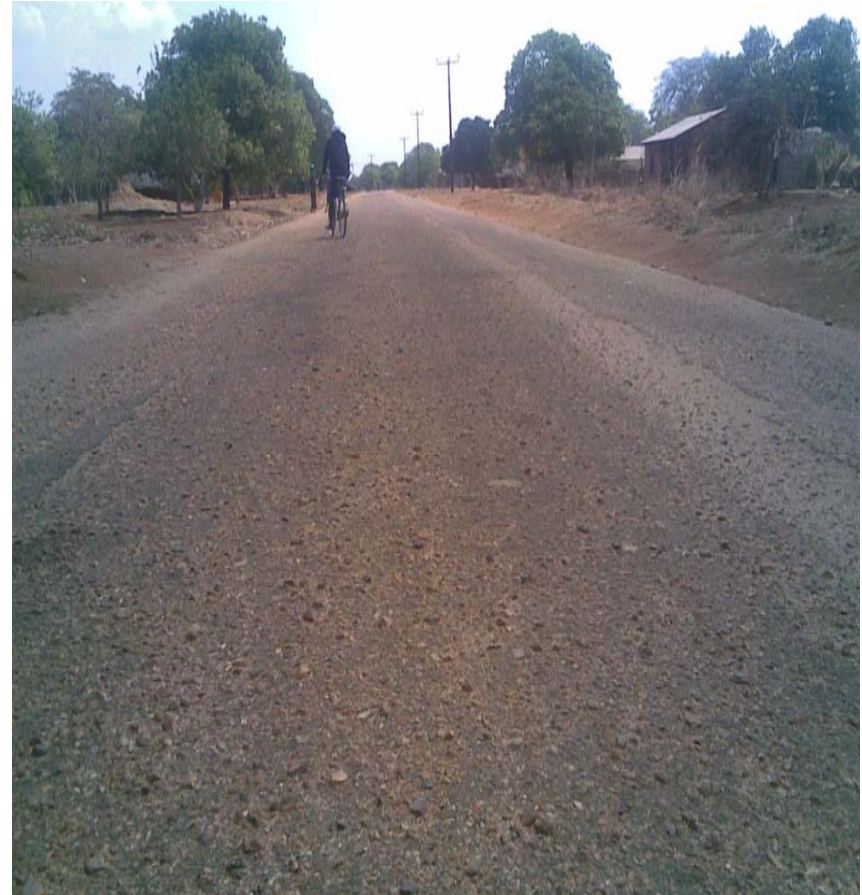
## **Photo 14 and 15: Otta Seal on Mpetá-Lupaso Regional Road in Mtwara Region**

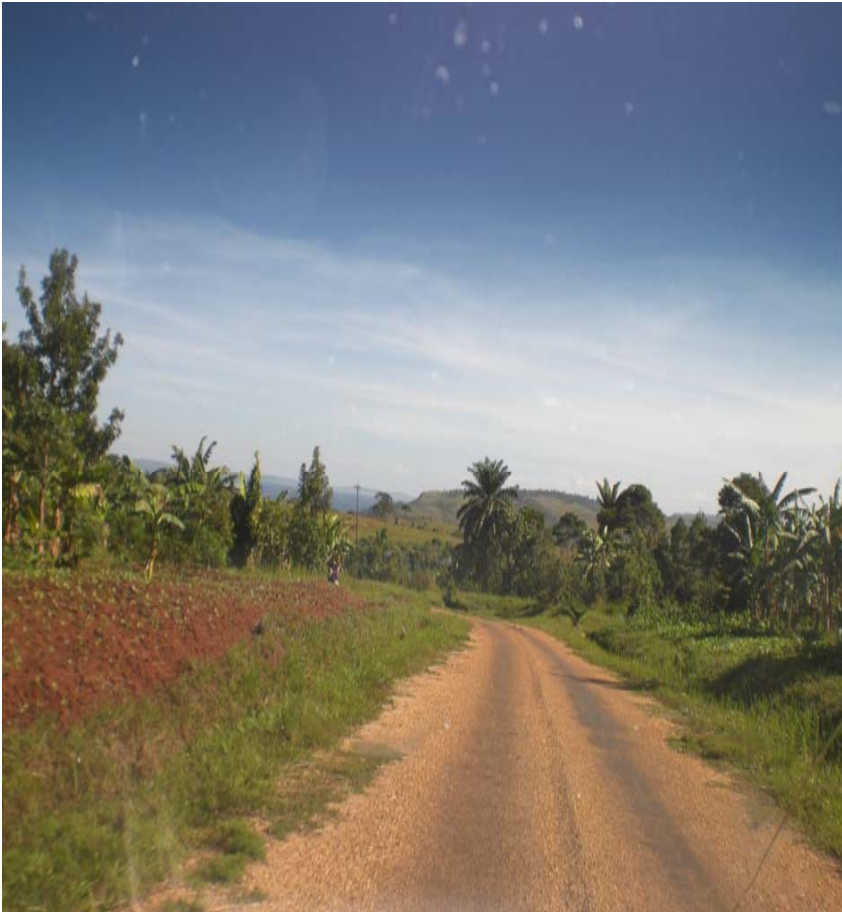
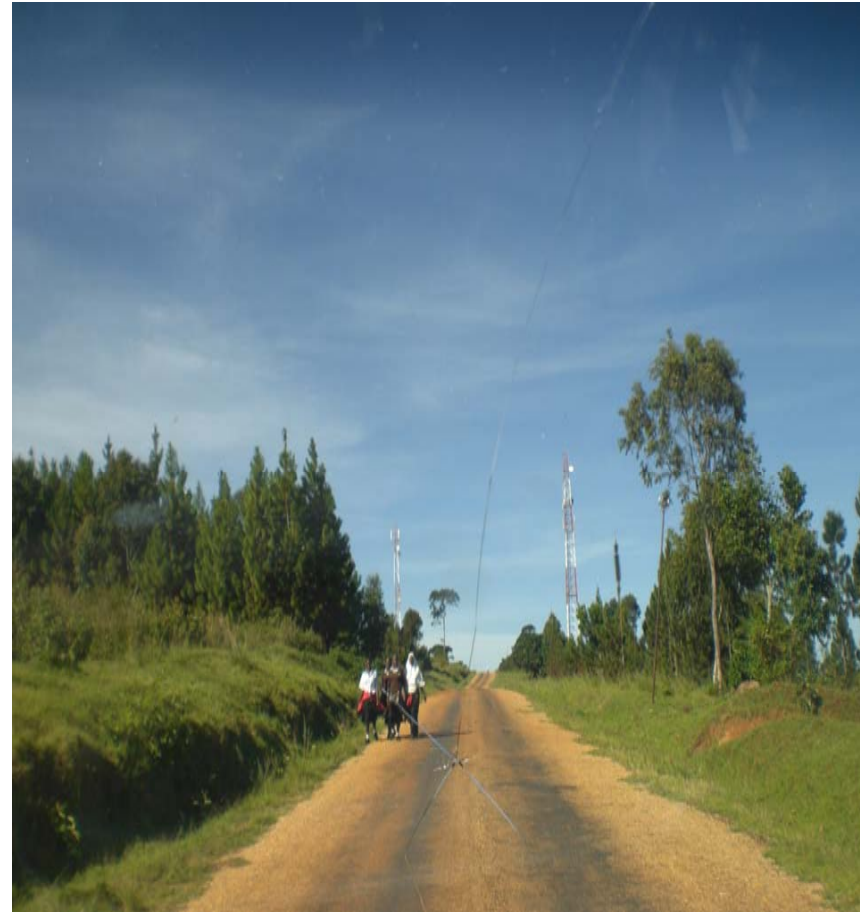
**Photo 16 and 17:** Second Otta Seal on a section with very low traffic volume on Kyetema-Kanazi-Kanyinya regional road (Kanazi-Kanyinya Section) in Kagera Region after more than 3 years of application and trafficking

- Insufficient knowledge and experience on application of Otta Seal
- Lack of equipment and plant for bituminous works caused delays
- Steep gradients on sections of some of the roads made it difficult to apply Otta Seal
- Very low traffic volume on some of the project roads led to very slow curing of the Otta Seal

- Otta sealing is considered to be inappropriate on road sections with very low traffic volume as trafficking plays an important role in curing of the Otta Seal.
- Otta Seal is difficult to apply on road sections with steep gradients.
- A number of contractual issues such as the requirement for the first Otta Seal to be trafficked for a minimum of 8-12 weeks before the second Otta Seal is applied have to be taken into consideration
- Generally, Otta sealed regional roads in Tanzania are performing quite well after about 4 years of trafficking to-date.

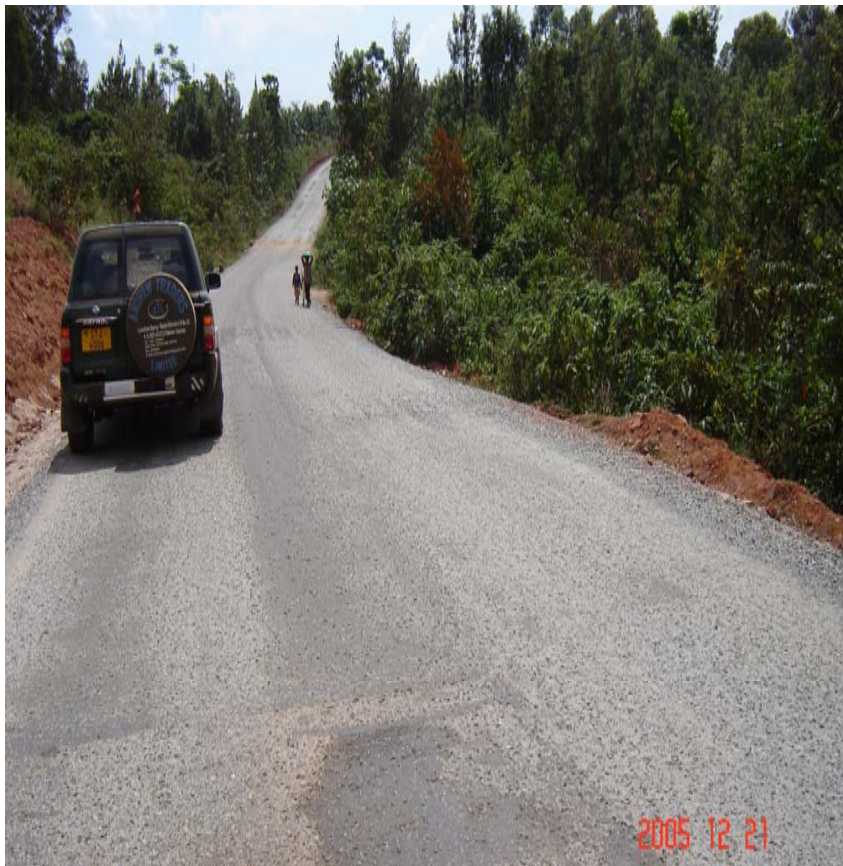
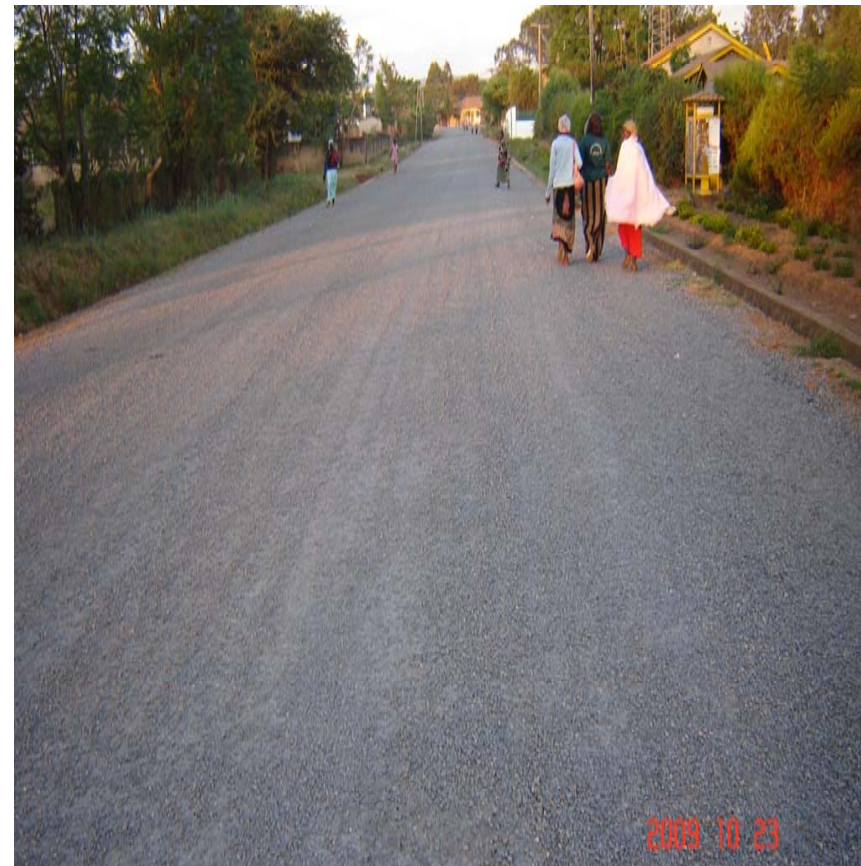
**Photo 18 and 19:** Conventional Bituminous Surface Dressing on Low Volume Regional and Urban Roads in Kagera Region (Left) and Rukwa Region (Right) Few Months After Construction

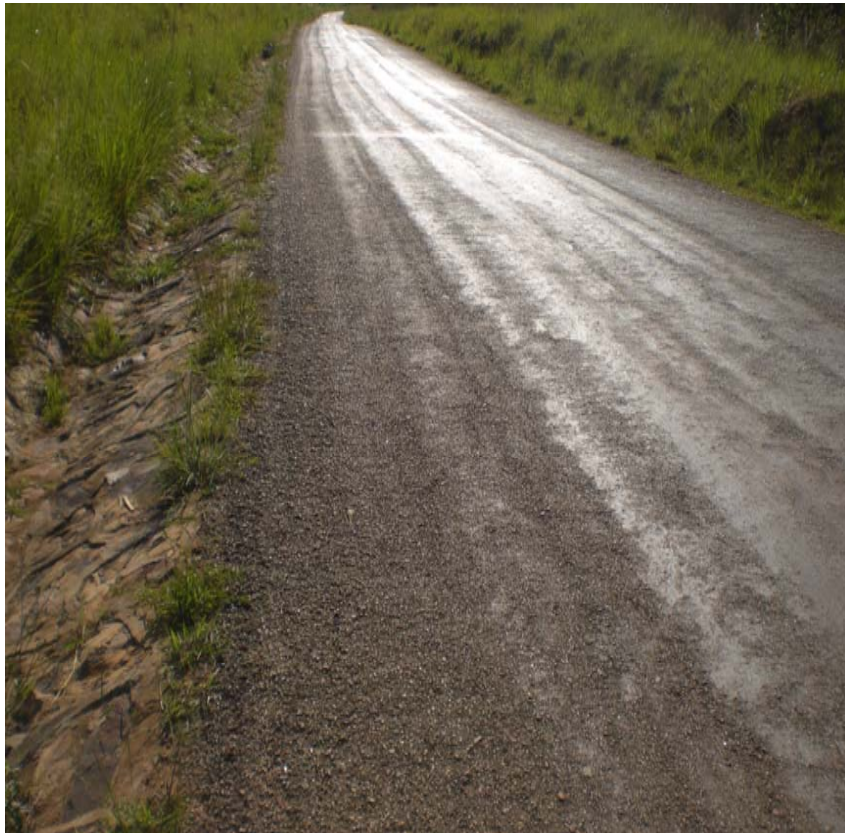
**Photo 20 and 21:** Adjacent Sections on Kyetema-Kanazi-Kanyinya Regional Road in Kagera Region Surface Dressed and Otta Sealed More Than 3 Years Ago

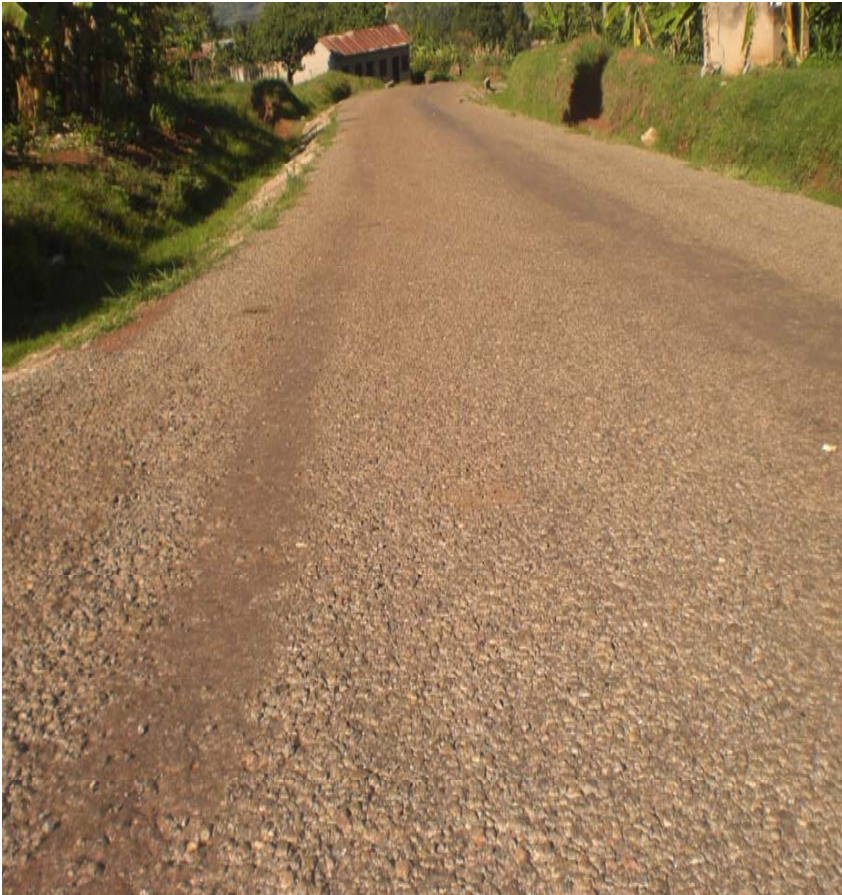
## Photo 22 and 23: Kanazi-Bulila Regional Road in Kagera Region Surface Dressed About 2 Years Ago
