FOOTBRIDGES

A Manual for Construction at Community and District Level

SUPPLEMENT A: CASE STUDY

Construction and Installation of a Modular Steel Truss Footbridge

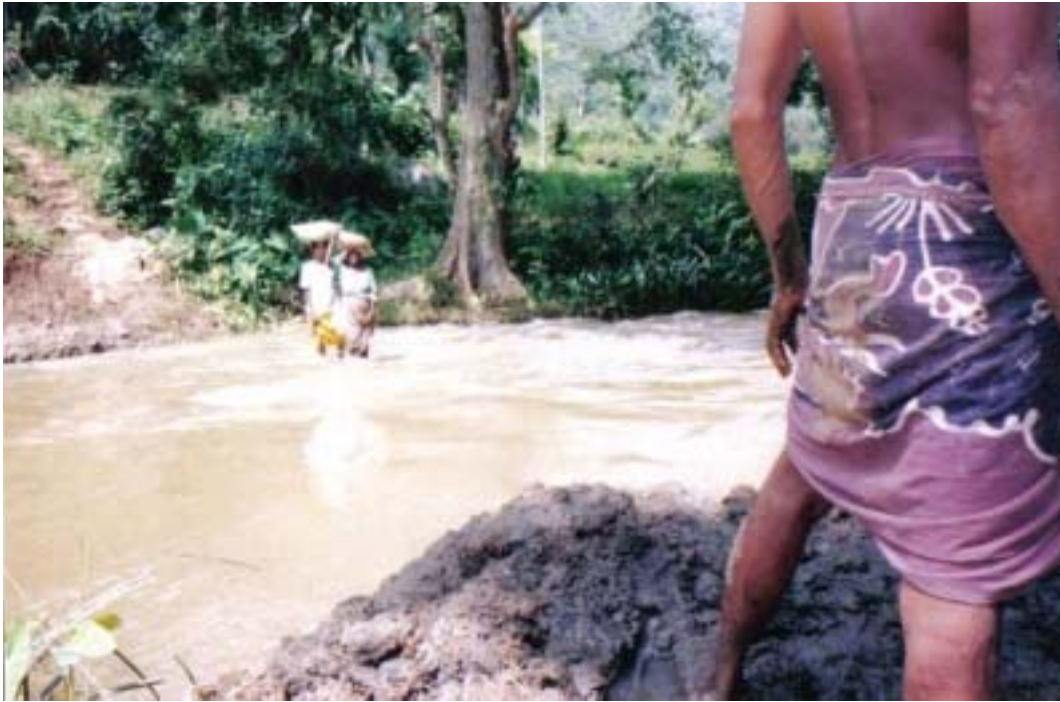
Figure 2.1: Site for the Footbridge

The site where the footbridge was located with women crossing at the ford. Note the steps leading down to the river.

The site is shown in Figure 2.1. The river is in a valley in an area of undulating terrain. There are paddy fields on both sides of the river. The river is about 12 to 15m wide. A well-used footpath crosses the river at the site, the present crossing of the river being by a ford. In the dry season the water is about knee high but in the rainy season the river is often impassable. This constrains the access of people to various facilities including preventing about 50 children from attending school. There is, therefore, an urgent need for a footbridge.

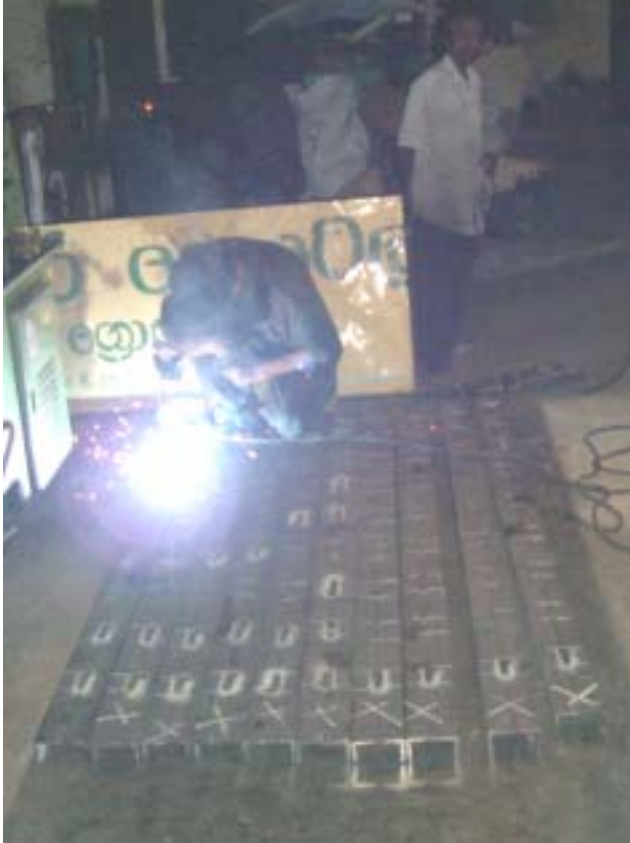
3.1 Welding of channels for the Bottom Longitudinals. Note the chalk marks across all the pieces showing the position of the stitch welds. The weld is between each pair of chalk marks.

Welding is still in progress.

The procedure is similar for the End Panel Longitudinals and Base Panel Longitudinals.

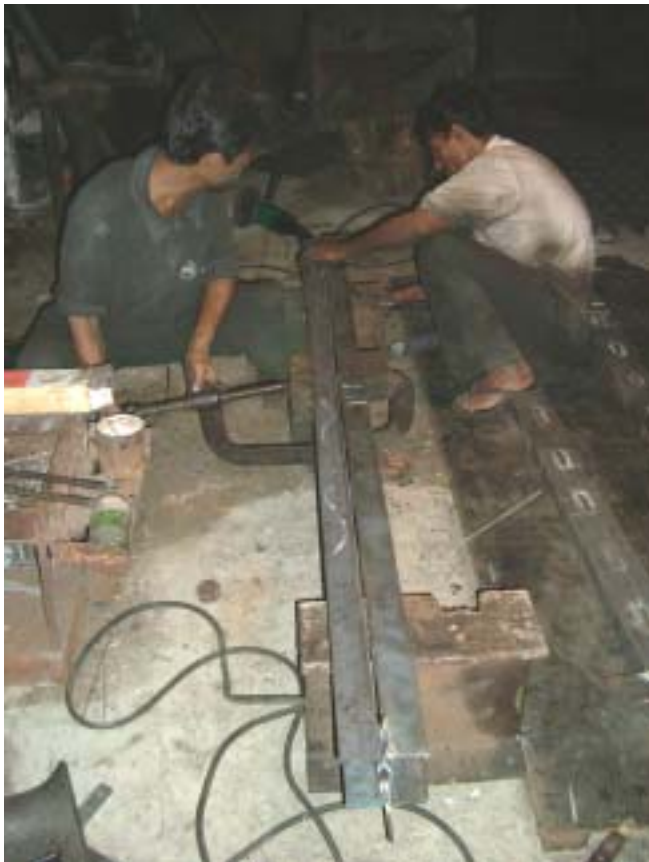
Figure 3.1: Manufacture of Side Panel Members (see Figure B4)

3.2 A pair of channel sections being aligned and clamped together to form a Bottom Longitudinal.

A gusset (G1 or G4) can be seen facing downwards i.e. the Longitudinal is resting upside down.

The procedure is similar for the End Panel Longitudinals.

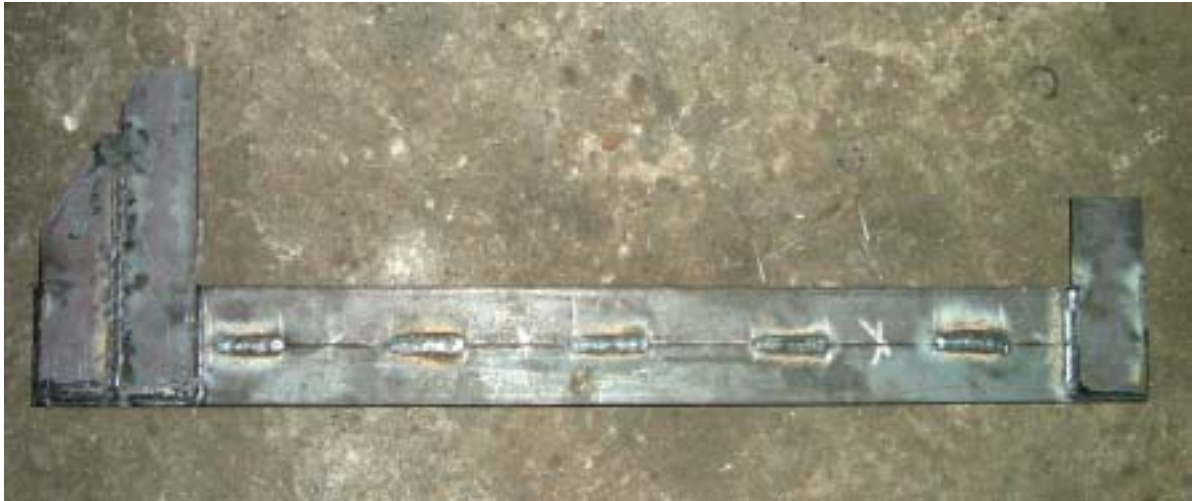
3.3 First step in welding up End Panel Bottom Longitudinal (EB) as in Figure B6, Step 1.2. Note 6mm space left around gussets for welding

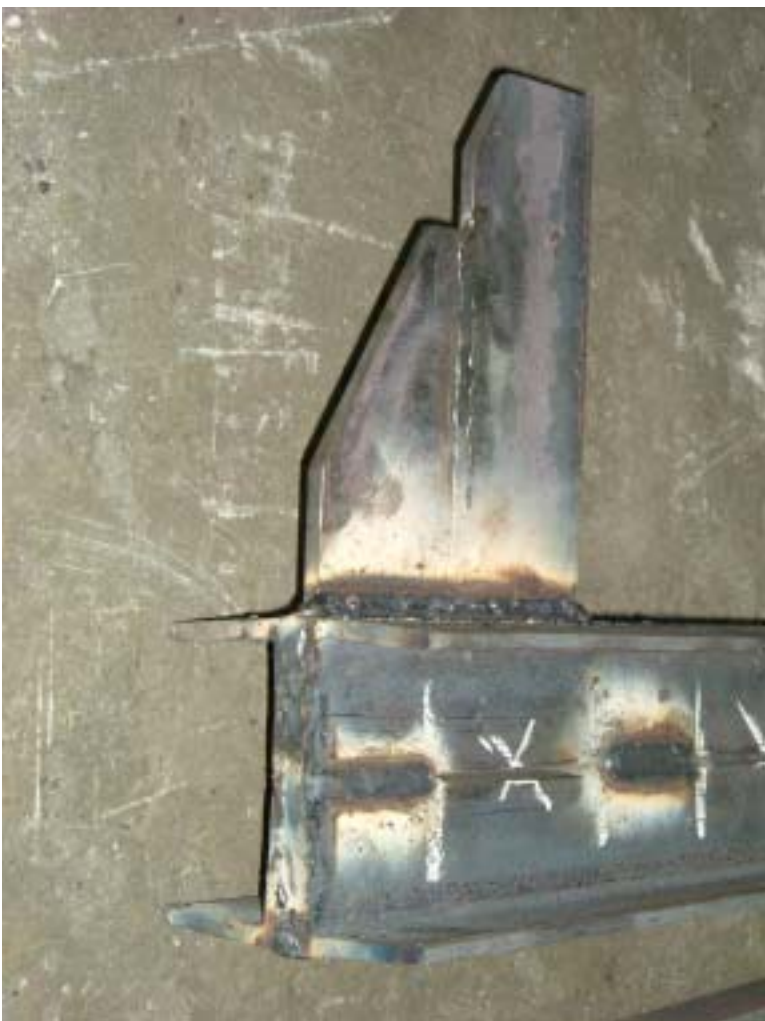
Figure 3.2: Manufacture of End Panel Bottom Longitudinal

3.4 Completed welding of End Panel Bottom Longitudinal as in Figure B6, Step 1.3.

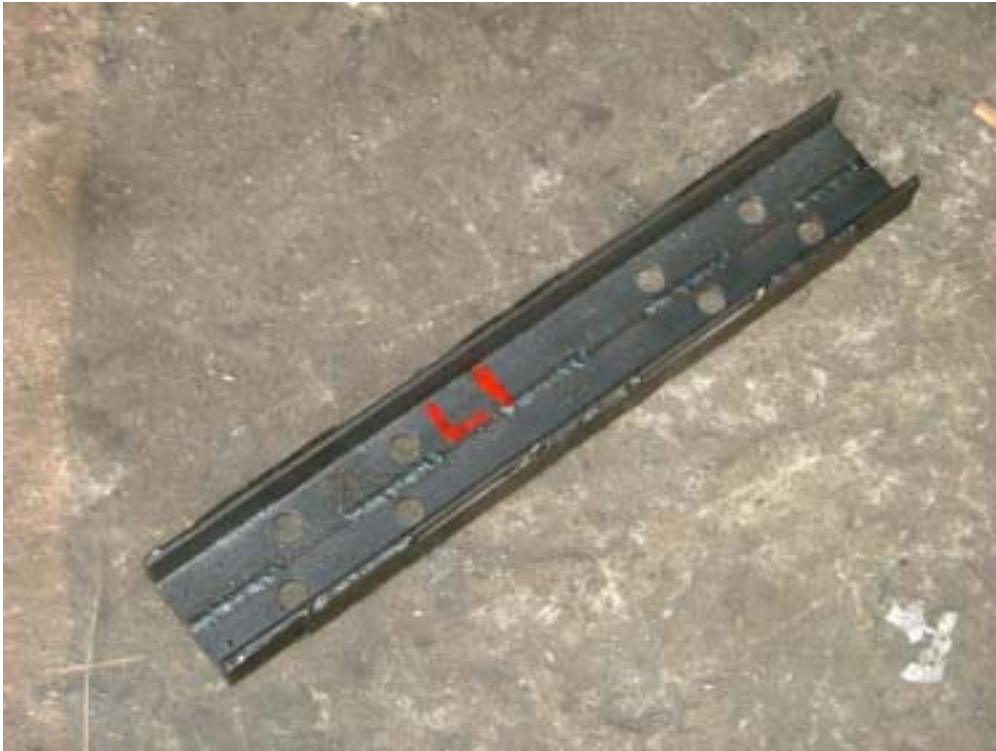
3.5 Joining bracket with bolt holes drilled. Note the 3mm thick stiffeners welded on the top and bottom surfaces.

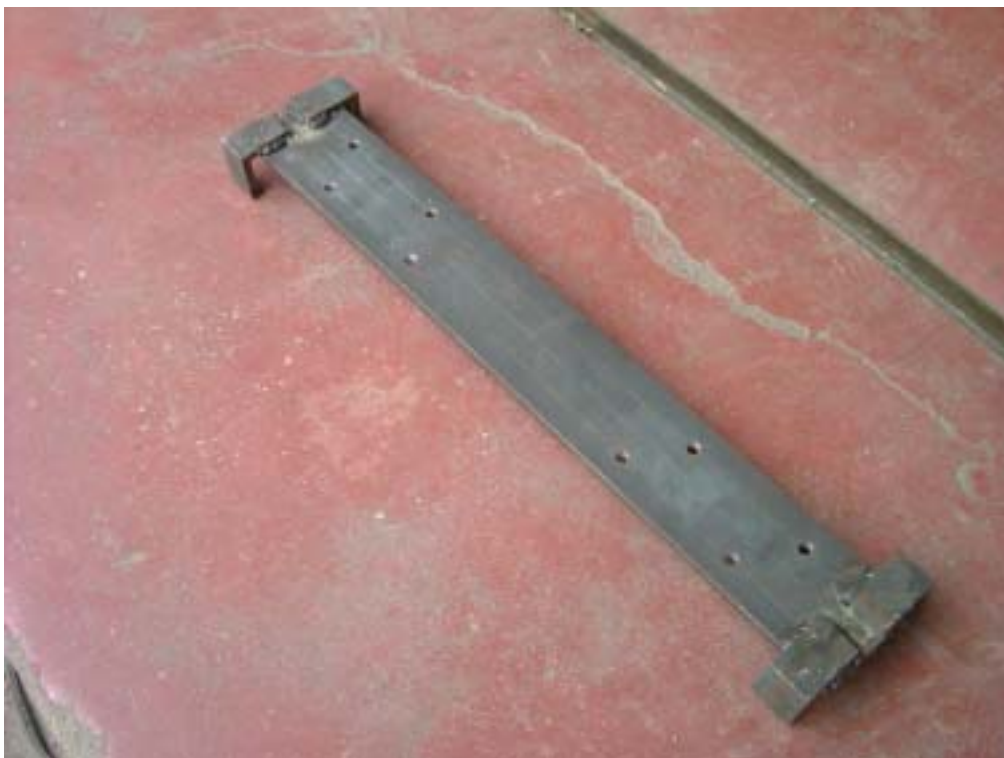
Figure 3.3: Details of Joining Bracket and Drilling Template (see Figure B9)

3.6 Template for drilling pilot holes in the joining brackets.

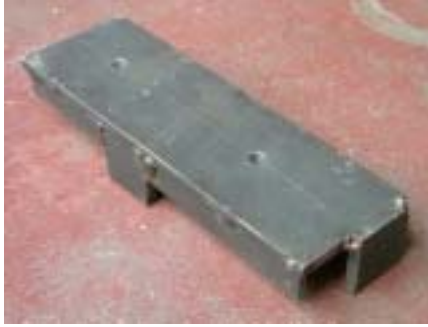
3.7 Drilling template for Side Panel Verticals (Figure B10.3)

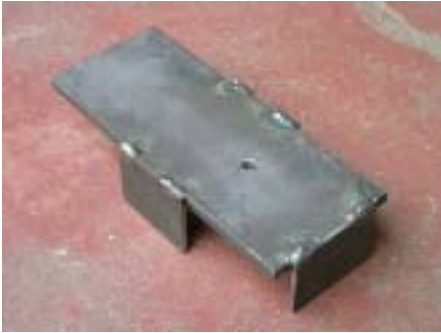
3.8. Drilling template for Base Panel Cross Members (Figure B10.4)

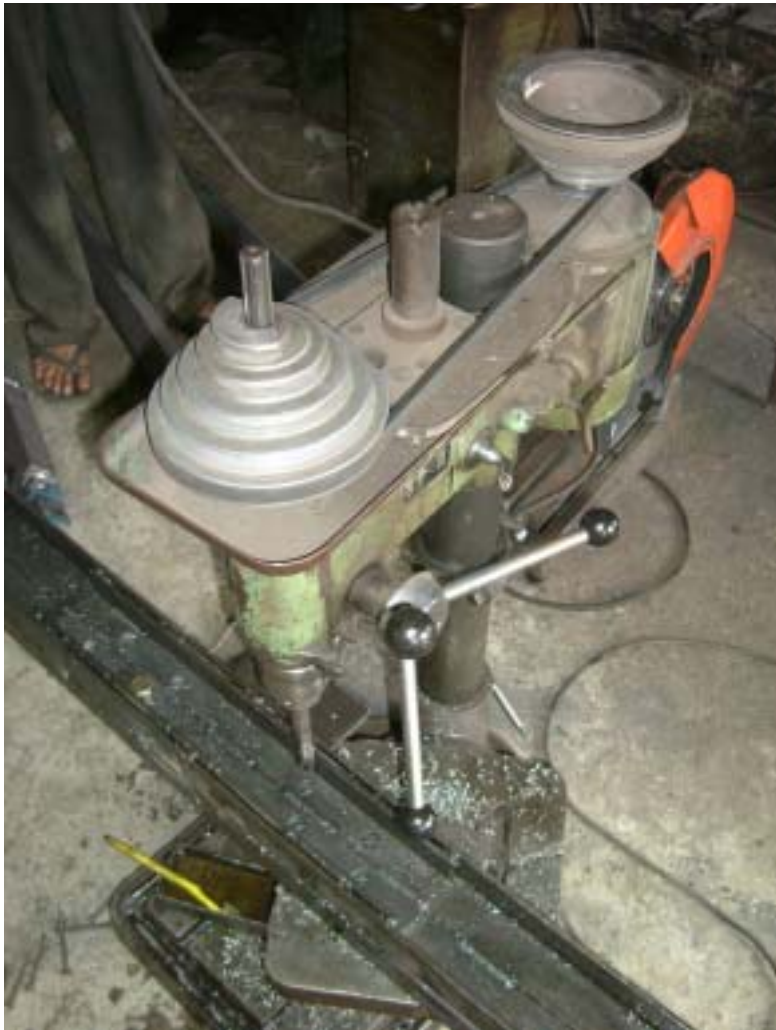
Figure 3.4: Drilling Procedures

3.9 Drilling holes for joining the Side Panels (Figure B11.5). Note the Joining Bracket is tack welded inside the joining Side Panel Bottom Longitudinals. Similarly the Base Panel Longitudinal is tack welded in the opposite side.

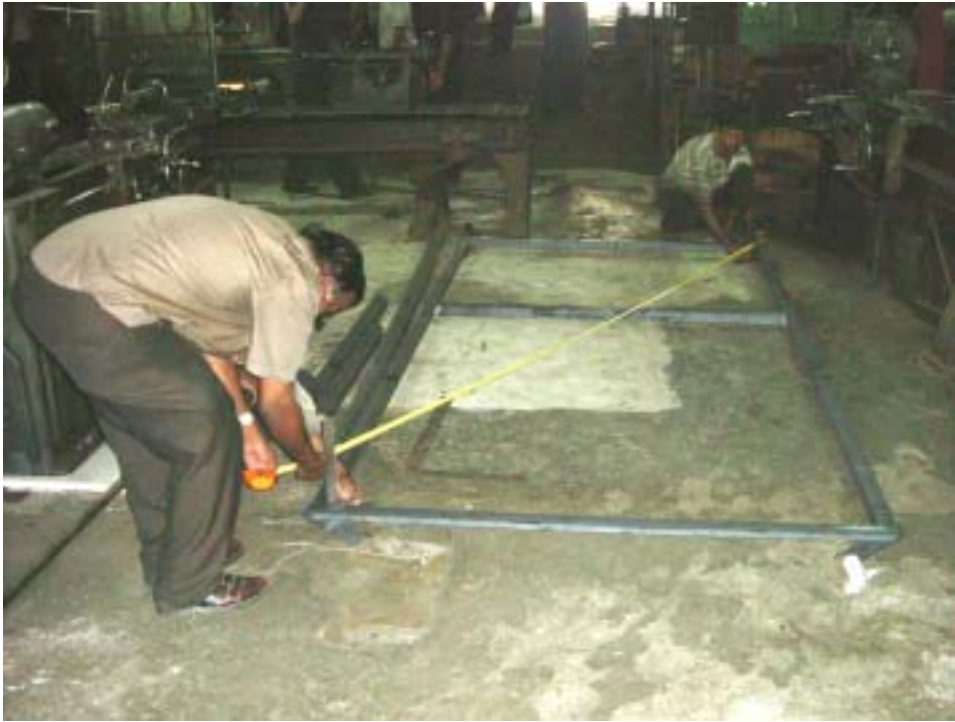
3.10 Checking the lengths of the diagonals in constructing the assembly jig (see Figure B12(i)). Note that jig is being set up on a flat floor area.

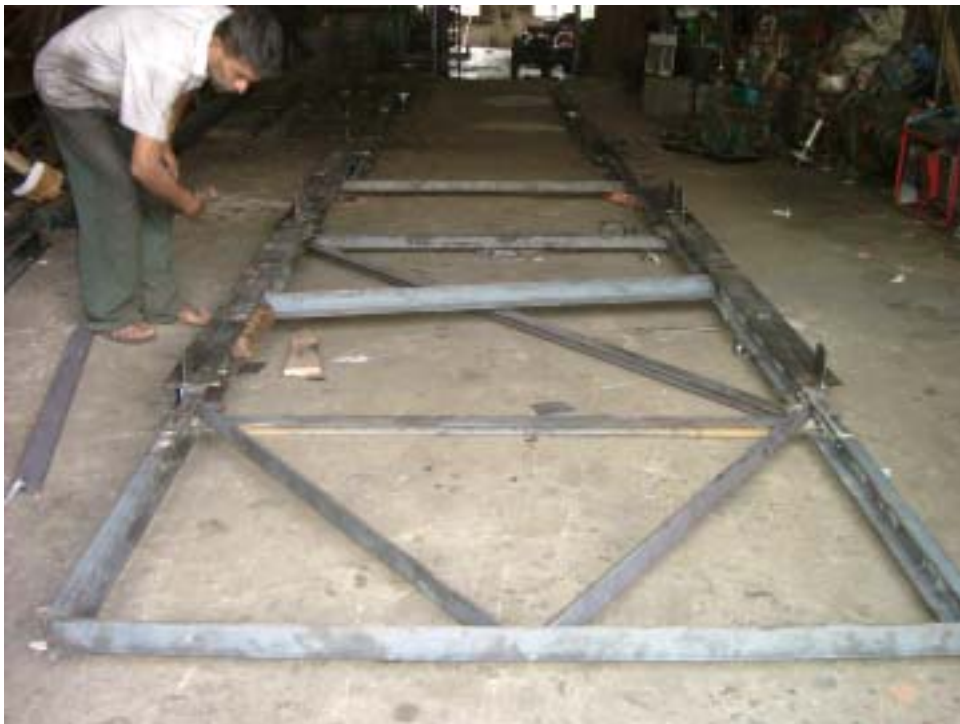
Figure 3.5: Construction and Use of Assembly Jig

3.11 A base panel being assembled in the jig (see Figure B13). (Note that the lower frame resting on the floor is the jig). Note the bolting together of the joints between the Side Panel Bottom Longitudinals and the Base Panel Longitudinals.

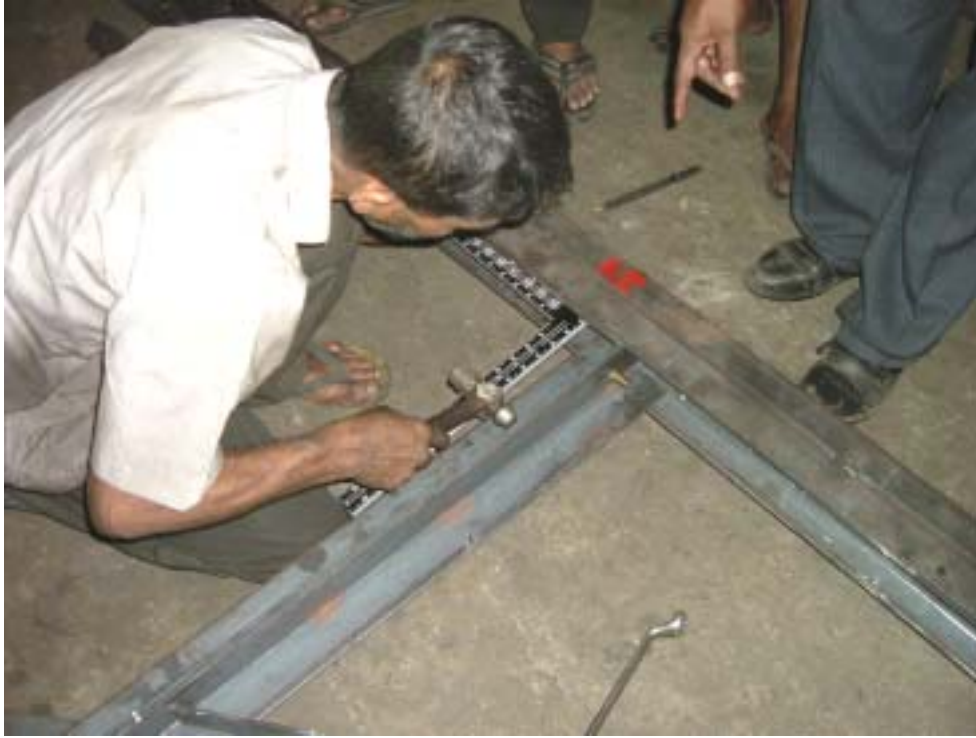
- 3.12 Fitting the Base Panel Cross-members in position (see Figure B13). This is at the joint of adjacent Base Panel Longitudinals which are inside the channel section of the Side Panel Bottom Longitudinals.

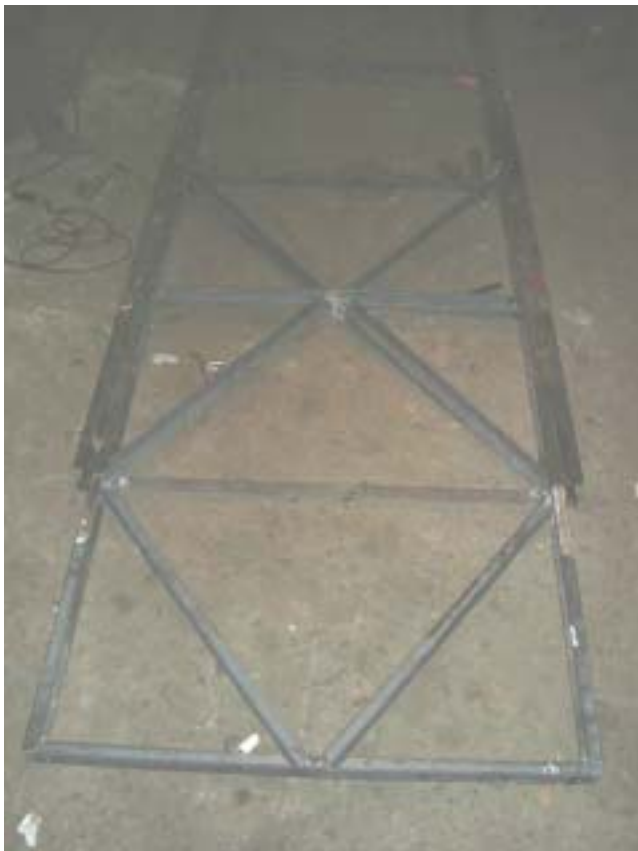
Figure 3.6: Construction of Base Panel

- 3.13 A completed base panel still set up on the jig and ready to be removed for final welding

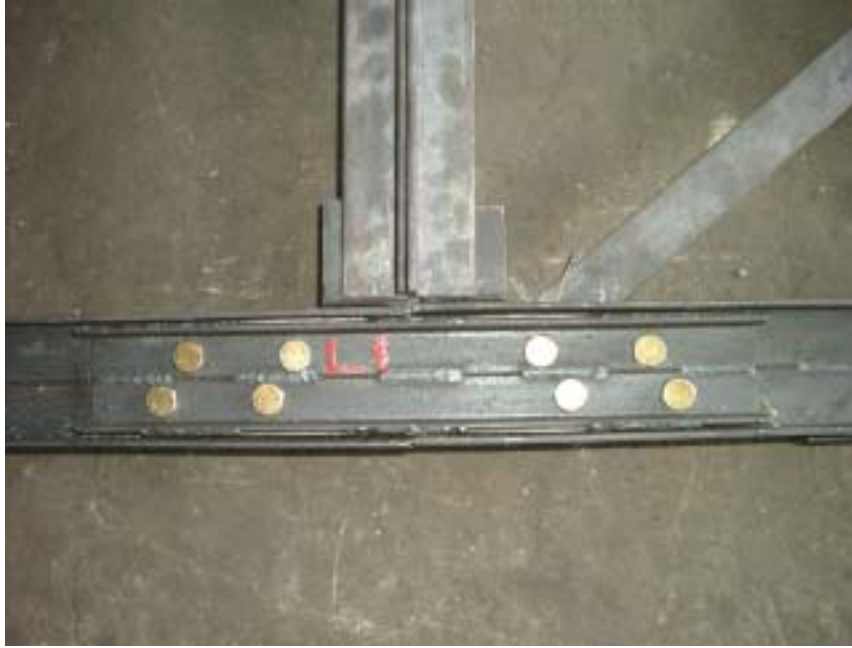
- 3.14 Joining Bracket bolting together 2 Bottom Longitudinals (SB) to fit Side Panel Verticals (SV) (see Figure B14).

Note: there is a problem here in that the Verticals are resting on the Gusset Weld so that the gap between the Verticals and the Bottom Longitudinals is too large for welding. It is **essential** that the bottoms of the verticals are welded all round. The gusset weld, therefore, needs to be ground to reduce the gap to 1 to 2mm to allow welding of the Vertical to the Bottom Longitudinal.

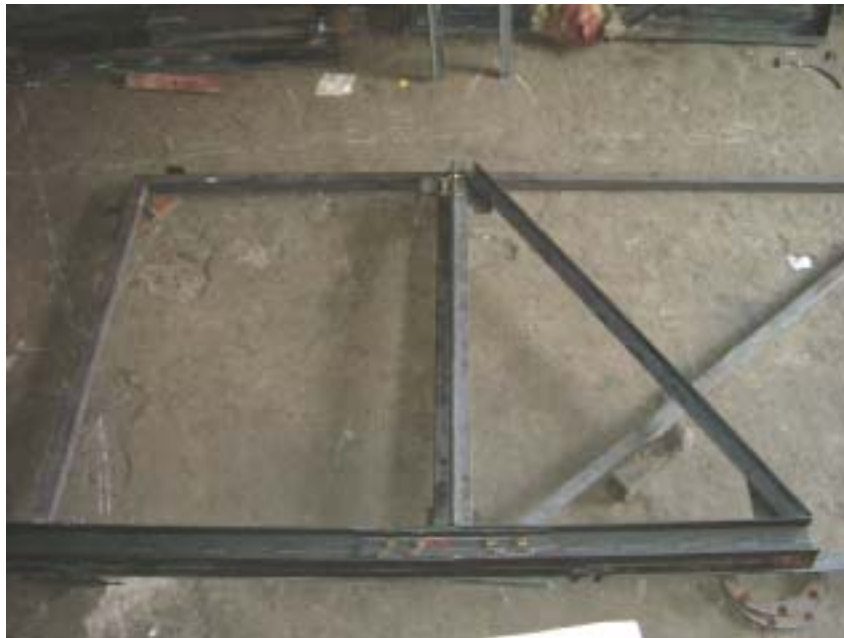
Figure 3.7: Assembly of Side and End Panels

- 3.15 End Panel (E1.L) and Side Panel (S1.L) assembled in the jig (see Figure 14 Step 1). The End Panel is ready to be removed and completed by adding the Deck Side Diagonal and fully welding the joints.

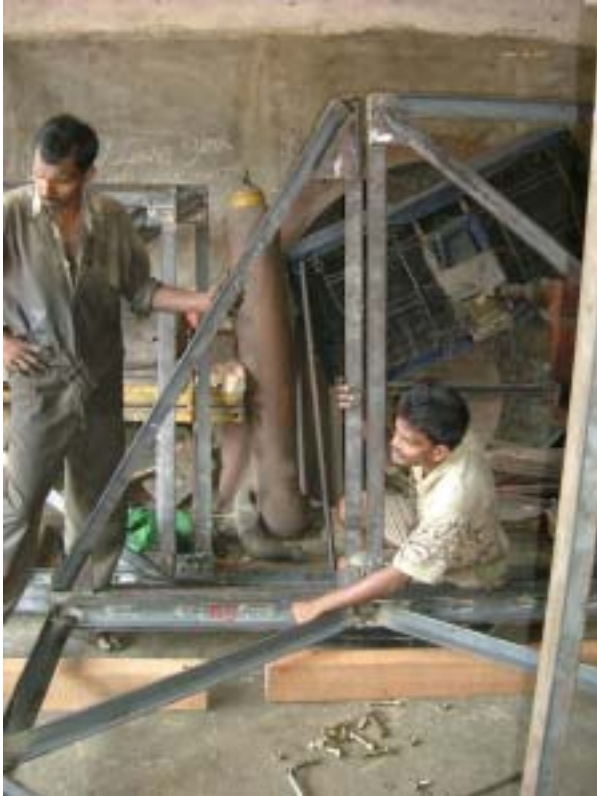
3.16 Beginning assembly of the Panels at the Left Hand end of the footbridge. Note the Base Panel Longitudinal (BL) fitting inside the Side Panel Bottom Longitudinal (SB)

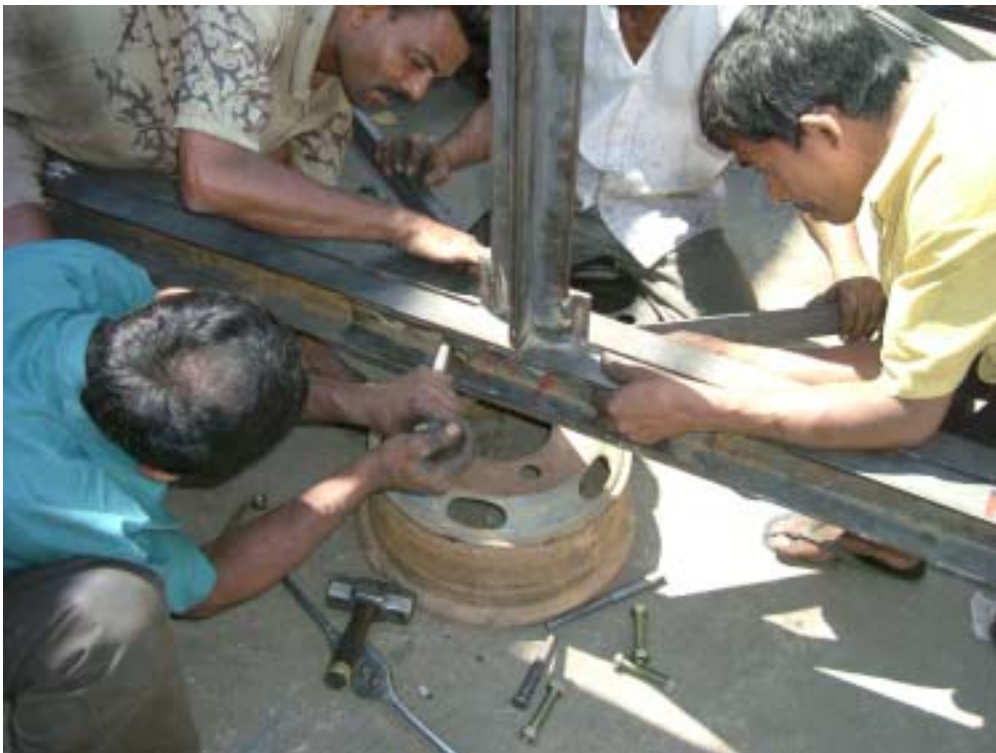
Figure 3.8: Assembly of the Footbridge in the Workshop

3.17 Lining up the holes at the bolted joint between adjacent side panels. Note the Joining Bracket fitted inside the channel of the Bottom Longitudinal.

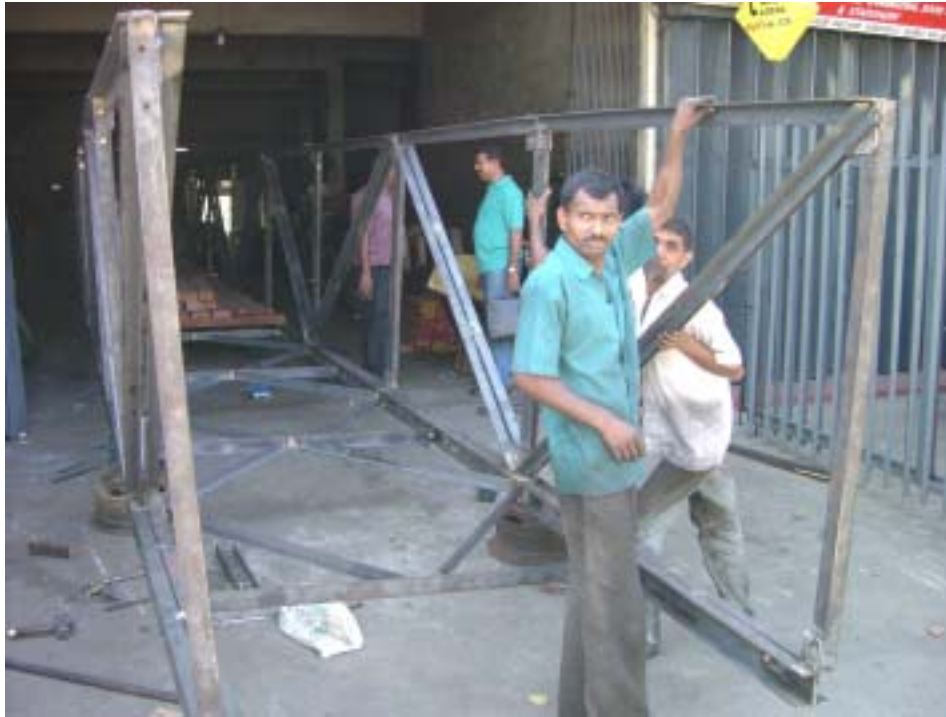
3.18 Assembly in workshop almost completed.

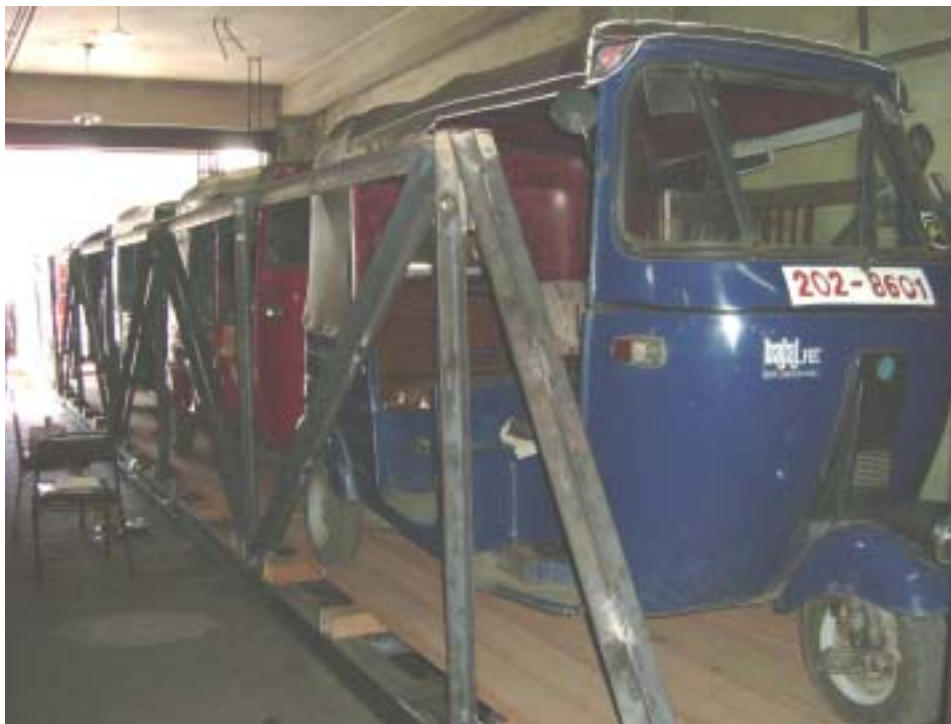
Figure 3.9: Assembly and Testing of the Footbridge in the Workshop

3.19 6 Bajajs (3-wheel taxis) loaded on the footbridge to test it in the workshop. This gave a total load of about 2 tonne, only about 22% of the design load but well above the maximum load expected in service. Ideally the footbridge should have been tested with a crowd load. However, strain gauges were attached at critical points to predict the effect of larger loads.

After assembly, the footbridge was tested in the workshop to make sure it performed satisfactorily and to check the design. Ideally this should be done with crowd loading but this was not found possible and 6 small vehicles were used instead. This gave a live load of about 22% of the design load, but well above the expected maximum service load of the footbridge.

Testing – the set up is shown in Figure 3.9. Electrical resistance strain gauges were attached at critical locations of the panels to check stresses. This is NOT part of the normal requirement for testing but was carried out to check the design analysis in order to confirm the design concept for the modular truss footbridge. The measured stresses were at least 10% lower than those from the analysis. The central vertical deflection of the bridge was measured as 4mm giving a predicted deflection at the design load of 20mm which is much below the allowable deflection of 68mm for a 17m span footbridge. The tests therefore confirmed that the design concept is satisfactory.

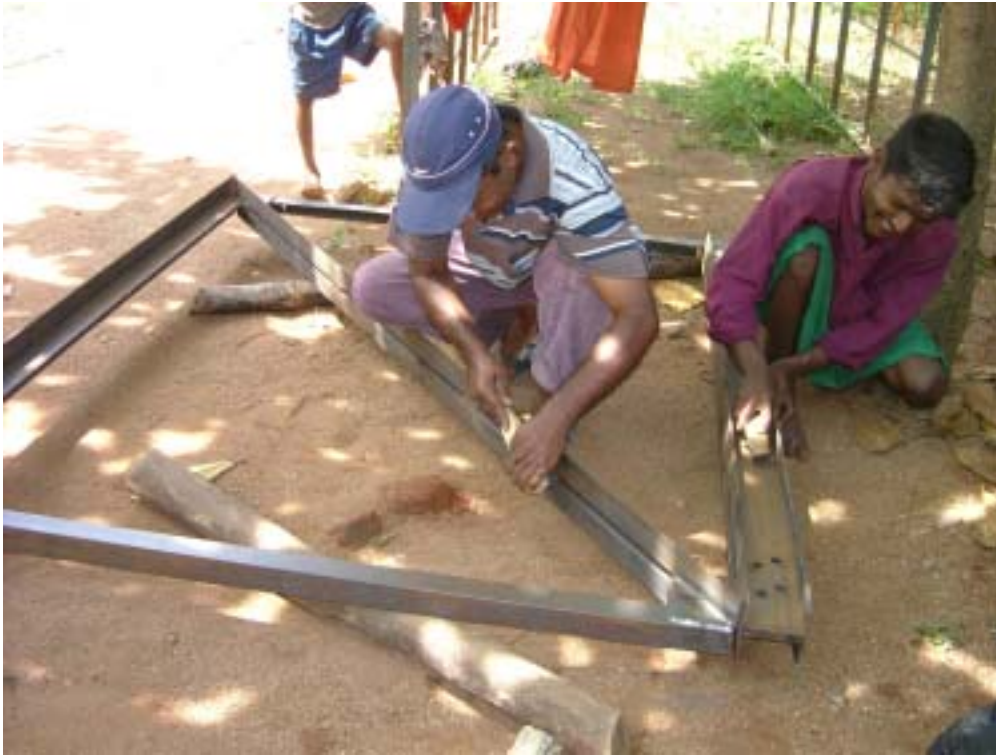
3.20 Preparation for painting using wire brushes to remove loose scale and rust. All welds need to be cleaned up and weld splatter removed. Degrease all surfaces with petrol soaked rags before painting.

- Figure 3.10 shows the panels being prepared for painting. All welds should be cleaned up, preferably by grinding, and all weld splatter removed. All surfaces were wire brushed to remove loose scale and rust and then degreased with petrol-soaked rags. 2 coats of paint were applied, a primer and a top coat of anti-corrosive paint. Ideally a second top coat should have been applied. The figure shows the use of paint soaked rags to thoroughly paint inside the spaces between the channels of the Bottom Longitudinals. This was also done for the spaces between the angles of the Diagonals.
- Figure 3.11 shows the clear labelling needed for each panel and member to ensure they are in the correct order for assembly on site.

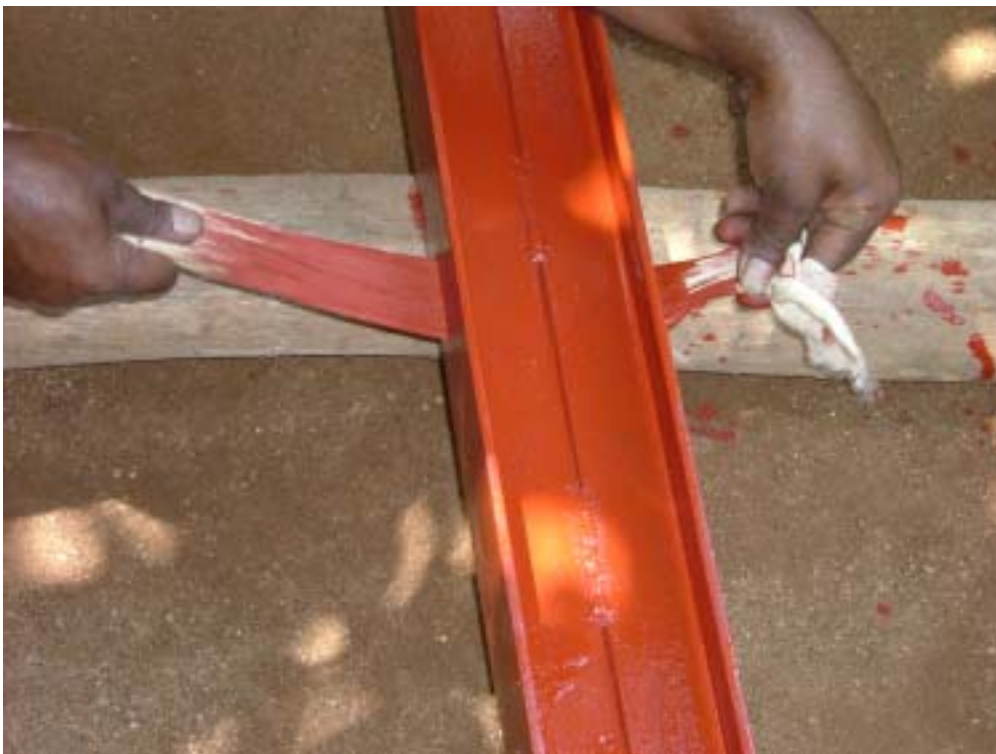
Figure 3.10: Preparation and Painting of the Panels

3.21 Using a paint soaked rag to paint inside the space between the channel sections of the Bottom Longitudinals. This also has to be done for the diagonals.

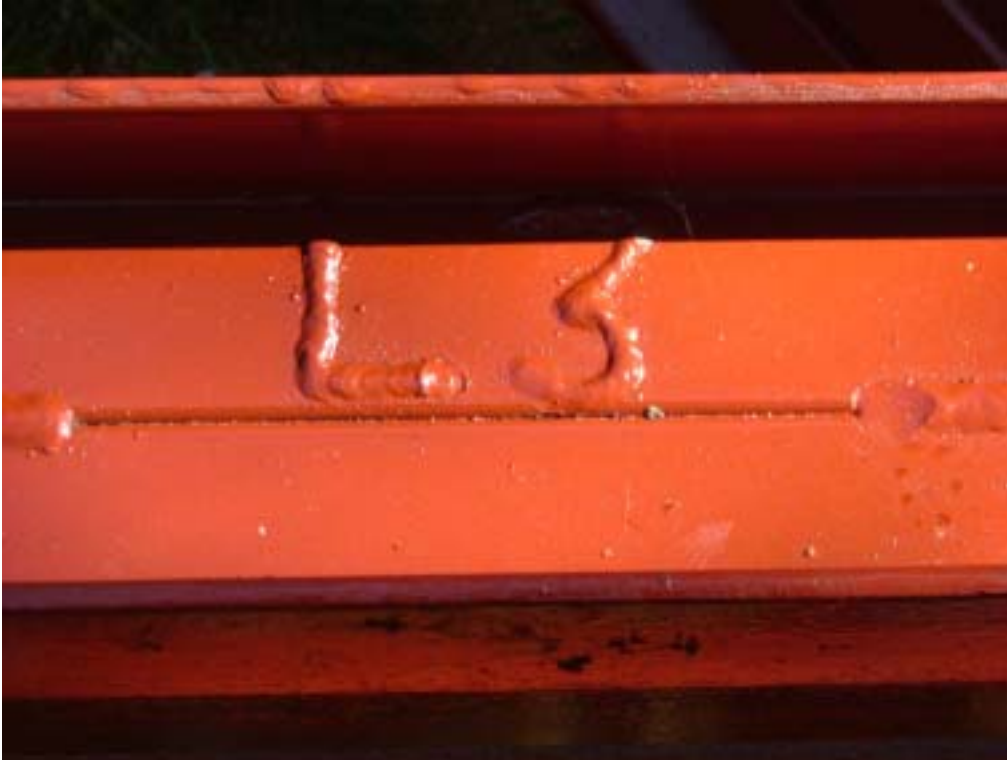
Figure 3.11: Marking of Panel Members

- 3.22 Note that all panels and brackets must be clearly identified at the stage of manufacture and assembly in a manner that remains clear after painting. This is essential to ensure that parts are correctly matched for the assembly on site.

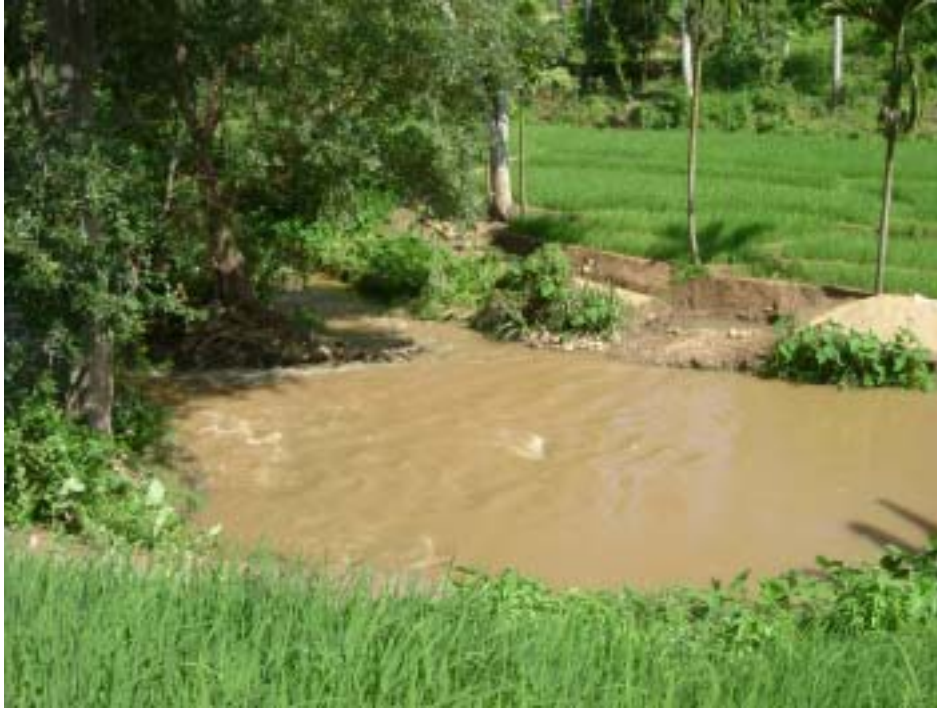
- 4.1 Start of preparation for the abutments. The far bank has been cleared and leveled and excavation for the abutment footing has been started.

- Figure 4.1 shows the preparation for the footing of an abutment, involving clearing and excavation. The average depth of excavation was about 1.2m for a footing of about 0.5m thickness. The work was carried out by local paid labourers
- Figures 4.2 and 4.3 show stages of the construction of the abutments. The construction was carried out by 2 or 3 persons with experience of building this type of abutment assisted by local labourers.

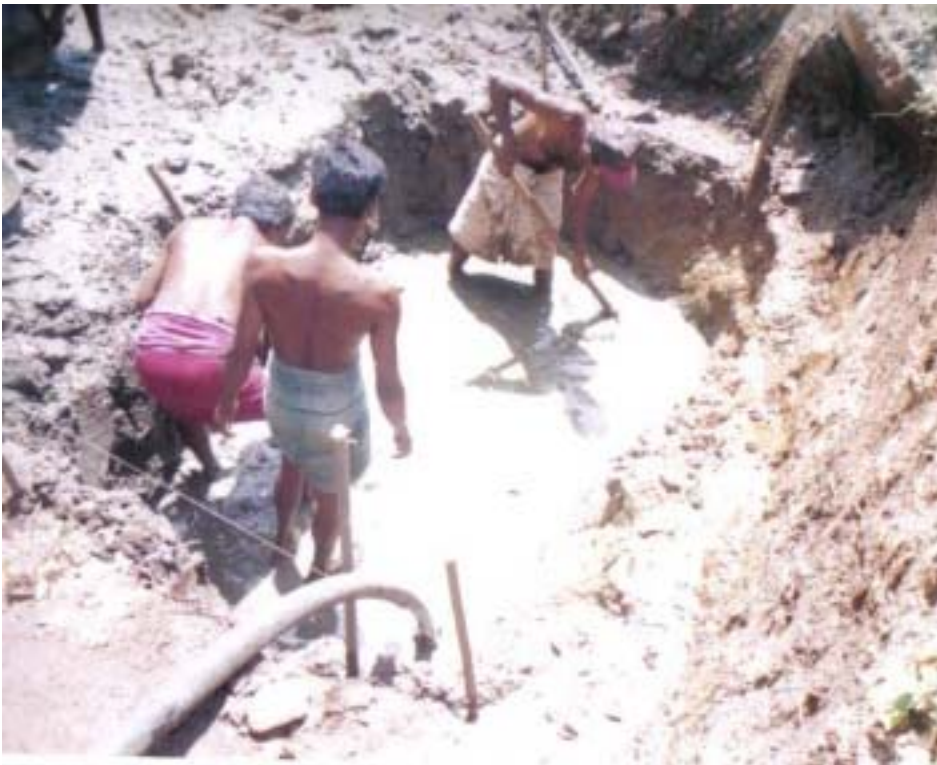
Figure 4.1: Preparation of Footings for Abutments

- 4.2 Excavation of the footing for an abutment. The depth of the excavation is below the water table. Note the suction pipe for a pump to extract the water during the construction of the footing.

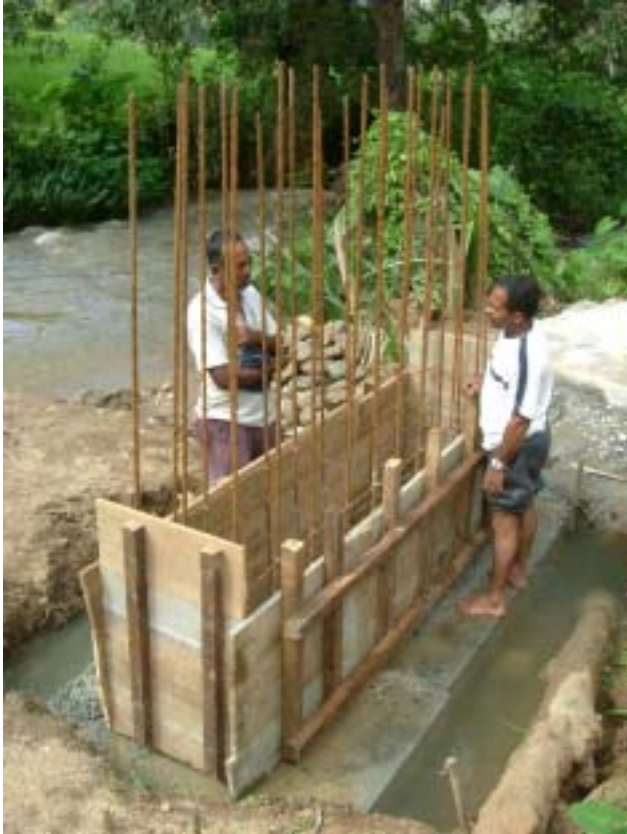
4.3 Details of the footing for the abutment. The local technical person supervising the installation decided to use a standard design of reinforced concrete abutment that they were familiar with. The footing is a concrete slab of 3 x 1.2m in area x 0.5m deep (approximately)

The abutments were designed by the site supervisor to a standard local design. This comprised a reinforced concrete abutment built on a concrete footing. The reinforcing steel allows a thinner cross section and therefore less concrete is used. The comparison of cost depends on the relative cost of concrete and steel. A masonry abutment would give the lowest cost and be the preferred design, but the reinforced concrete design is the type commonly used in the area.

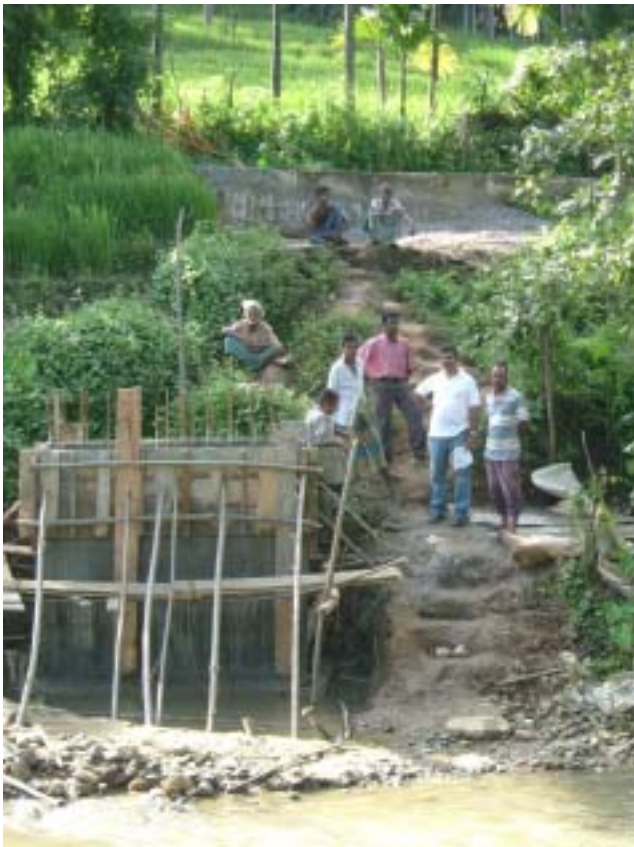
Figure 4.2: Construction of the Abutments

4.4 Construction of the abutment on the steeper bank of the crossing. The shuttering is supported by poles and is moved upwards as each layer of the concrete is cast. Each layer of the concrete is about 600mm thick. The overall size of the abutment is 2.4m long x 0.6m wide x 2.4m high.

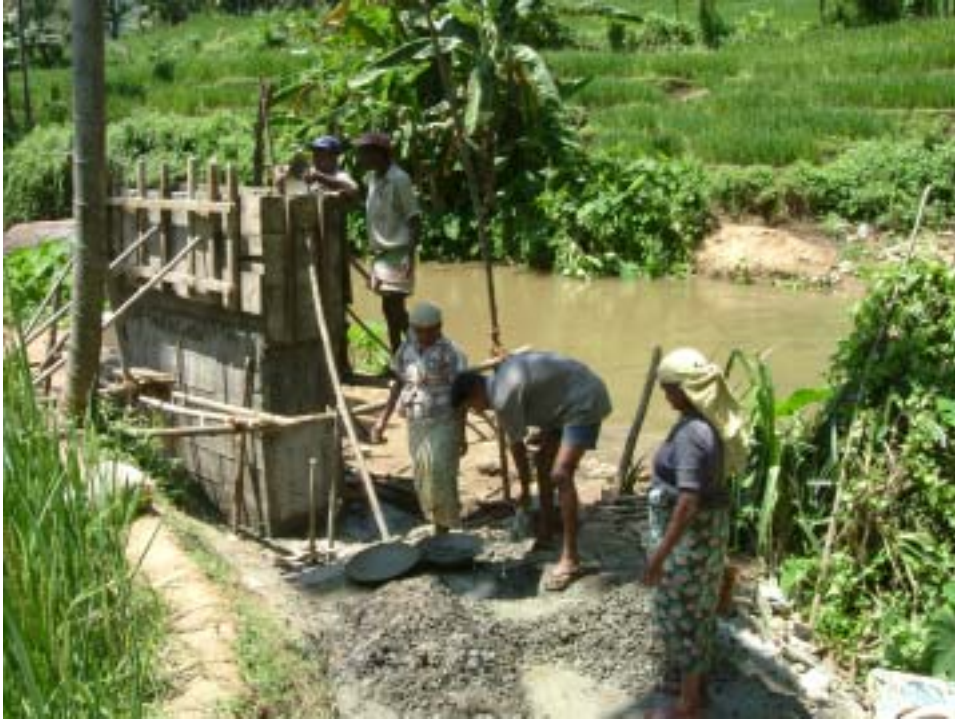
4.5 Mixing and pouring the concrete for construction of an abutment.

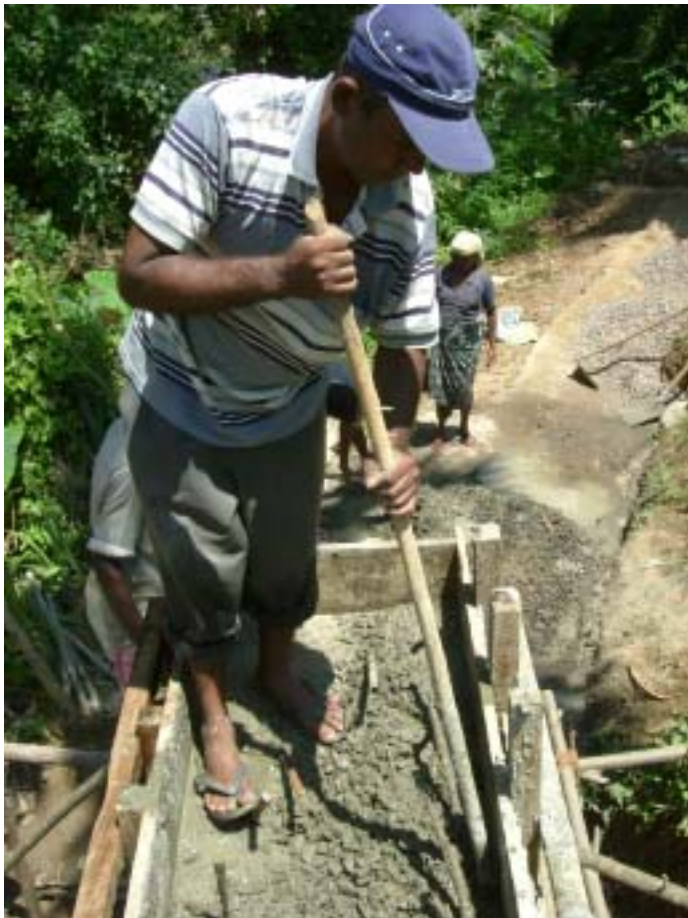
Figure 4.3: Concrete Work in Constructing the Abutments

4.6 Tamping the concrete to make sure it is densely spread. Larger stones collected by the community are spread over the central section to reduce the volume of cement needed.

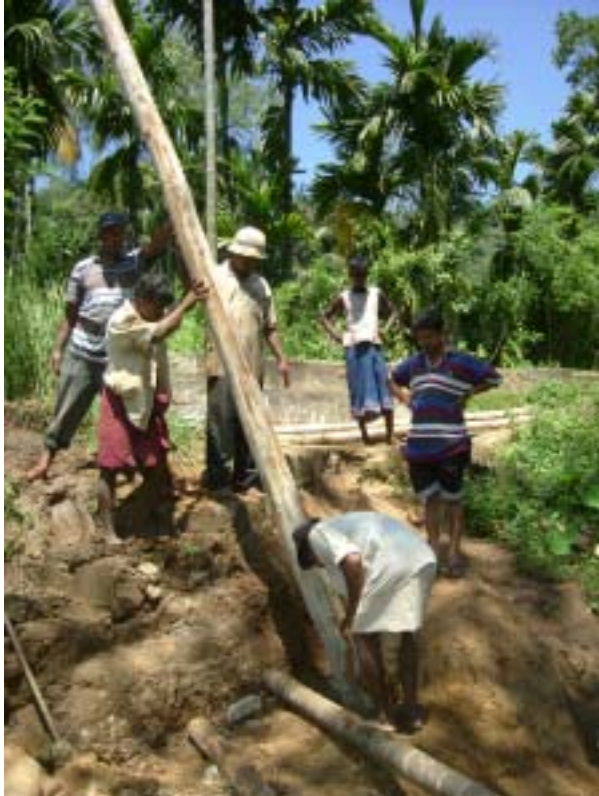
- 4.7 Fitting foot of tower pole into an excavated hole. The hole should be at least 0.5m deep. The pole is about 120mm in diameter

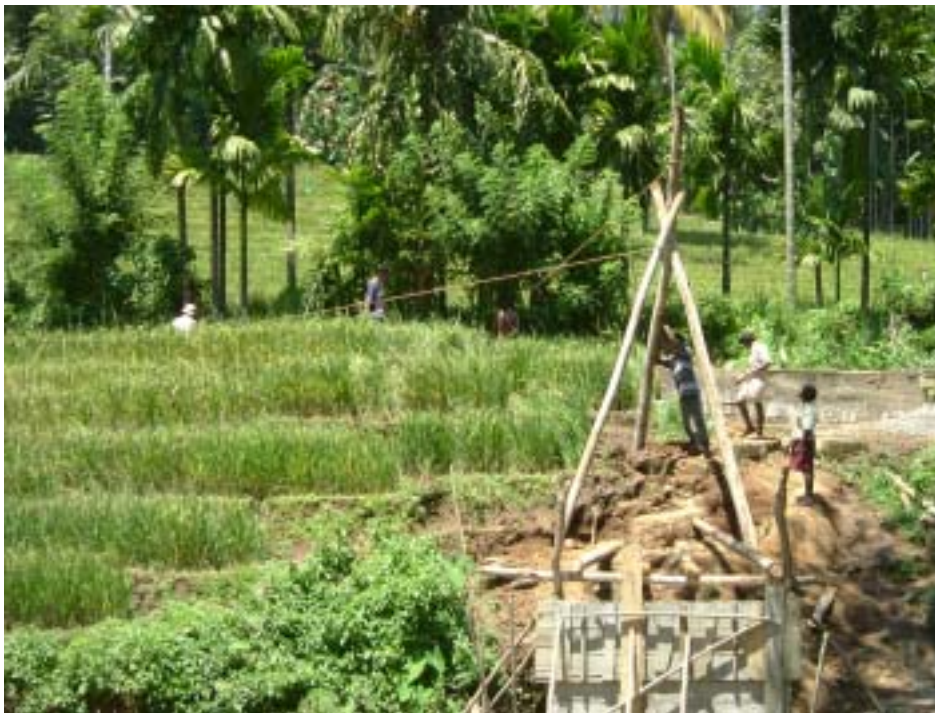
Figure 4.4: Erection of Tripod for Installing the Footbridge (see Figure 7.14 of Manual)

- 4.8 Tower poles erected up the bank from the abutment and stabilized with guy ropes tied to adjacent trees. Note the poles between the abutment and tripod which are the beginning of the support structure for the platform on which the footbridge is to be assembled.

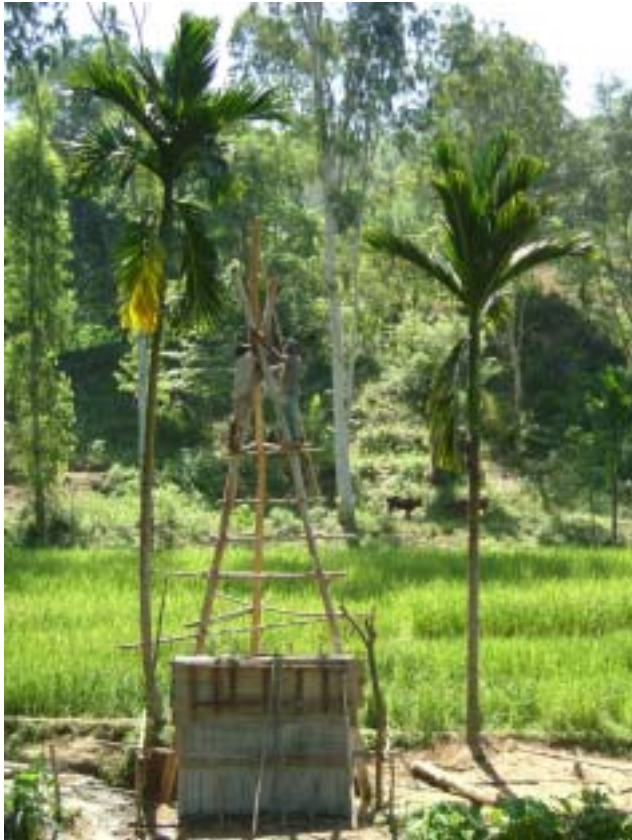
4.9 Completion of a tower for supporting the cable for the installation of the footbridge. The support beam for the cable is about 6m above the ground on this lower bank of the river. The cross-members bracing the poles are about 50mm in diameter.
