FOOTBRIDGES

A Manual for Construction at Community and District Level

SUPPLEMENT A: CASE STUDY

Construction and Installation of a Modular Steel Truss Footbridge

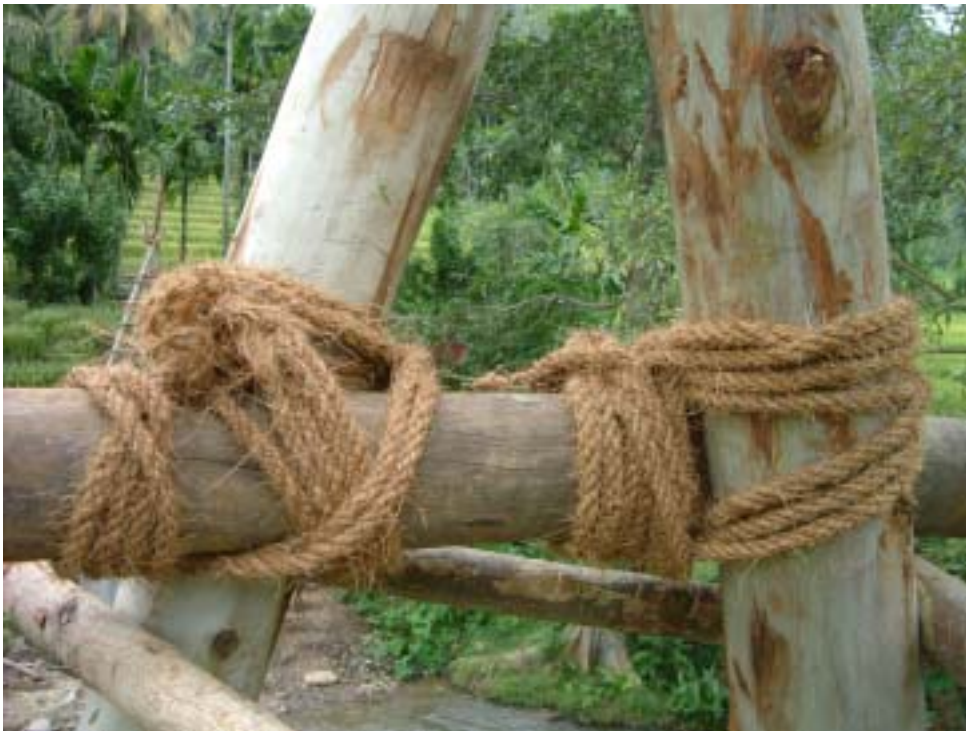
Figure 4.5: Details of the Construction of the Cable-Way

4.10 Details of the support beam for the cable. This is 120mm in diameter. It is important that the cable runs in a straight line from anchor at one bank, over the cross-members on the two towers to the anchor at the other bank, in order to minimize side-ways forces on the two towers.

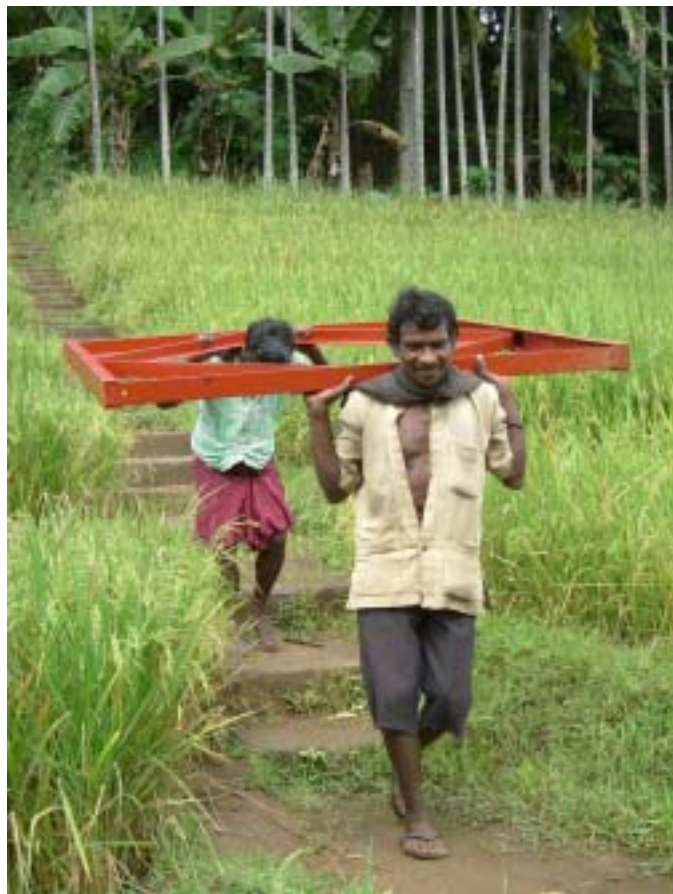
Figure 4.6: Community Members Carrying Footbridge Panels from the Road to the Site

4.11 Carrying a Side Panel down the steps to the site.

4.12 Carrying a Base Panel to Site.

- Figures 4.4 and 4.5 show the erection of the towers for the cable-way. The overall details of the cable-way are shown in later photographs
- Figure 4.6 shows panels being carried from the road to the site, a distance of 300 to 400m

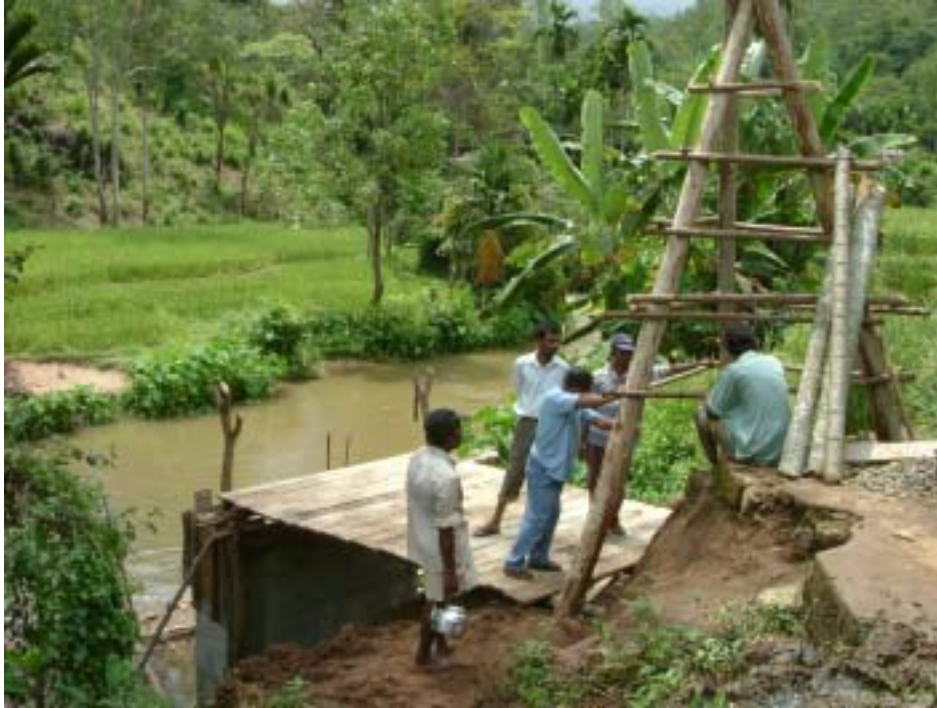
- 4.13 Construction of a platform on which to assemble the footbridge modules. This comprises planks that are supported by logs that rest on the abutment at one end and the bank at the other end. The platform is 4m long x 3m wide.

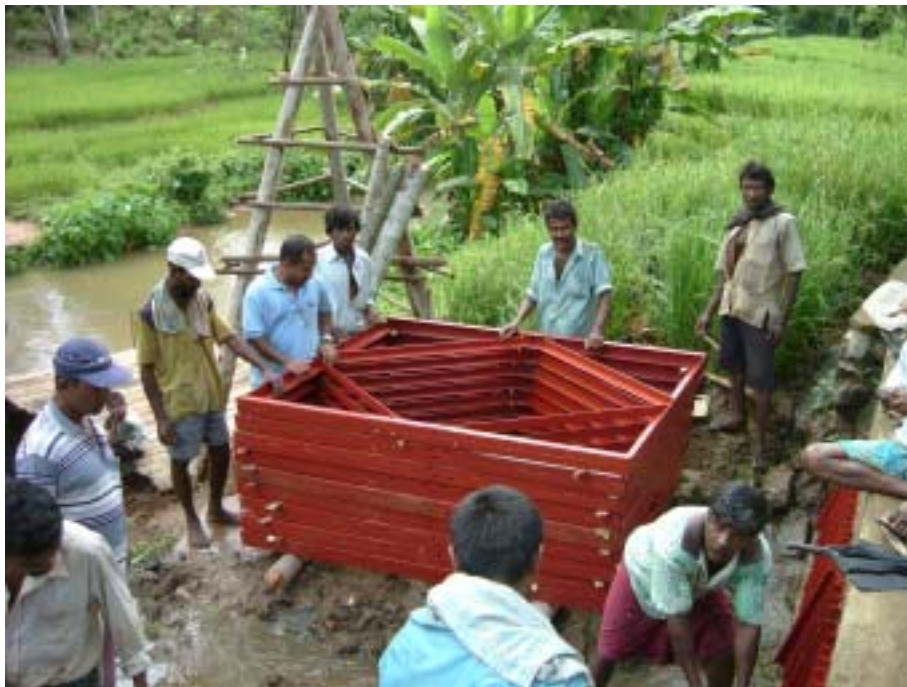
Figure 4.7: Preparations for Assembly of the Footbridge

- 4.14 The panels are stacked ready for assembly of the footbridge. Note also the joining brackets on the right hand side. Panels and members should be stacked carefully with separating spacers to avoid contact and damage to the paintwork. Panels and members should be stacked in the correct sequence ready for assembly.

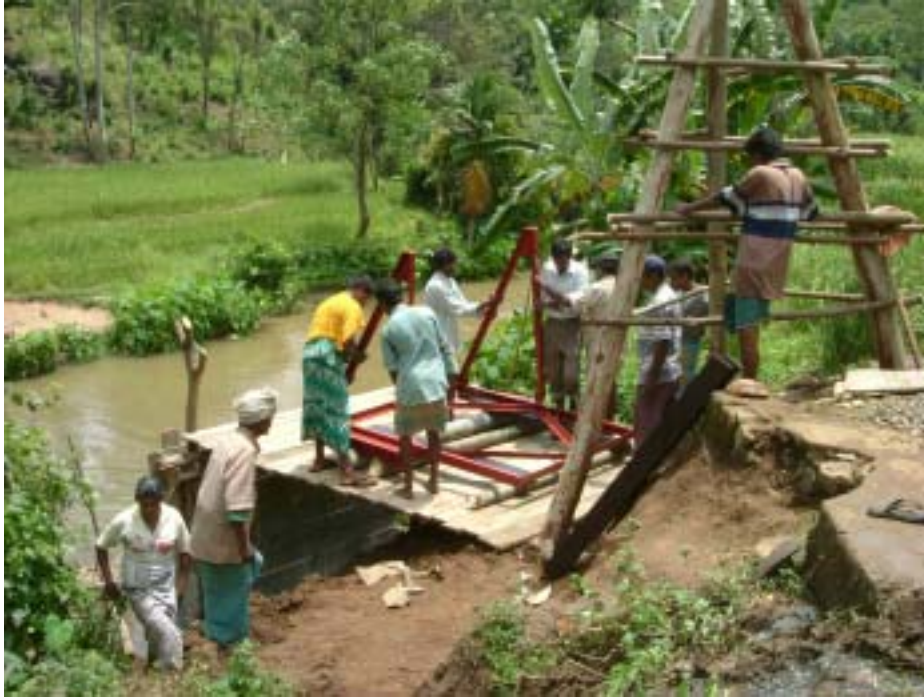
- 4.15 Start of assembly with End Panels E1.L and E1.R and Base Panel B1. Note that the Base Panel rests on wooden planks that are supported on log rollers. It is important that the Base Panels do not rest directly on the rollers as this would damage the paintwork. The rollers are approximately 100mm in diameter x 2m long.

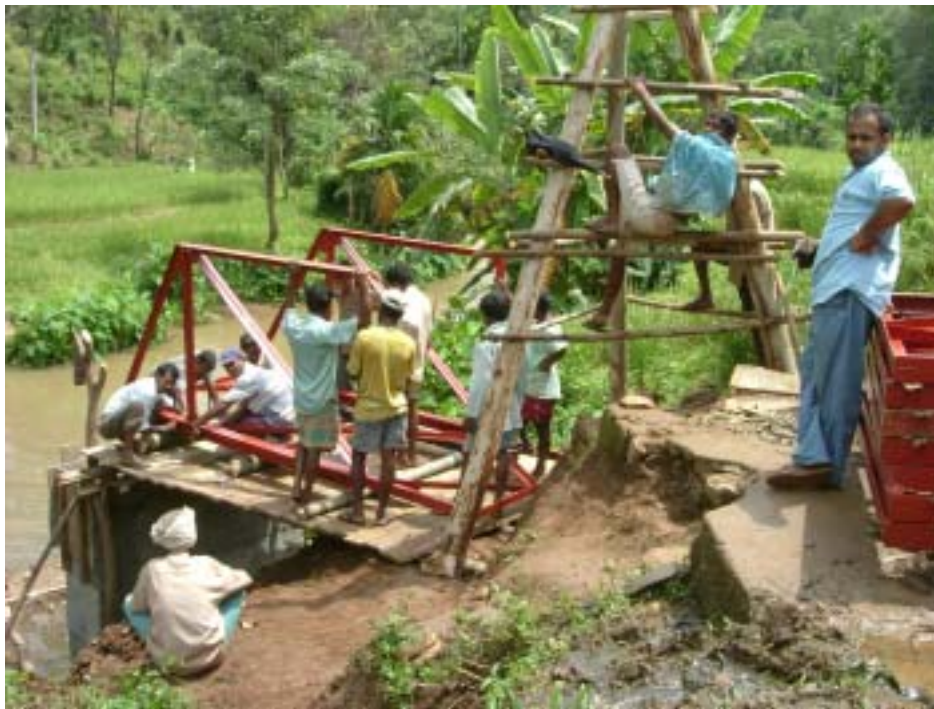
Figure 4.8: Start of Assembly of the Footbridge

- 4.16 Assembly of Side Panels S1.L and S1.R and bolting of the joints with Joining Brackets J1.L and J1.R. This set of bolts should not be tightened until the next set of panels has been added so that holes can be lined up. Assembly was carried out by technicians from the workshop together with help from members of the community.

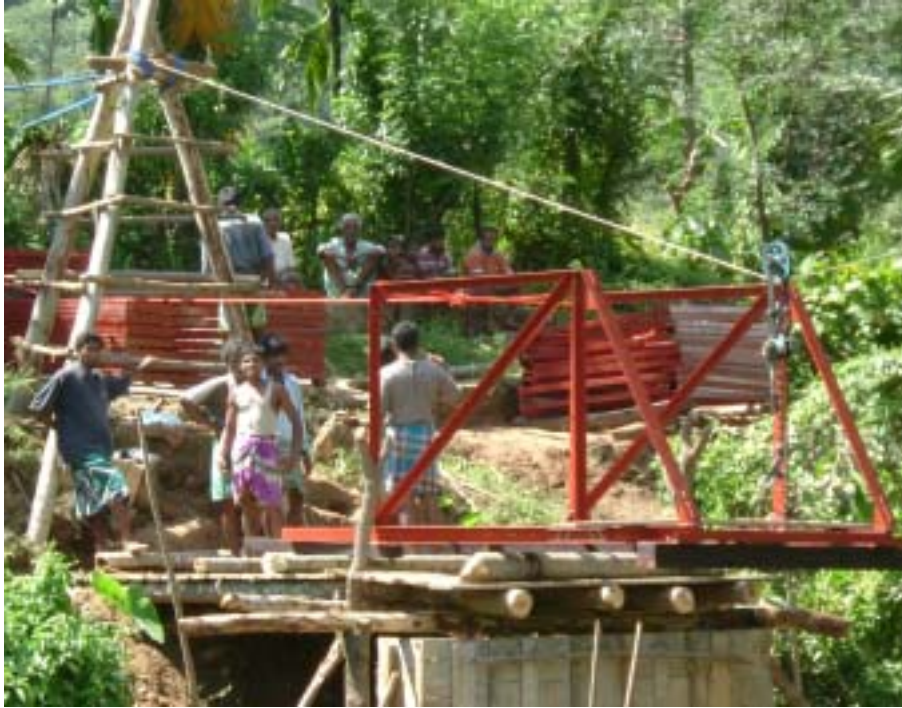
- 4.17 The assembled part of the footbridge is pushed out over the river on the rollers to make space for the next module. The end of the bridge is supported by a pulley block and chain hoist that rolls along the cable.

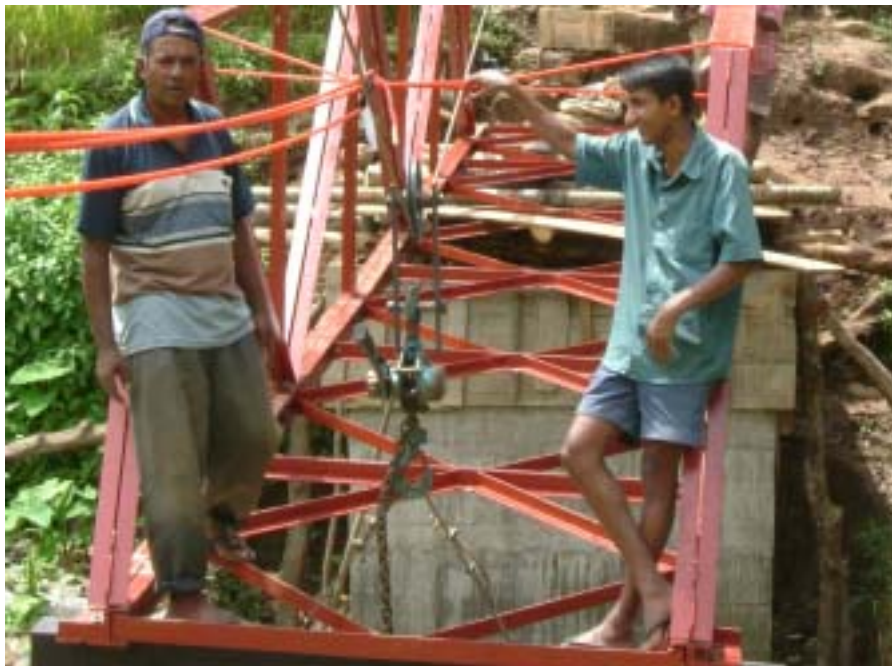
Figure 4.9: Pulley Block Arrangement

- 4.18 Details of the pulley block. The chain hoist enables the level of the end of the footbridge to be adjusted and the end to be lowered onto the abutment. Note also the ropes and pulley used to pull the bridge across the river. A pulley is also used at the anchor end so that passing the rope around the pulleys gives a mechanical advantage of 3 : 1, i.e. the pulling force on the bridge is 3 x force applied by the pullers but the movement is only 1/3.

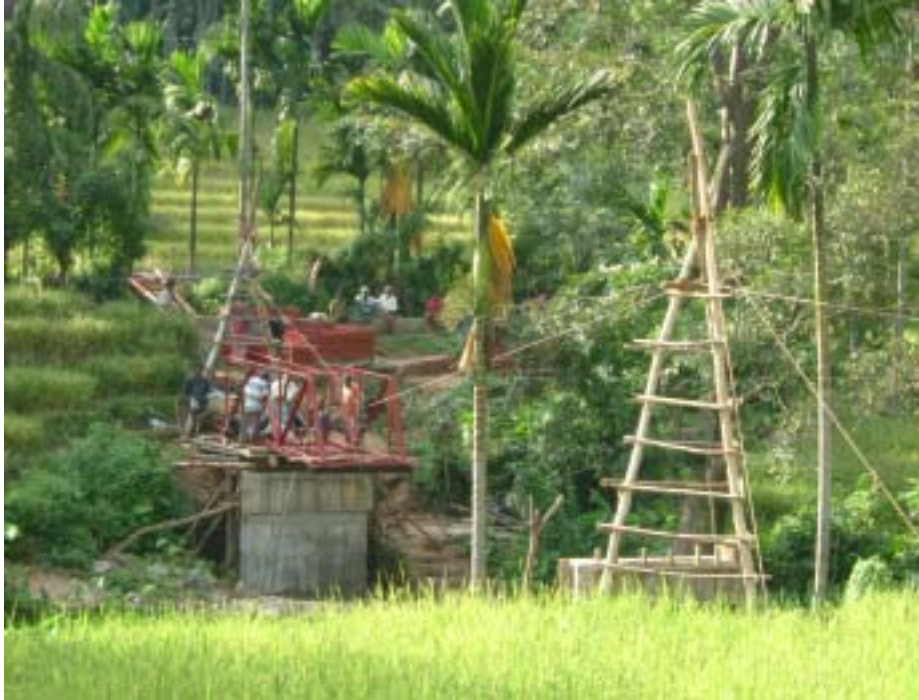
- 4.19 Overall arrangement of the cable-way used for installing the footbridge. The cable passes over the cross-beams at the tops of the 2 towers. The angle of the cable is roughly the same on both sides of the tower to balance the horizontal force components and therefore minimize the force tending to pull the tower over. Note in the background the cable is anchored to the centre of a log wedged behind 2 trees.

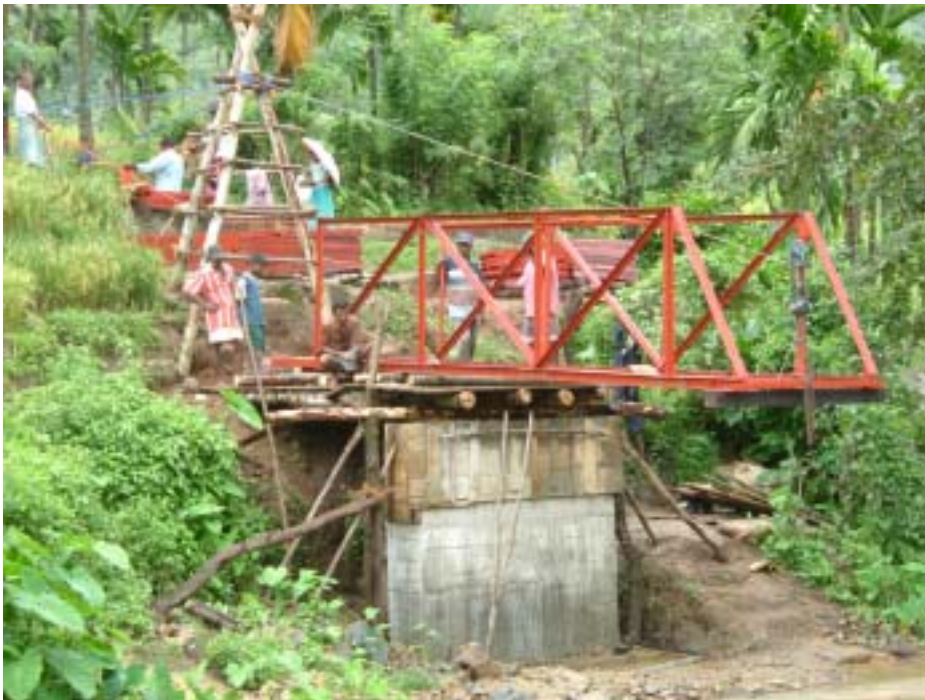
- 4.20 Side panels 1, 2 and 3 have now been assembled. Note that during the initial installation the pulley traveler runs downhill. A steadying rope is therefore needed to control the forward movement of the footbridge. The person at the top left is applying the steadying force. The force is fairly low due to the relatively high friction at the rollers.

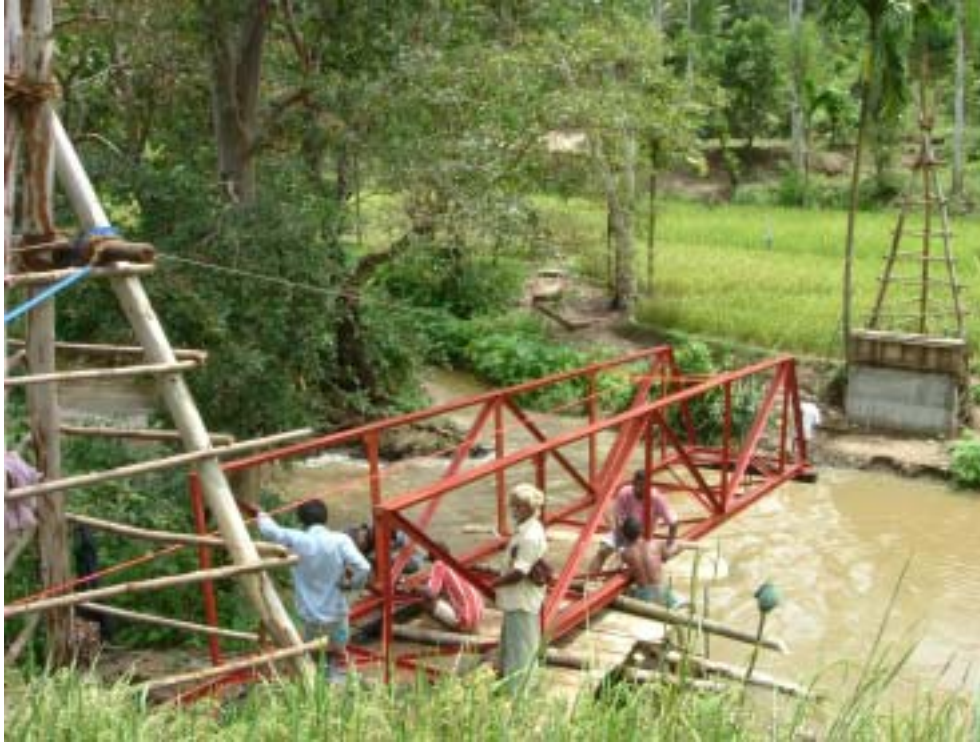
4.21 Bolts being tightened at Joint 3 as Joint 4 has been assembled and bolts fitted. The set of bolts at a joint should be fitted before the previous set are tightened.

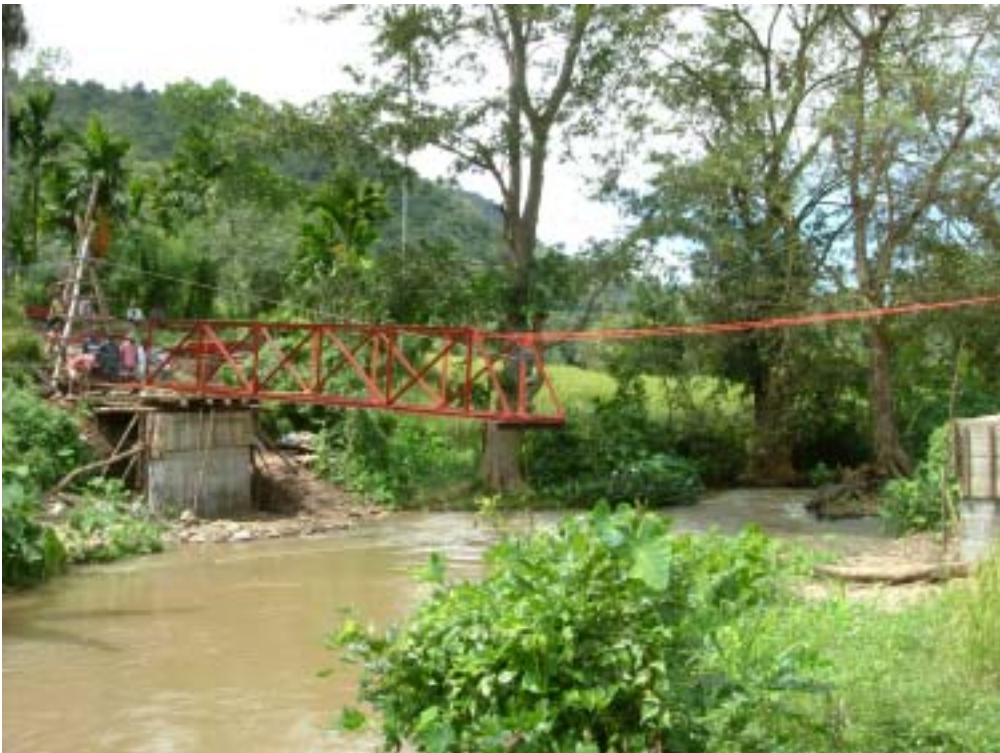
4.22 As the pulley block passed half-way it begins to travel “up-hill”. The triple pulling rope is then needed to pull the bridge across the river together with persons pushing at the assembly end. Note the pulling ropes are initially nearly horizontal. As the end of the bridge approaches the abutment the ropes have to be inclined upwards from the bridge to get a more effective pull.

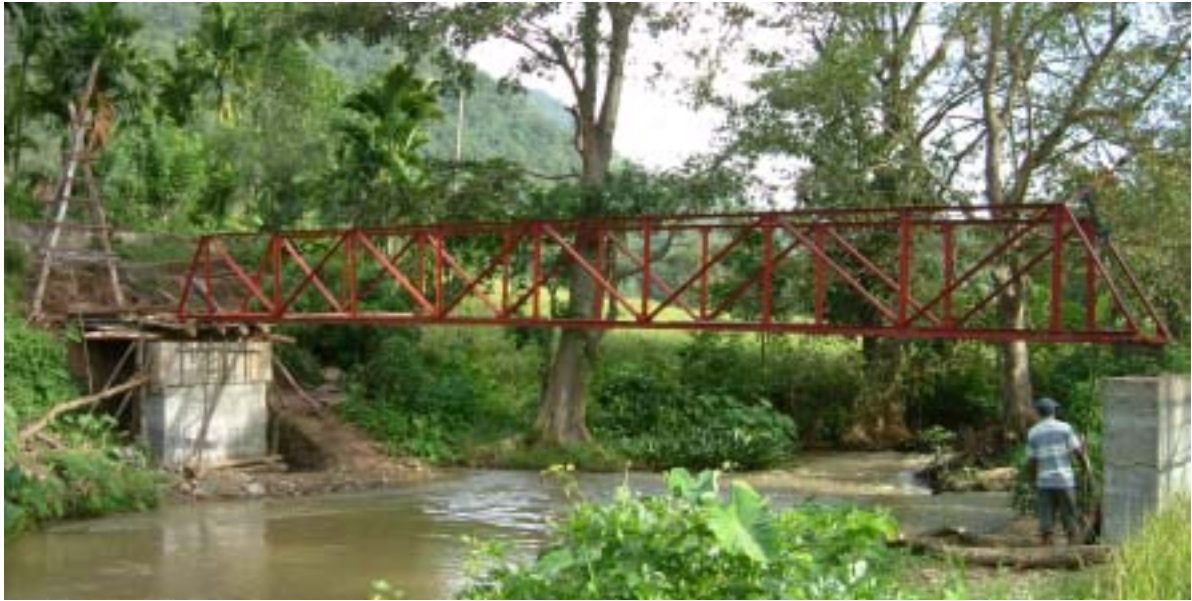
4.23 Fully assembled footbridge supported above the two abutments. Note that the pulling rope is now passed over the cross-member at the top of the tower in order to pull at an upward angle on the bridge

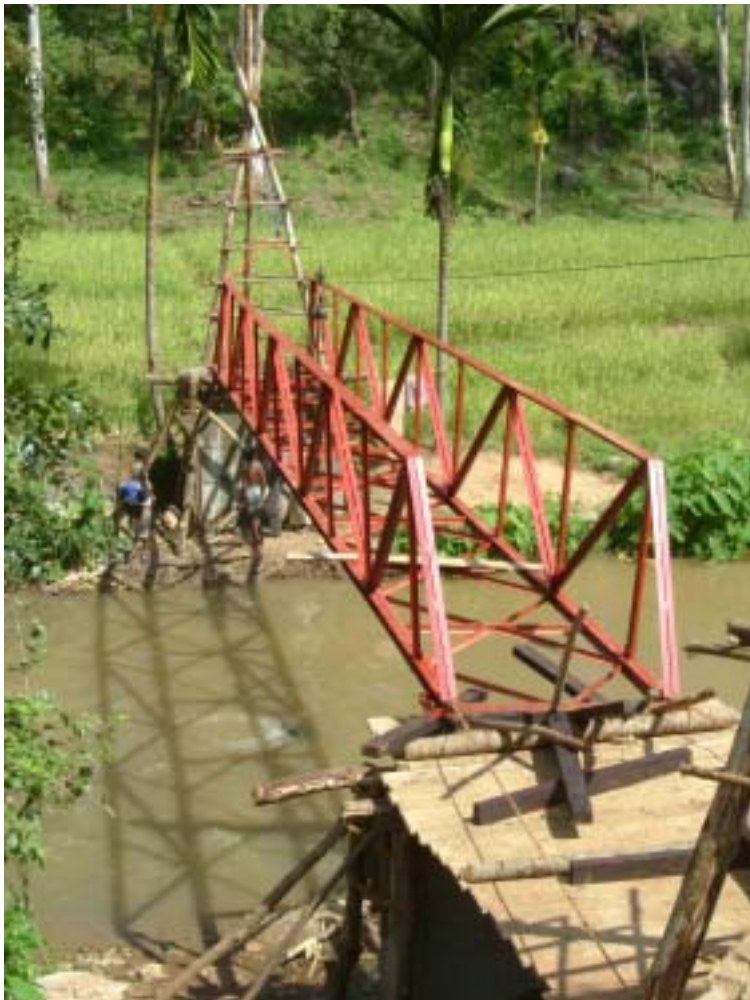
4.24 Assembled footbridge supported on packing at each abutment. Note that the pulley block is now supporting the centre of the bridge.

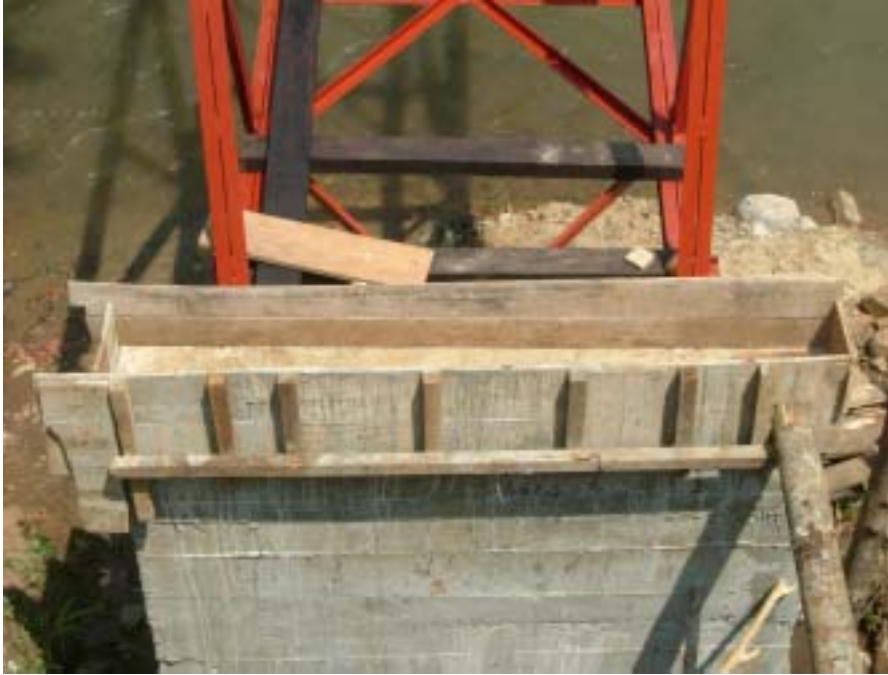
4.25 Shuttering set up around the top of the abutment to cast the concrete bearing cap.

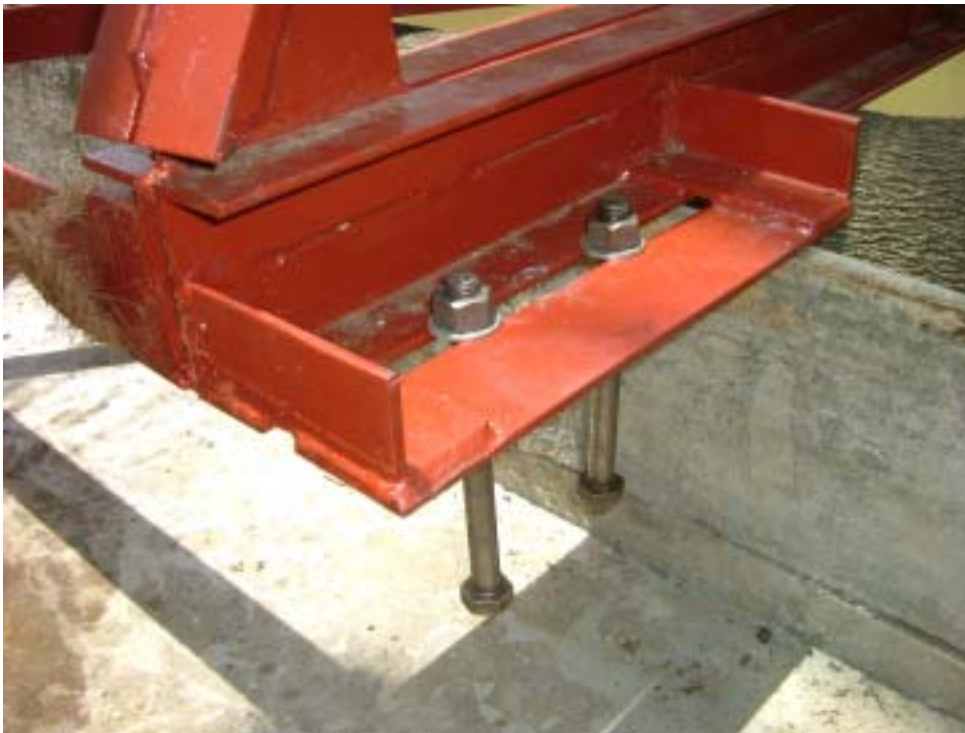
4.26 The end of the footbridge supported on the shuttering with the fixing bolts hanging from the bearing foot.

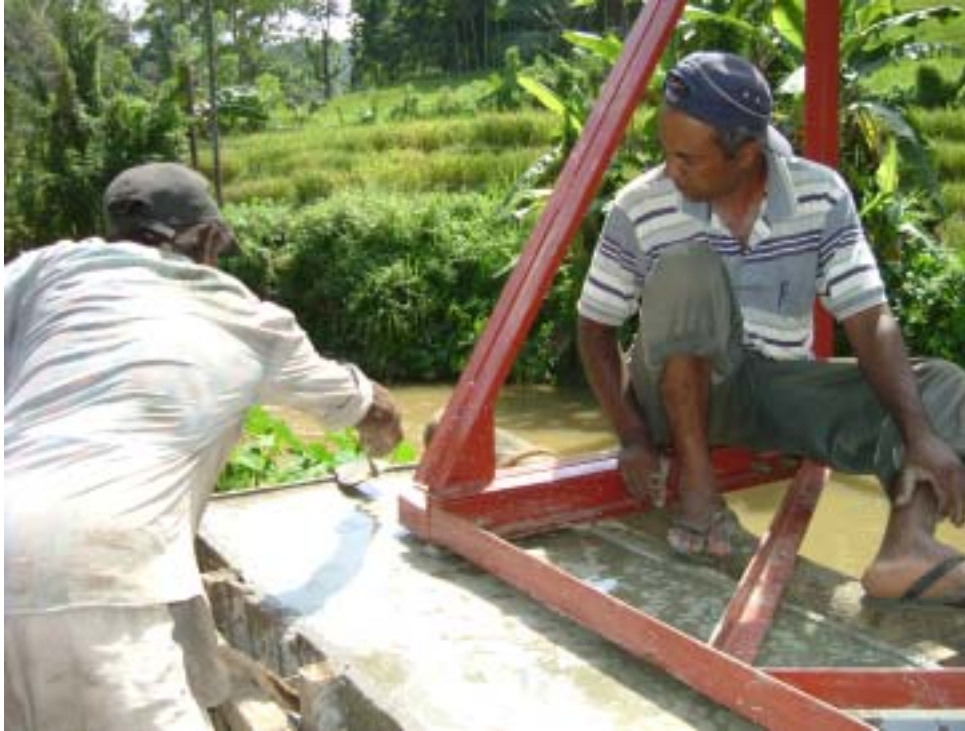
4.27 Completing the concrete bearing cap

- Figure 4.13 and 4.14 show the completion of the bearing caps and the bearing arrangement for the footbridge on the abutments. Note that the bridge is fixed by bolting at one end and allowed to slide longitudinally at the other to cater for changes in length caused by temperature variations

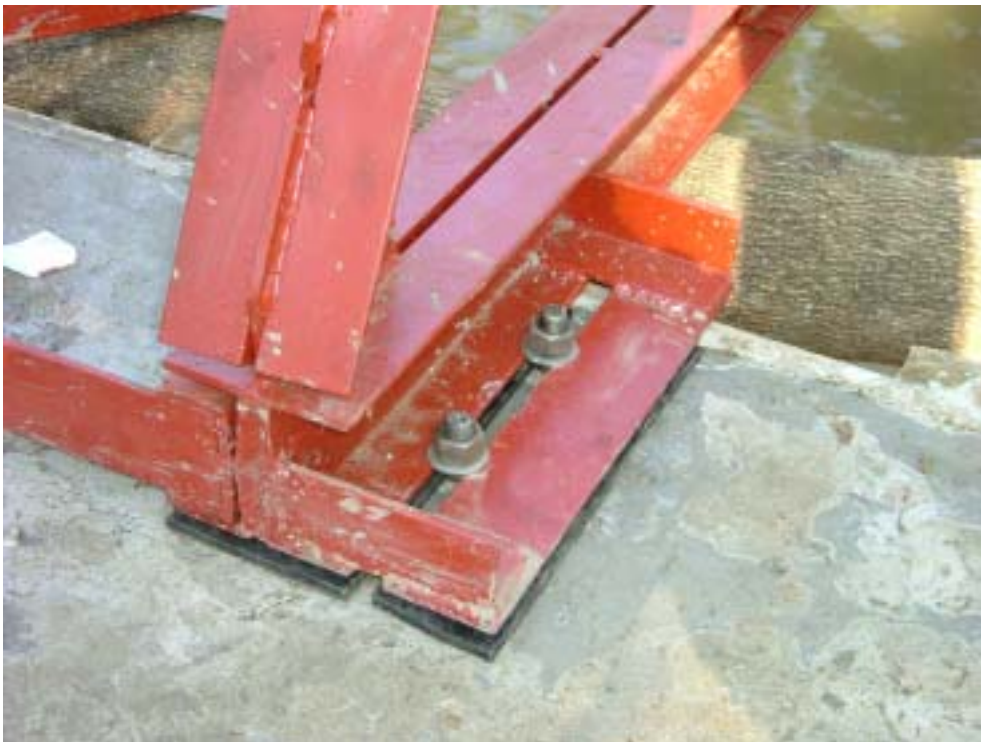
4.28 Bearing foot at the Fixed End of the footbridge. Note the rubber sheet used to support the foot.

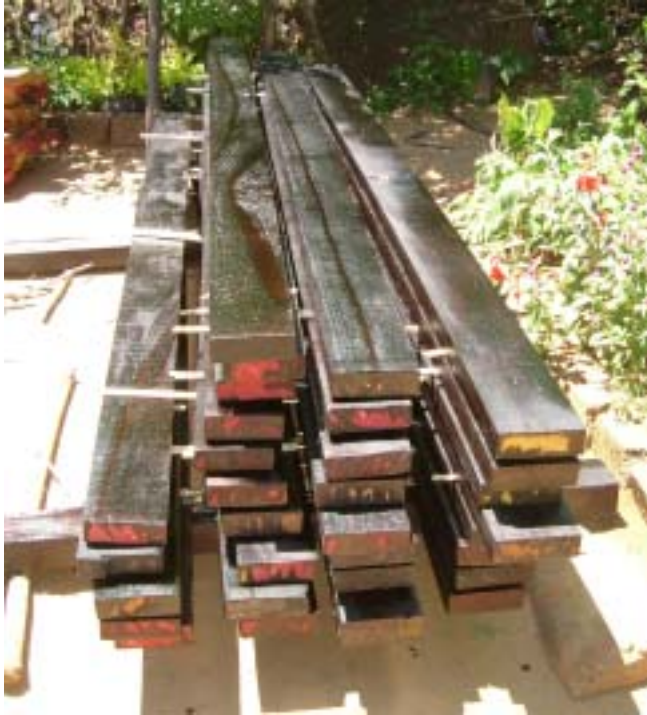
4.29 The deck planks were treated with a bituminous wood preservative before installation. It is seen that the ends, the most susceptible surface, have not been adequately treated. At least 2 coats are needed on all surfaces.

- Figure 4.15 shows some of the planks after treatment with a bituminous preservative. It is noted that the treatment should also have included the end grain and have been repeated a number of times to get reasonable penetration
- Figures 4.15 and 4.16 show the arrangement of the decking planks and the methods for fixing them in position

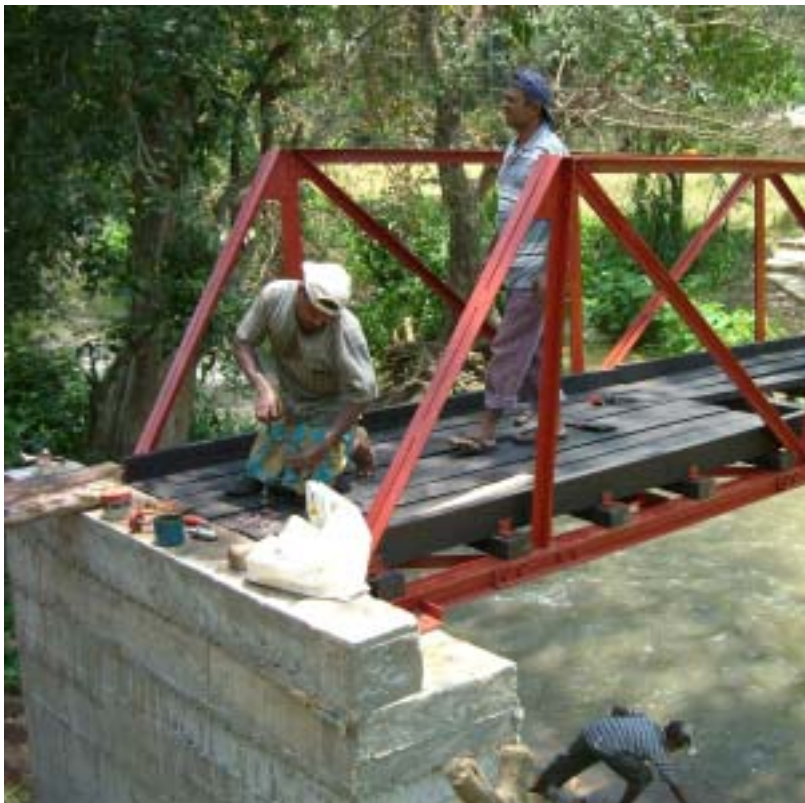
4.30 Arrangement of decking. Cross-beams of 125 x 75mm rest on the Bottom Longitudinals at a spacing of 600mm. 8 runners of 150 x 50mm are screwed on the top of these with 75mm brass screws. Note the holes being drilled for the screws. Kerbs are also 150 x 50mm. The use of screws was a local decision. It is a better option than galvanized nails but more costly.

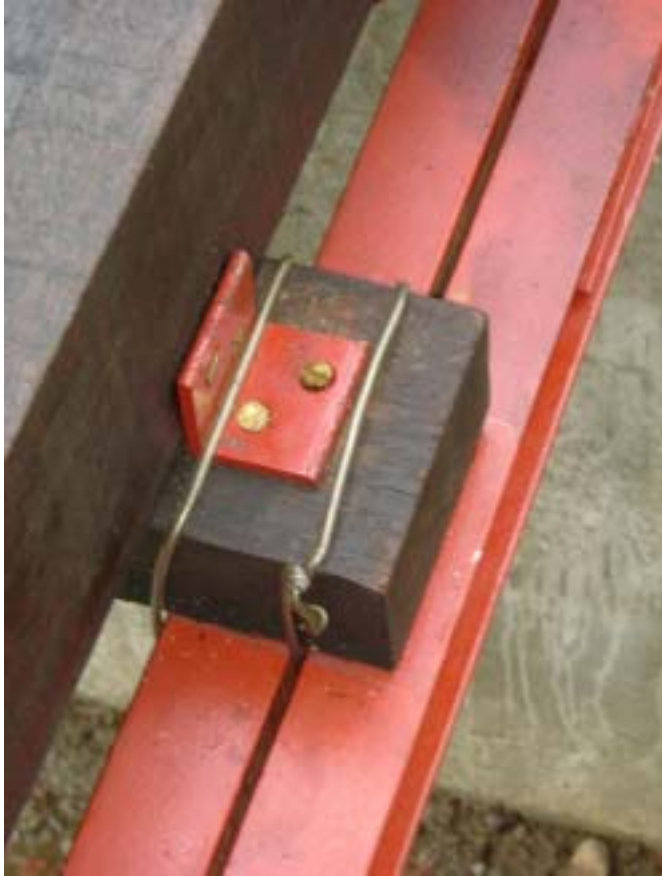
- 4.31 Cross-members are attached to the kerbs with 60mm long brackets of 50 x 50 x 6mm angle. At junctions of the kerbs, 120mm long brackets are used to join the kerbs together.

The cross-members are bound to the Bottom Longitudinals with 2mm galvanized wire fitted in plastic tubing to prevent damage to the paintwork.

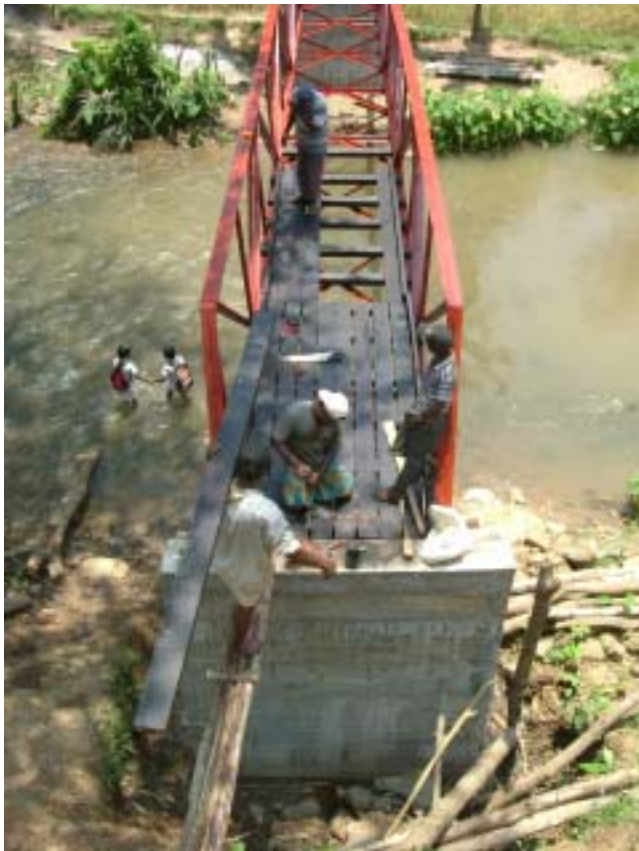
- 4.32 The arrangement of the deck showing the longitudinal runners supported by the cross-beams. Although it is recommended to overlap the joints of the runners, this is not a significant issue.

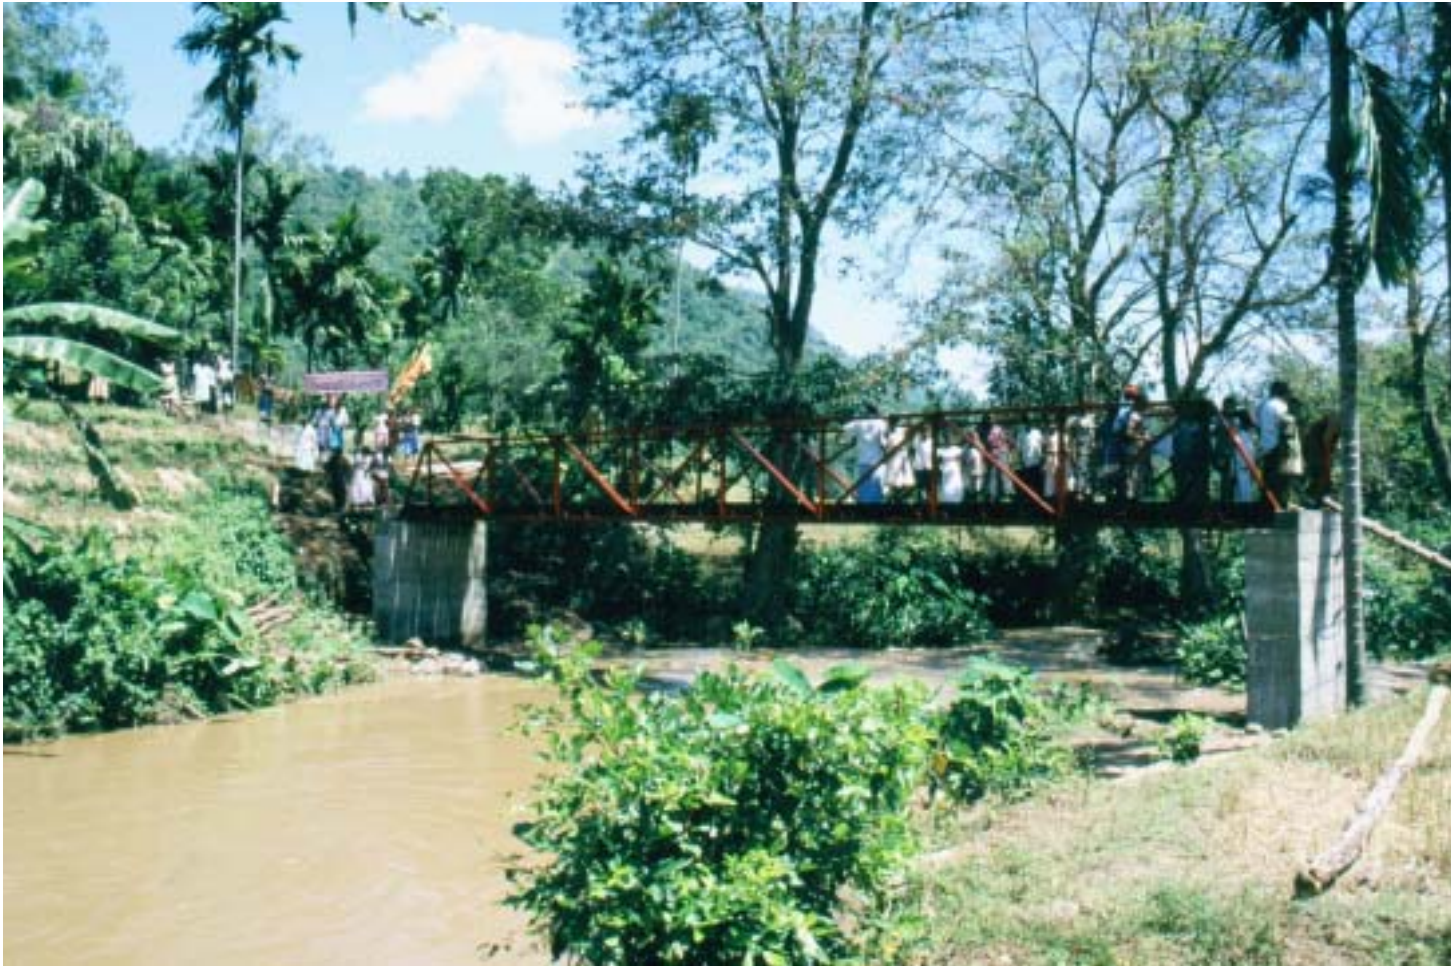
Figure 4.17: The Completed Footbridge

The opening ceremony for the completed footbridge. The community still has to complete backfilling the areas behind the abutments to form the approaches to the footbridge.

- Figure 4.17 shows the completed footbridge. The approaches to the bridge still have to be constructed by the community.
