# Low Cost Slope Stabilisation

**Tim Hunt**

**Scott Wilson (Thailand)**

**This will be illustrated by the work carried out under the SEACAP 21 project in Laos**

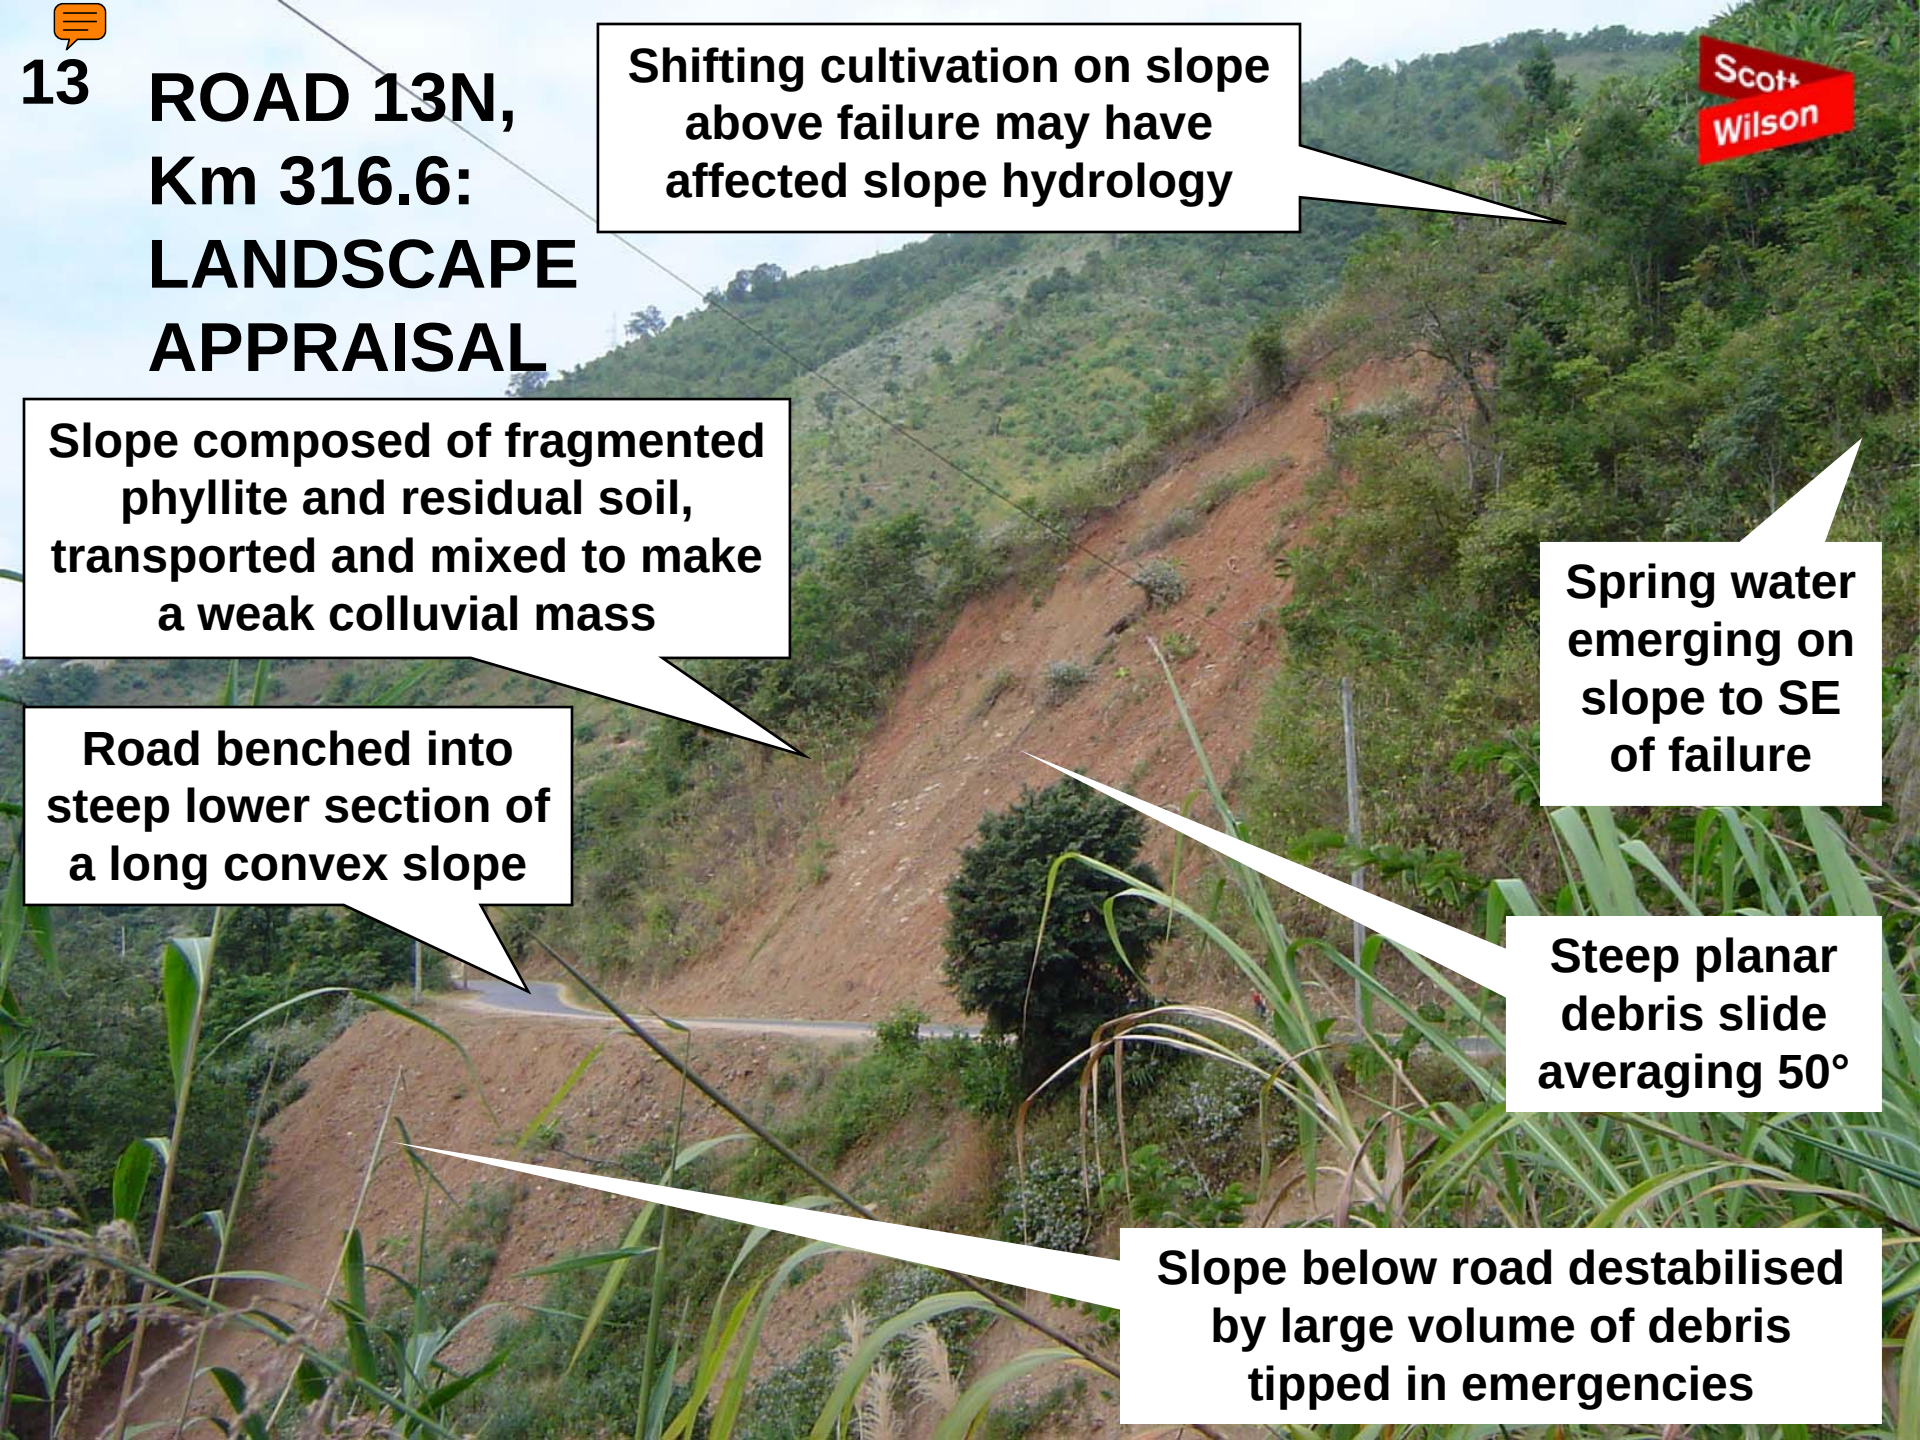
# ROAD 13N, Km 316.6: LANDSCAPE APPRAISAL

Shifting cultivation on slope  
above failure may have  
affected slope hydrology

Slope composed of fragmented  
phyllite and residual soil,  
transported and mixed to make  
a weak colluvial mass

Road benched into  
steep lower section of  
a long convex slope

Spring water  
emerging on  
slope to SE  
of failure

Steep planar  
debris slide  
averaging 50°

Slope below road destabilised  
by large volume of debris  
tipped in emergencies

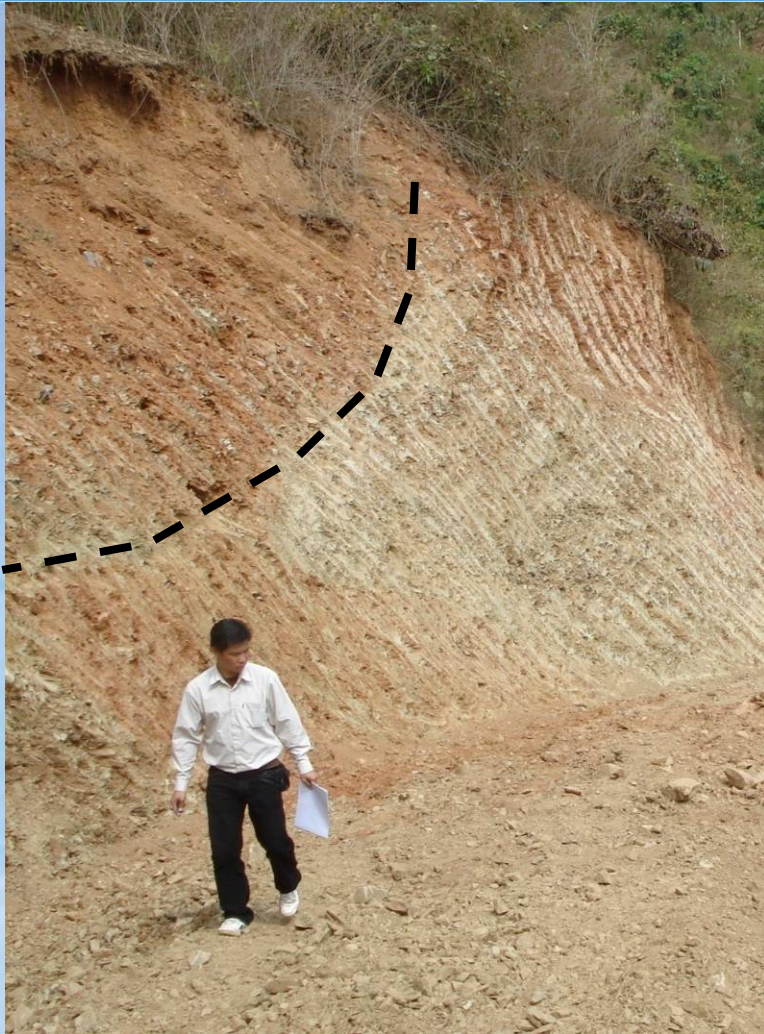
**Failure plane**

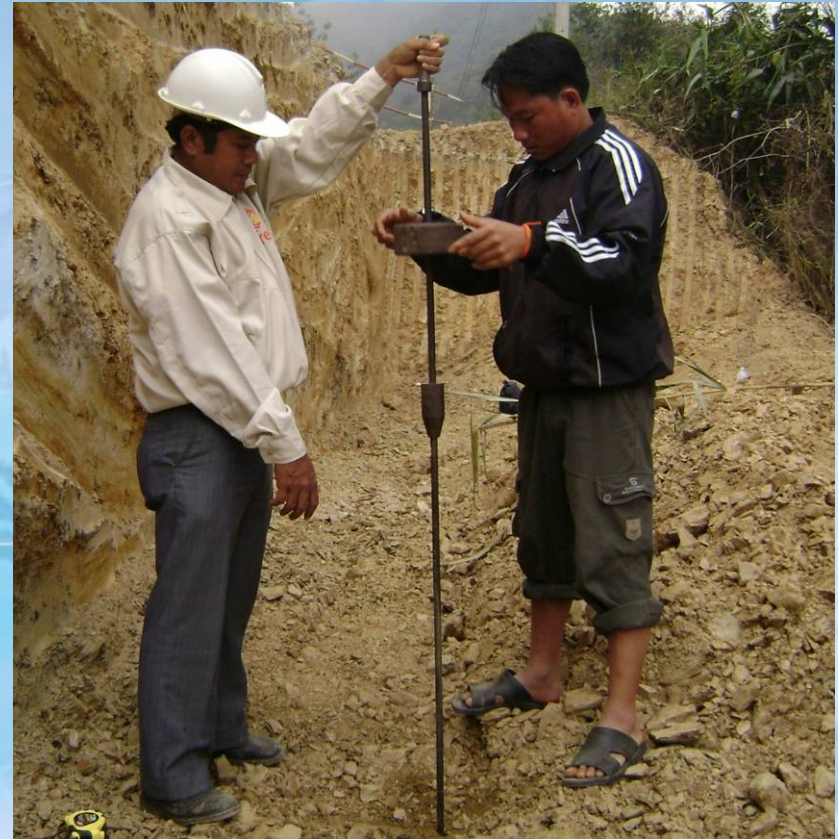
**DCP testing**

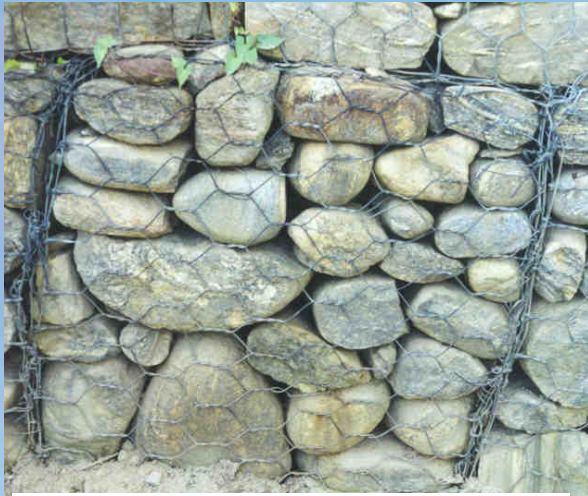
**Rounded stone**

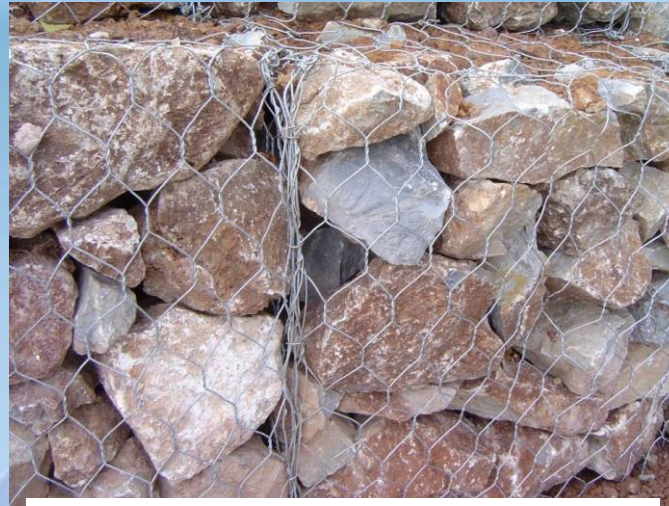
**Angular stone 1**

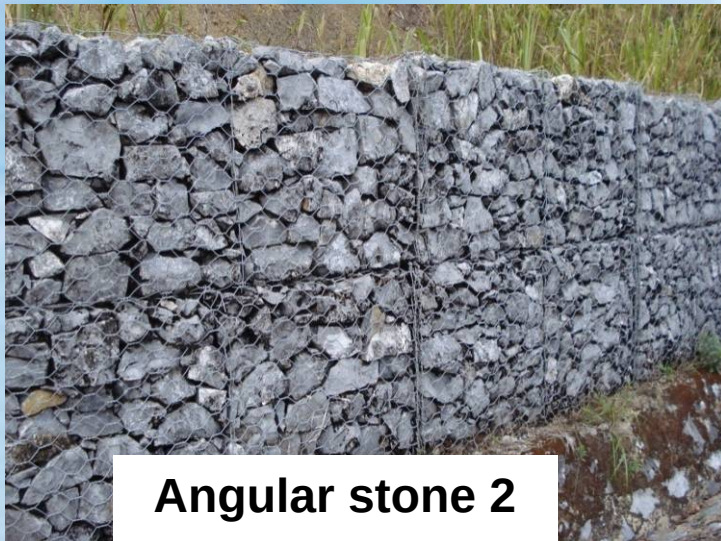
**Angular stone 2**

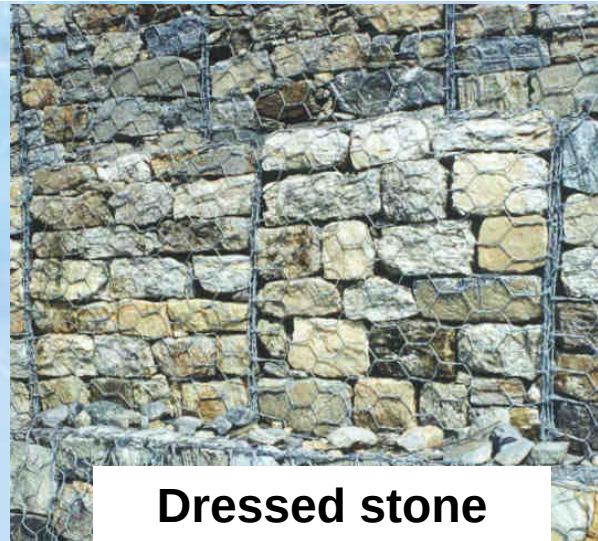
**Dressed stone**

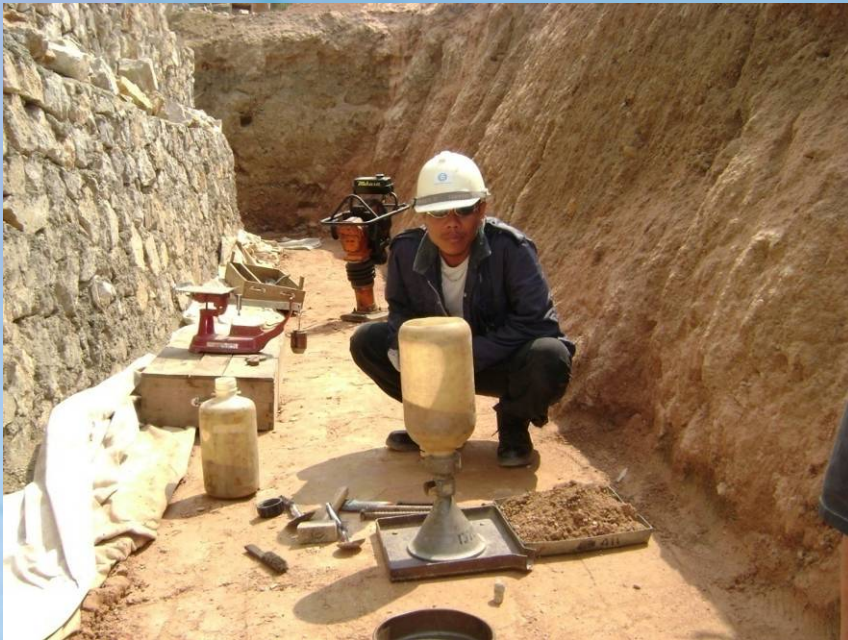
**Backfill density testing**

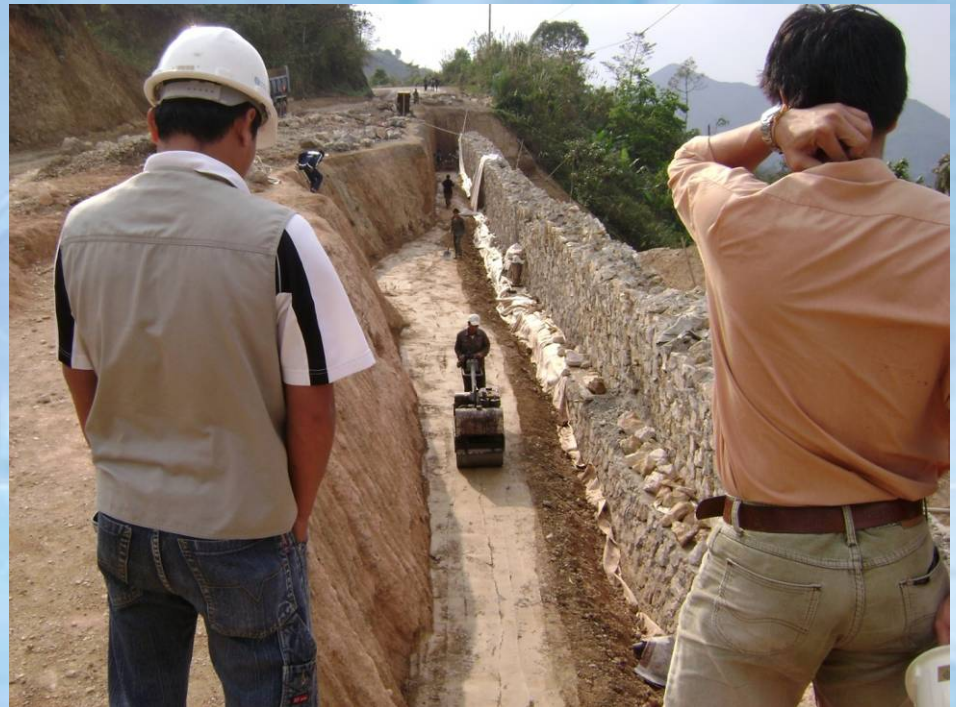
**Compaction using pedestrian roller**

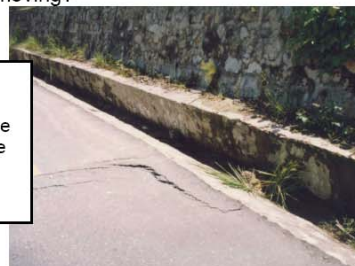
Cracking in roadside drain and road surface caused by large scale slope movements

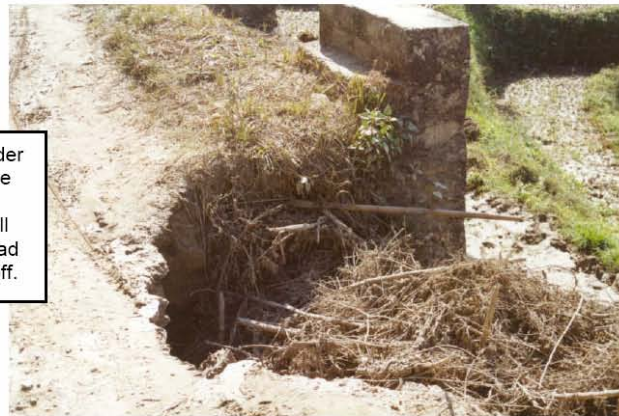
Severe shoulder erosion at the end of a retaining wall caused by road surface run-off.

Erosion taking place below the road is usually due to a concentrated flow of water from the road finding its way onto an erodible slope or gully. This often happens when the roadside drains have been blocked, or where the surface water is able to run down the lower side of the road. In these cases the blockage should be cleared, or a temporary earth bund constructed on the edge of the road to prevent the water from running down the slope. The problem also often occurs at the lower end of road supporting retaining walls. Eventually, the temporary earth bund should be replaced with a concrete upstand or kerb, to make sure that the water flow is redirected to a suitable location where it will not cause further erosion.

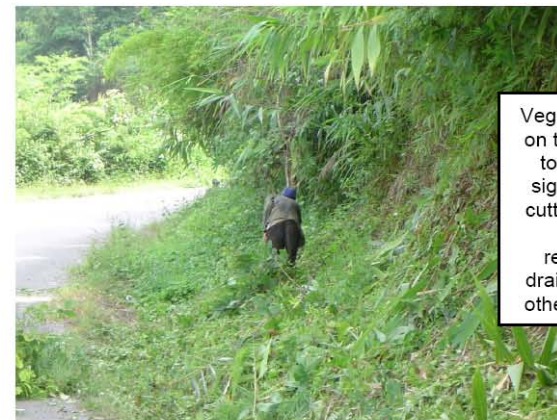
Vegetation is being cut on the lower cut slope to improve drivers' sight lines. Once the cutting is finished, the material will be removed from the drain and piled on the other side of the road.

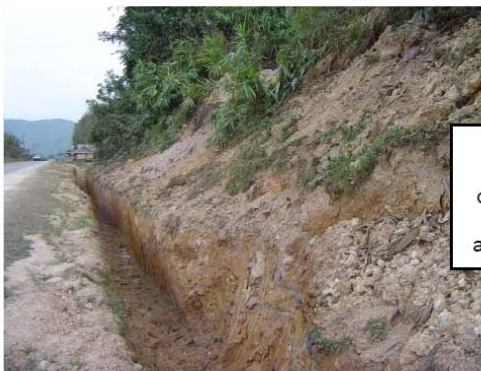
A temporary drain dug in debris that has fallen from above the road.

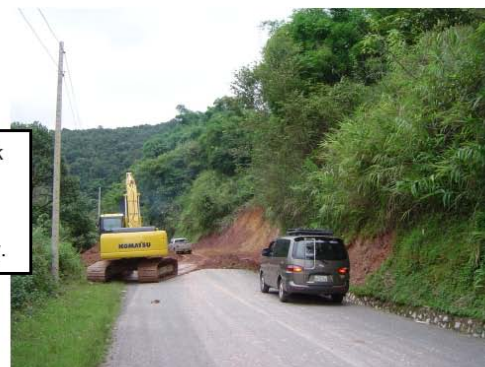
Emergency work following the collapse of a culvert on a national highway.

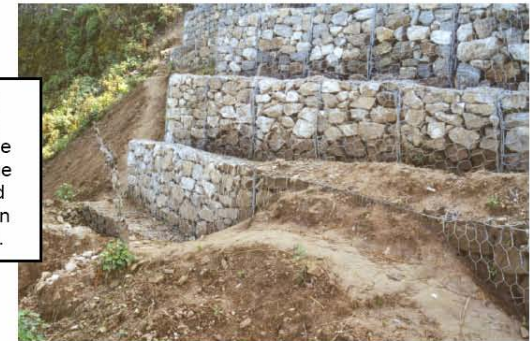
Gabion walls. Remember that gabion walls are permeable to water. Any water permeating through the gabions down to foundation level must be allowed to escape easily. This means that any surplus spoil placed in front of the wall during excavation must be removed to prevent ponding.

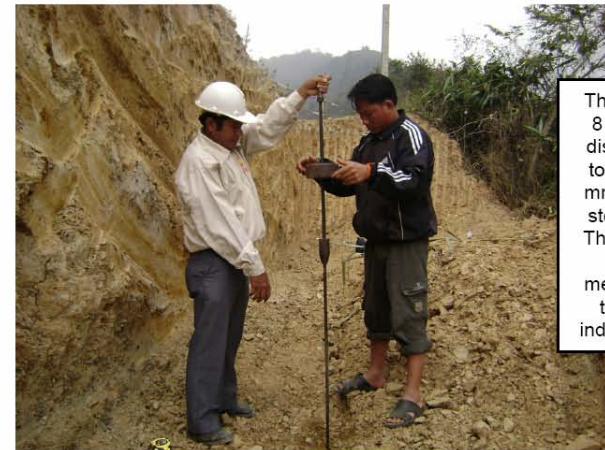
The DCP comprises an 8 kg hammer falling a distance of 575 mm on to a rod to which a 20-mm diameter hardened steel cone is attached. The number of blows to drive the cone a measured distance into the ground gives an indication of its strength.

Foundation level. Most small scale wall foundation levels can be determined by visual inspection. The use of a Dynamic Cone Penetrometer (DCP) may help in determining a suitable foundation level and further information on this device is given in the *Slope Maintenance Manual*.

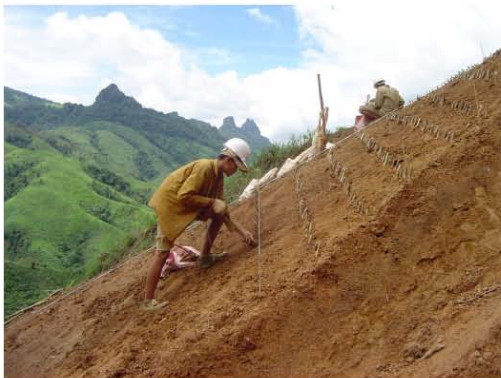
Grass slips are planted in lines across the slope. The best results usually come from lines that are at 45° to the maximum slope. Start from the top and work downwards.

Mark out the lines on the slope and then plant the grass slips to the original depth and gently firm the soil back around them.

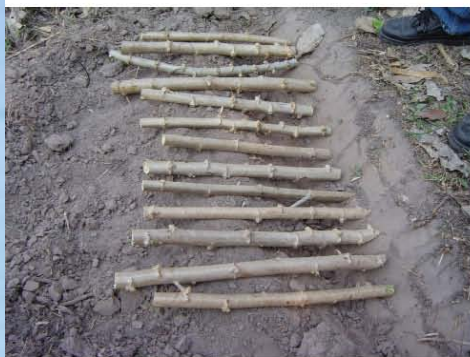
Mark out horizontal lines every 2 metres down the slope. Start from the bottom and work upwards. Dig shallow trenches along the lines, 350 to 450 mm wide.

Lay the cuttings across the trenches with the bottom inwards and 80 to 100 mm of the top protruding from the slope. The cuttings should be 50 mm apart. Place a small amount of soil over the cuttings and then lay another line of cuttings. Replace all the soil and firm it down gently.

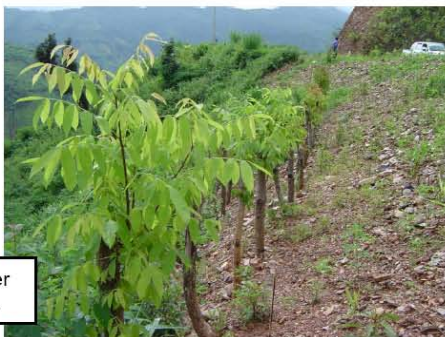
Truncheon cuttings after one season of growth.

Use a crowbar to make a vertical hole that is about 20 mm wider than the cutting and at least 1 metre deep. Place the cutting in the hole and gently fill around it with loose soil. Truncheon cuttings are usually planted 1 metre apart on deep debris slopes.

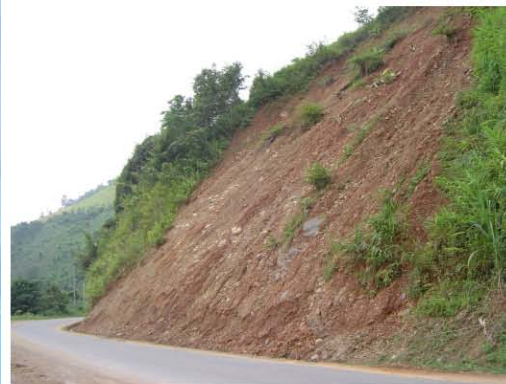
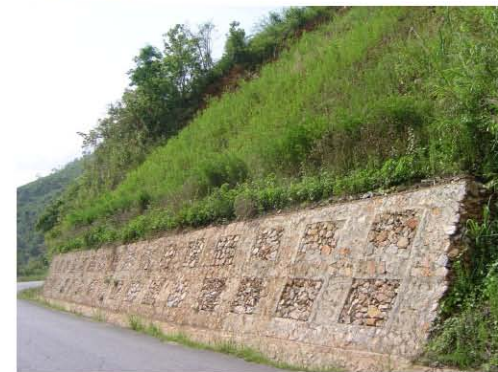
Road 13 North, km 316.  
A revetment wall and various types of bio-engineering works were used to protect the slope.
