SEACAP 21/002

**Feasibility Study for a
National Programme
to Manage Slope Stability**

**SEACAP Practitioners' Workshop
4-5 November 2008**

**Slope stabilisation trials on Road 13N and
Road 7 in Lao PDR**

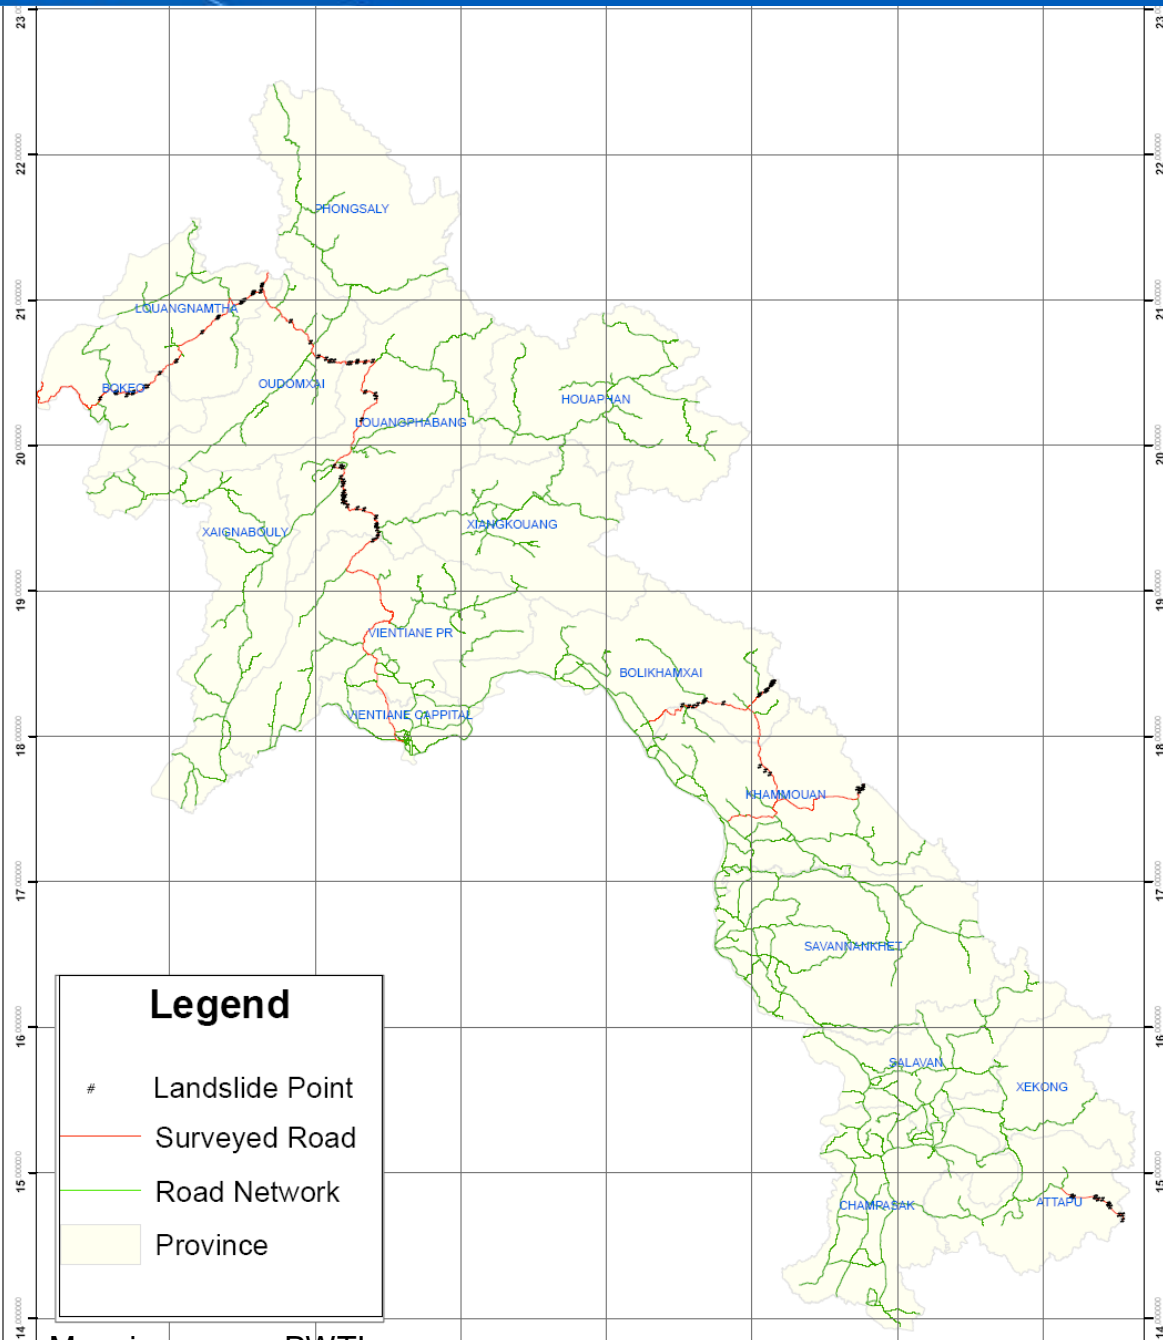
Landslide Inventory

- Notes, photographs and hazard/risk rating for >150 landslides
- Over 1,500 km of the 7000 km National Road included in Inventory
- Approx 50% of the hilly or mountainous National Road network

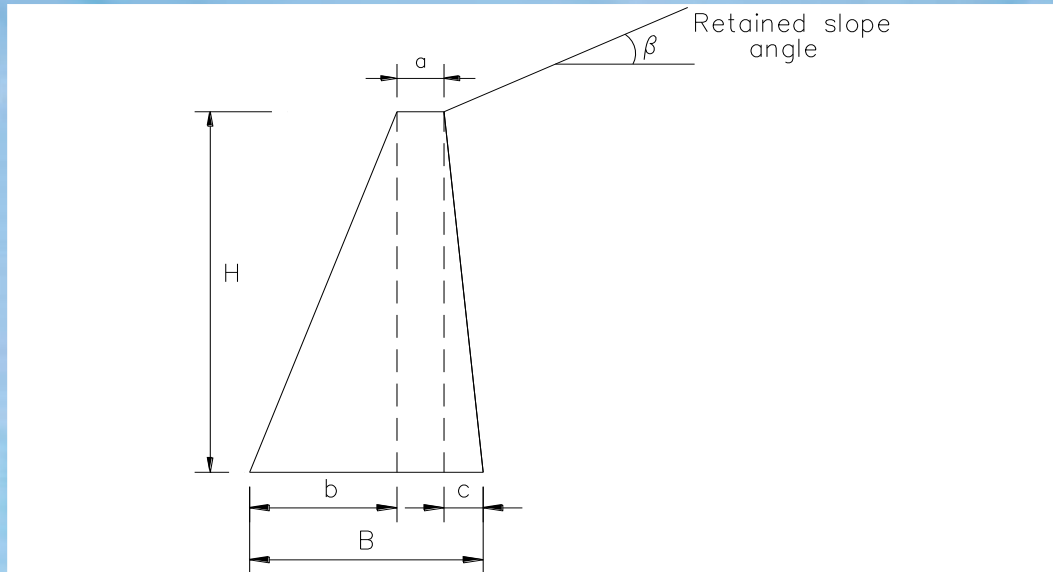
Design Spreadsheet for Masonry Gravity Walls

DENSITY OF WALL MATERIAL	22	kN/m ³		
PHI OF BACKFILL	30	ϕ	rad	0.523599
BACKFILL DENSITY	18	kN/m ³		
PHI OF BASE	20			
ACTIVE COEFF (Ka)	0.26			
Active Pressure	21	kN/m ²		
SURCHARGE	10	kN/m		
Back Slope Angle of Wall	95	α	rad	1.658063
WALL FRICTION	20	δ	rad	0.349066
SLOPE	0	β	rad	0

Ka	
$\sin^2(\alpha+\phi)$	0.67101
$\sin^2\alpha$	0.992404
$\sin(\alpha-\delta)$	0.965926
$\sin(\phi+\delta)$	0.766044
$\sin(\phi-\beta)$	0.5
$\sin(\alpha+\beta)$	0.996195

a	b	c	B	H
0.6	1.091	0.262	1.953	3

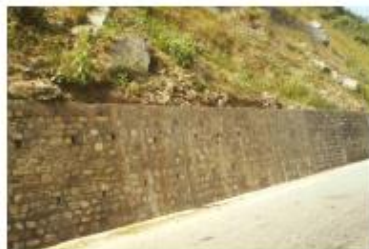
Mortared masonry wall

There are three main types of wall constructed in Laos: masonry, gabion and reinforced concrete. Masonry walls can be composite or fully mortared.

From considerations of cost, durability, appearance and strength, cemented masonry walls are generally recommended except where foundation conditions are soft or expected to move over time. In those cases, gabion walls are recommended.
